AVIATION INVESTIGATION REPORT

A02P0168

ENGINE POWER LOSS

BELL 214B-1 (HELICOPTER) C-GTWH

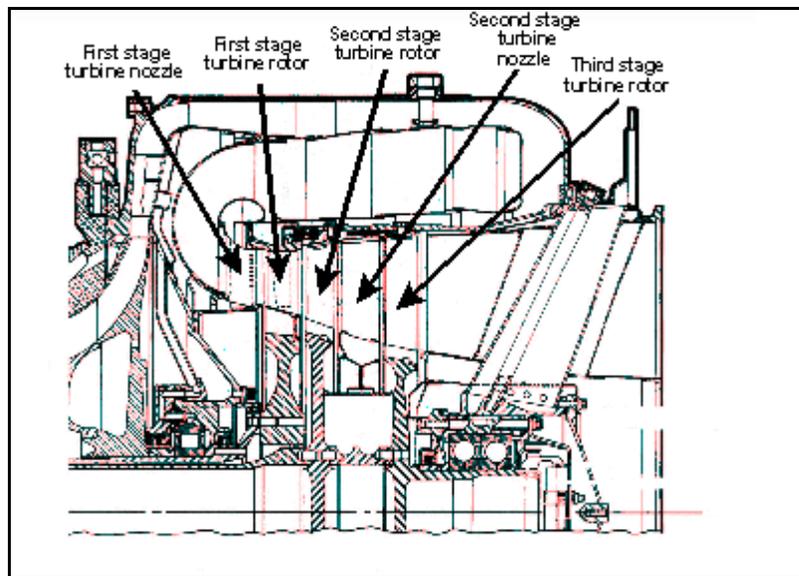
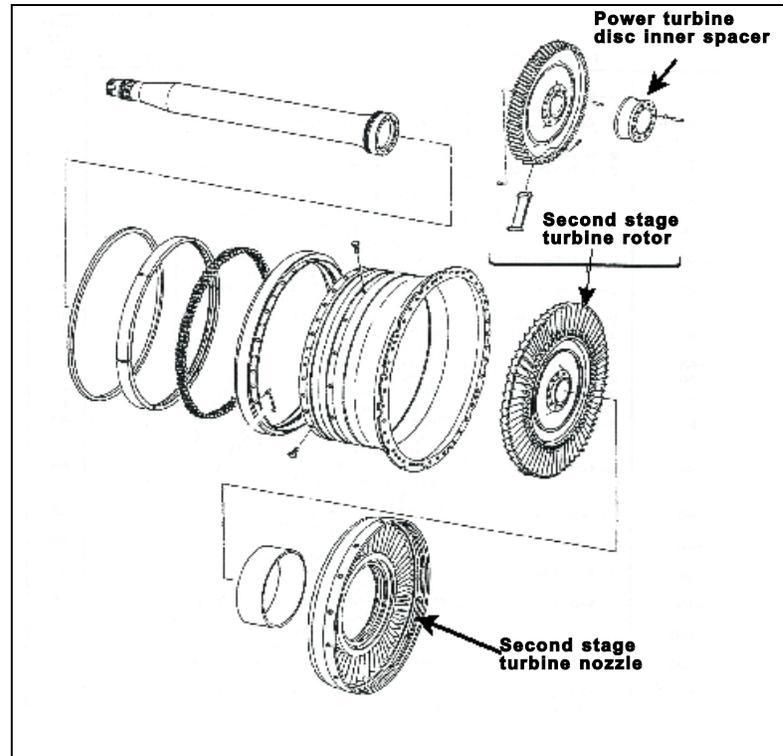
The gas flow through the engine downstream of the combustion chamber is through the first-stage nozzle, the first and second-stage turbines, the second-stage nozzle, and the third-stage turbine (see figures 1 and 2). The first-stage nozzle and first-stage turbine had no significant damage. The second-stage turbine (part number 2-140-040-45), which is coupled to the third-stage turbine via the power turbine disc inner spacer, showed tears and dents on the trailing edges of the blades, mostly toward the blade tips. Four of the blades had tip shrouds missing. The second-stage nozzle (part number 2-140-240-01) had largely disintegrated. A cluster of nine vanes remained attached; the vanes of that cluster were torn and dented from the trailing edge side, with the outboard half being the most affected. The third-stage turbine blading was completely destroyed; only blade roots and stubs remained in the disc.

The fracture surfaces of the third-stage turbine blades were examined for signs of any progressive failure mechanism. All fracture surfaces exhibited topography consistent with an impact and overstress load condition. No indication of fatigue or other type of time dependant failure mode was found. The leading edges of the blade stubs had been abraded due to contact with the second nozzle.

Although the second-stage nozzle had largely disintegrated, a detailed examination of the remaining structure was conducted. The aft portion of the inner vane support was substantially worn away from being in contact with the forward side of the rotating third turbine. A sample of cracked aft inner support sheet metal was removed and an examination of the fracture surfaces was conducted revealing that the prevailing fracture topography was an oxidized intergranular surface with evidence of multiple secondary cracking. The second-stage nozzle is a brazed assembly. Examination of the remaining seams revealed that the braze between the aft seal and the inner shroud was not uniform and that several areas were nearly devoid of braze. Also, the second-stage nozzle had an unauthorised "window patch" weld repair on the outer ring, and the nozzle serial number appeared to have been altered.

Damage to the second-stage nozzle and third-stage turbine indicate that the two components contacted each other while the engine was operating at significant rpm. The damage pattern suggests that the failure sequence was initiated by a loss of integrity of the second-stage nozzle, possibly due to extensive cracking or separation of a braze joint. Such damage is likely to have caused a remarkable loss in delivered engine power, yet insufficient to cause the engine to stop.
