**AVIATION INVESTIGATION REPORT
A04H0004**

**REDUCED POWER AT TAKE-OFF AND COLLISION WITH
TERRAIN**

**MK AIRLINES LIMITED
BOEING 747-244SF 9G-MKJ
HALIFAX INTERNATIONAL AIRPORT, NOVA SCOTIA
14 OCTOBER 2004**

Report Number A04H0004

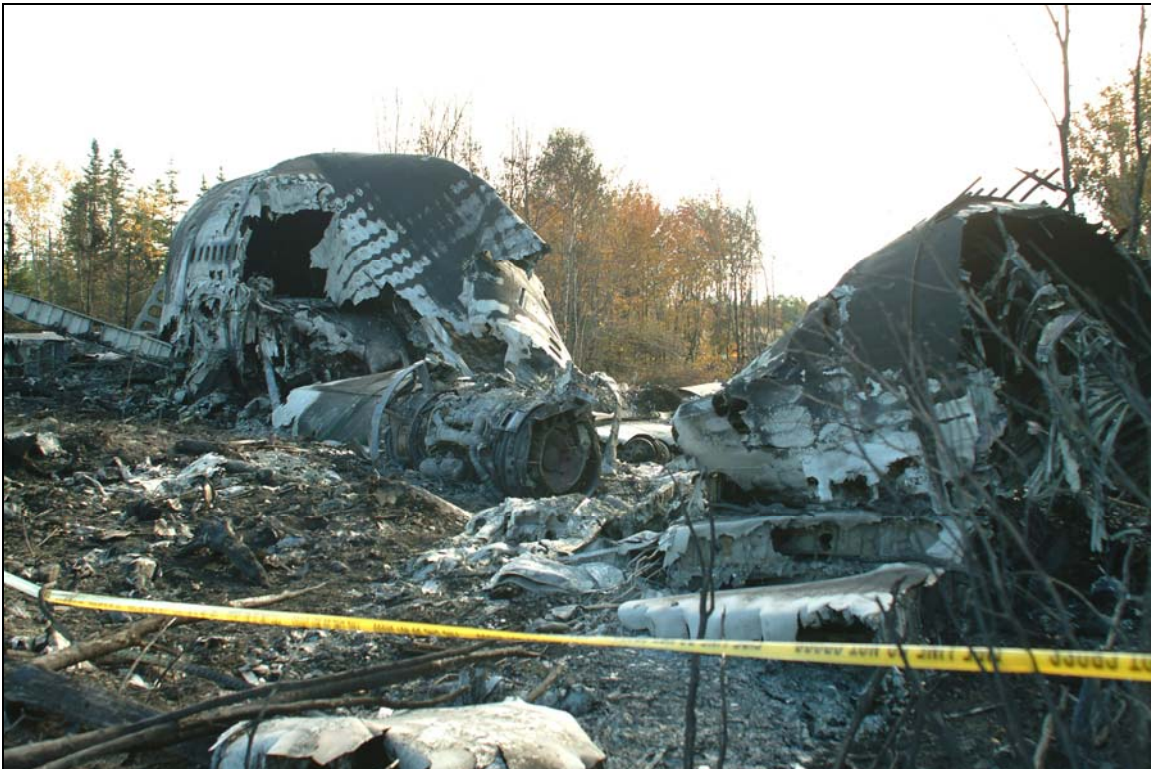
The first damage to the aircraft occurred when, on rotation, the aircraft's lower aft fuselage struck the runway twice and remained on the ground to a point 825 feet beyond the end of Runway 24. Severe damage occurred when the aircraft's lower aft fuselage struck the berm and the vertical stabilizer and both horizontal stabilizers separated from the fuselage. The final impact was in a wooded area where impact forces and an extensive post-crash fire destroyed the remaining aircraft structure forward of the aft pressure bulkhead (see Photo 1).

Photo 1. Main fuselage and number 4 engine

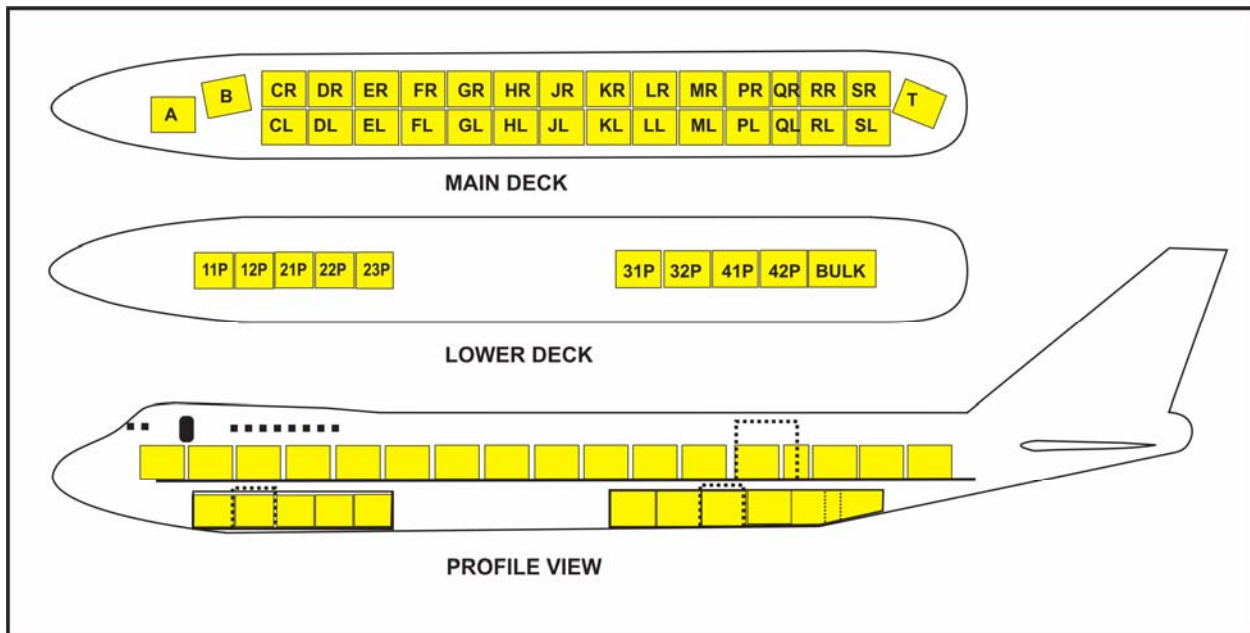
The occurrence aircraft had a number of cargo floor power drive units (PDUs) removed from the aircraft and blanked off because they were unserviceable. As part of the cargo load, a large roll of steel was placed on a 20-foot-long pallet for a total weight of 13 206 kg. When the steel was being loaded onto the aircraft, it could only be moved by the cargo loading system as far as the functioning PDUs would permit. Normally, pallets can be manhandled into position if the PDUs are unserviceable, but, because of the weight of this pallet, it could only be loaded into positions LR and MR (see Figure 1).

Figure 1. Cargo positions

The weight limits for positions LR and MR are 4264 kg respectively, for a total weight limit of 8528 kg. The weight of the steel and the pallet exceeded the limits by 4678 kg. The MK Airlines Limited operations manual (OM), Part A, Chapter 8, stated in part that “the loadmaster/captain must comply with additional structural limits as specified in the loading manual with regard to the maximum mass per cargo compartment.” If all the PDUs had been serviceable, the steel load could have been properly placed in positions HR and JR, where the limit was 13 608 kg.

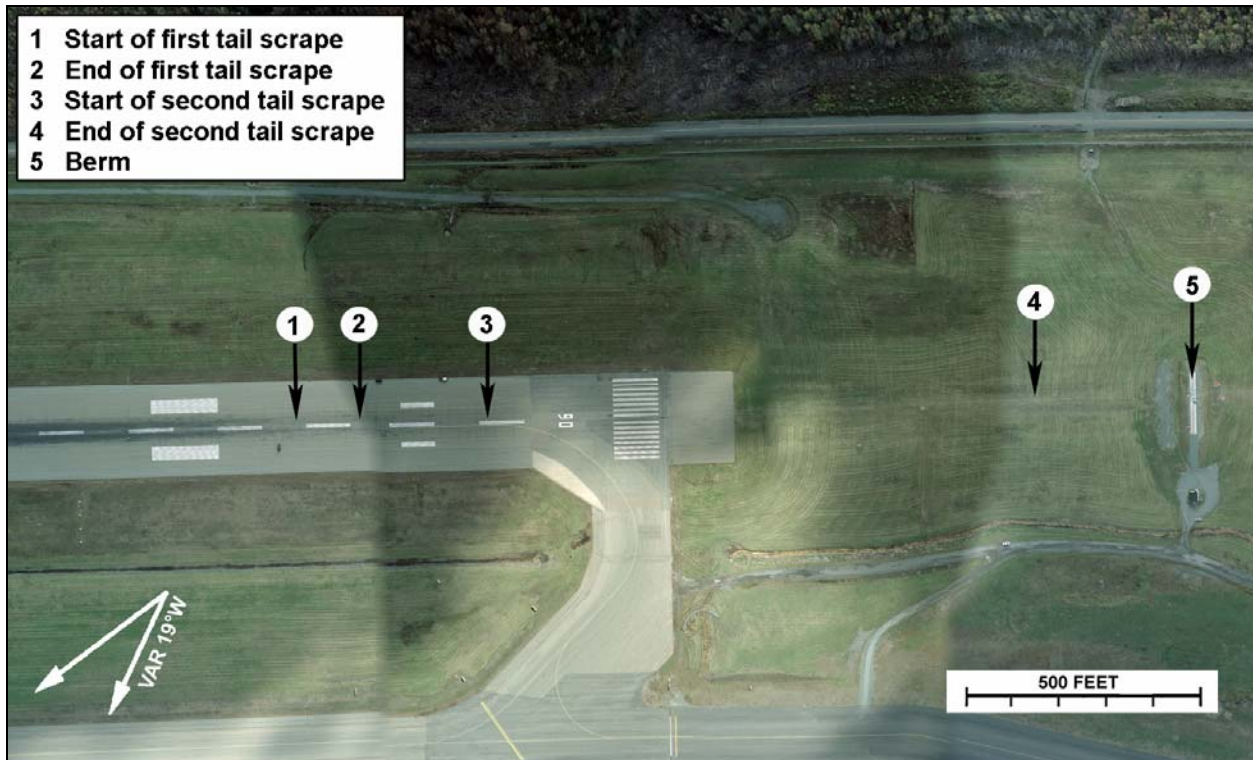
Photo 2. Location of scrape marks and berm

The first indication of aircraft contact with the runway was a scrape mark, which began 830 feet before the end of Runway 24 and was 30 inches left of the runway centreline; it became progressively wider, ending 705 feet from the end of the runway. The scrape mark formed a line approximately one-half degree off the centreline toward the left (see Photo 2).

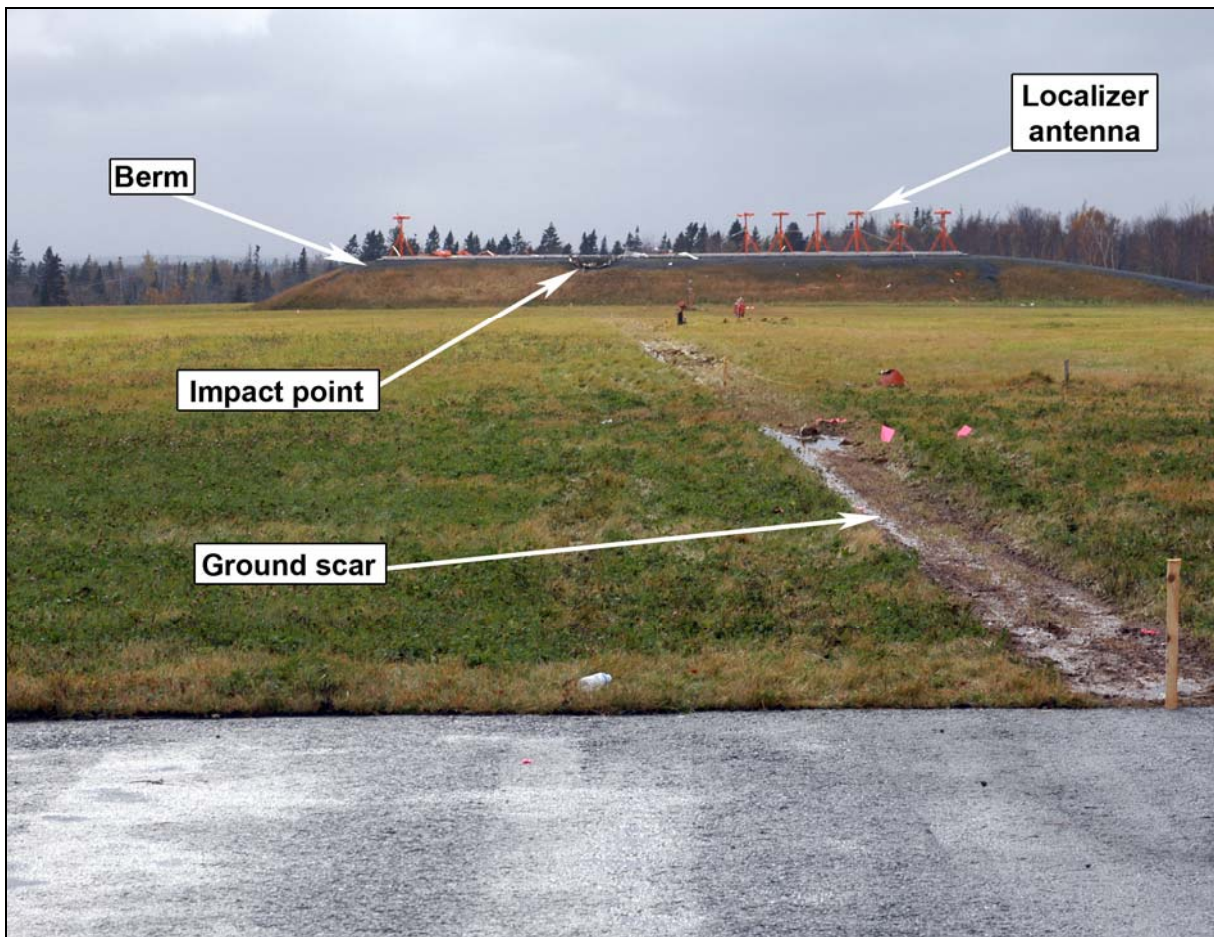
A second scrape mark began 412 feet from the end of the runway and was initially about 3 inches wide, expanding to about 24 inches wide at the runway threshold. There were aluminum scrapes and shavings all along this scrape mark. It continued through the paved runway overrun area and across the grassy area. On the grassy area, the ground scar was initially about 24 inches wide and 2 inches deep, eventually fanning out to about 30 inches wide (see Photo 3). The ground scar became less pronounced until it disappeared at a point approximately 315 feet before the berm, indicating that the aircraft became airborne. The only indication of aircraft contact with the ground was the ground scar caused by the lower aft fuselage. There was no indication that the tires contacted the ground beyond the paved surface. No primary aircraft structure was found in the debris trail before the berm.

Photo 3. View of ground scar and initial impact point with the berm

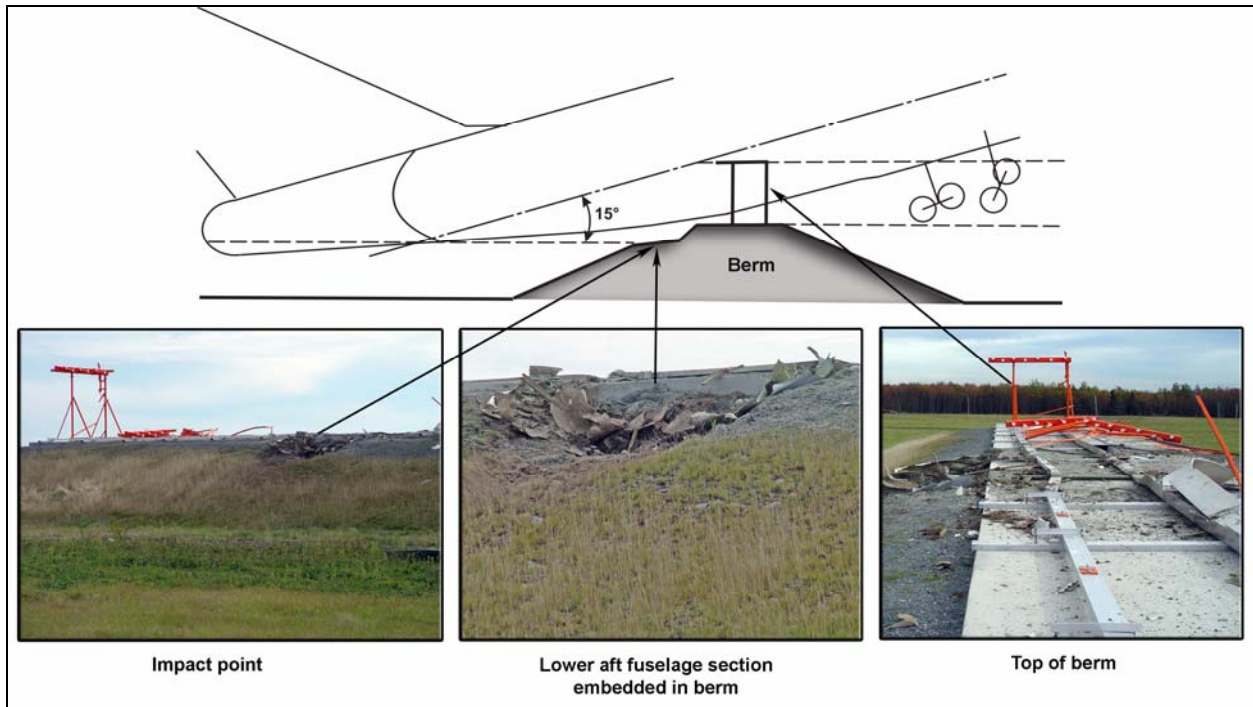
Fuselage structure, comprising the fuselage joint of the aft pressure bulkhead at Station 2360 and some adjacent belly skin, was found embedded in the berm. These pieces were embedded approximately 18 feet to the left of the extended runway centreline, about 30 inches below the top of the concrete pad, and had penetrated about 24 inches into the berm. Black rubber transfer marks, consistent with aircraft tire contact, were on some of the fractured pieces of the ILS antenna, indicating that the tires had struck the antenna (see Photo 4). No similar marks were observed across the concrete pad on top of the berm, indicating that the tires were above the concrete pad as the aircraft passed over it. The pieces of aircraft belly skin found embedded in the berm were identified as coming from the centreline of the aircraft and included roughly the same amount of structure from each side of the centreline. This is consistent with the aircraft having struck the berm in a roughly wings-level attitude. The aircraft pitch was between 15° and 24° at berm impact. If the aircraft was pitched at less than 15°, the wheels would have struck the top of the berm, and if the aircraft was pitched at greater than 24°, the tires would not have struck the antenna.

Photo 4. Minimum aircraft pitch attitude at point of impact with berm

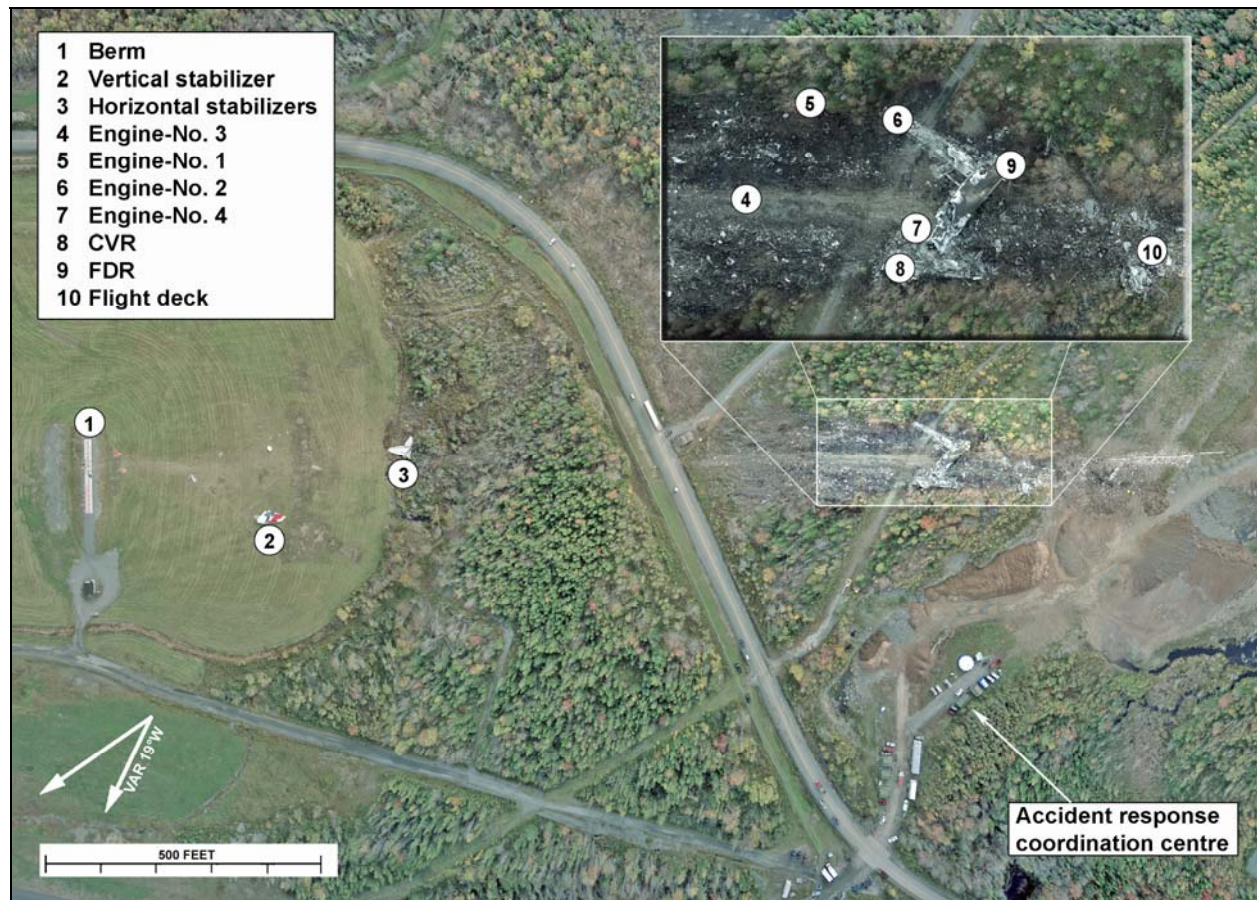
The cockpit voice recorder (CVR) was a Collins model 642C-1, part number 522-4057-010, serial number 1660, that was fitted in March 2004. The CVR was found under debris in its mounting bracket near its installed location (see Photo 5), and it had been exposed to fire and extreme heat for an extended period. The recording tape had melted; consequently, no CVR information was available to investigators. Although this model of recorder was not required to meet the more stringent fire test requirements that exist today, the conditions of extreme heat were such that the likelihood of any tape-based recorder surviving in those conditions is considered very low.

Immediately beyond the berm, there was extensive debris that included the vertical and horizontal stabilizers, a section of aft pressure bulkhead, the tail cone, the auxiliary power unit, and some pieces of aft fuselage belly skin. In the wooded area beyond the berm, there were numerous smaller pieces of aircraft structure and cargo. The debris trail then diminished until the main impact, suggesting that, following the separation of the empennage, the rest of the aircraft remained relatively intact until impact (see Photo 5).

Photo 5. Accident site and wreckage location

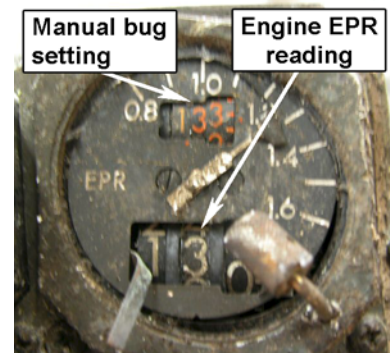
The number 2, number 3 and number 4 EPR gauges were recovered and examined. The number 2 EPR gauge had a manual bug setting of 1.32 and an engine indication reading of 1.01; the number 3 EPR gauge had a manual bug setting of 1.3X (the last digit had broken off at impact) and an engine indication reading of 1.02; and the number 4 EPR gauge (see Photo 6) had a manual bug setting of 1.33 and an engine indication reading of 1.305. The EPR settings on the three recovered instruments were set to 1.32–1.33. These readings were considered to be reliable, with the slight differences attributed to movement during the impact sequence.

Photo 6. Engine number 4 EPR gauge
