AVIATION INVESTIGATION REPORT

A04P0240

BLADE STRIKE AND ROLLOVER

EUROCOPTER AS350 B2 (HELICOPTER) C-GSHH

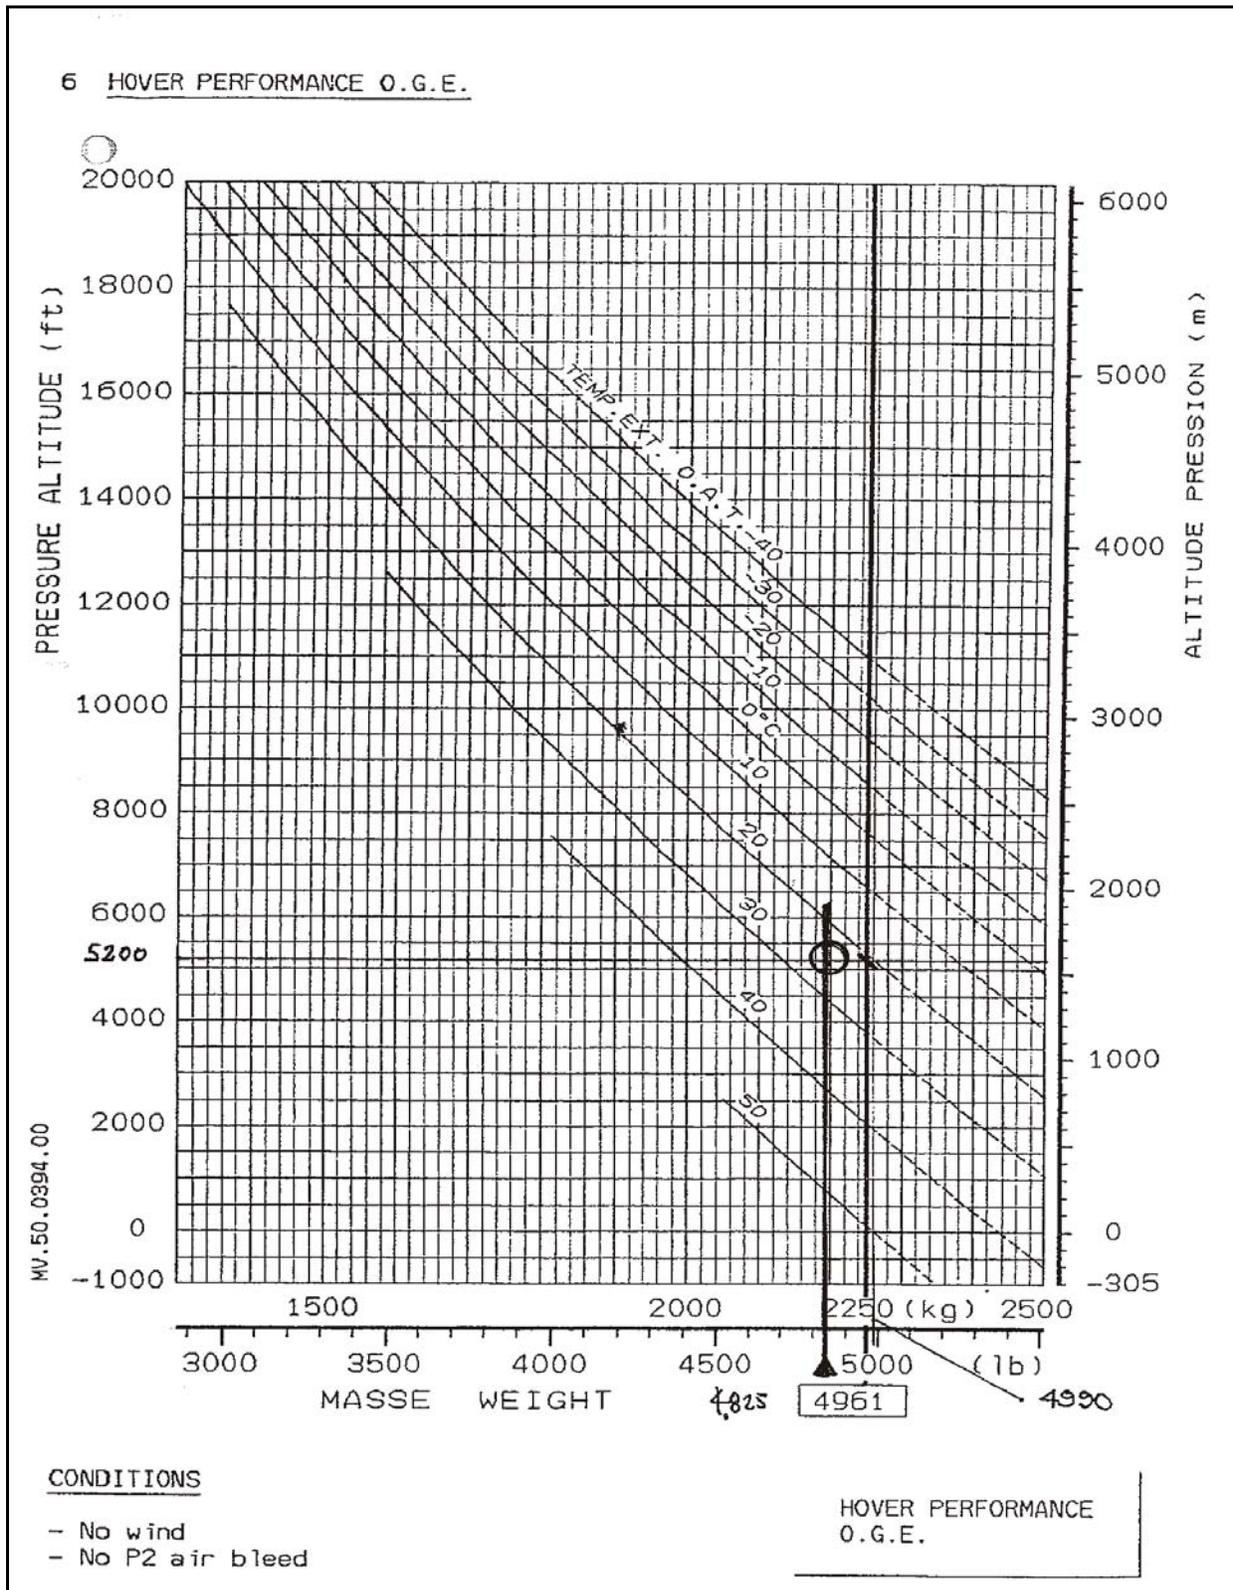
Appendix A – Hover Performance Out-of-Ground-Effect

Using the HOGE curves (see Appendix A), assuming an outside air temperature of 20°C, a pressure altitude of 5200 feet, and a gross weight of 4825 pounds, at the second take-off attempt the helicopter was approximately 150 pounds less than the maximum weight permitted for those conditions. As ambient air temperature increased to 25°C, this margin would have been progressively eroded to zero. The actual performance of the helicopter would also have been affected by several other factors, including wind and wind gusts, pilot handling techniques, and engine and rotor system efficiency.
