AVIATION INVESTIGATION REPORT

A07A0056

REDUCTION GEARBOX FAILURE

BELL 407 HELICOPTER C-GOFL

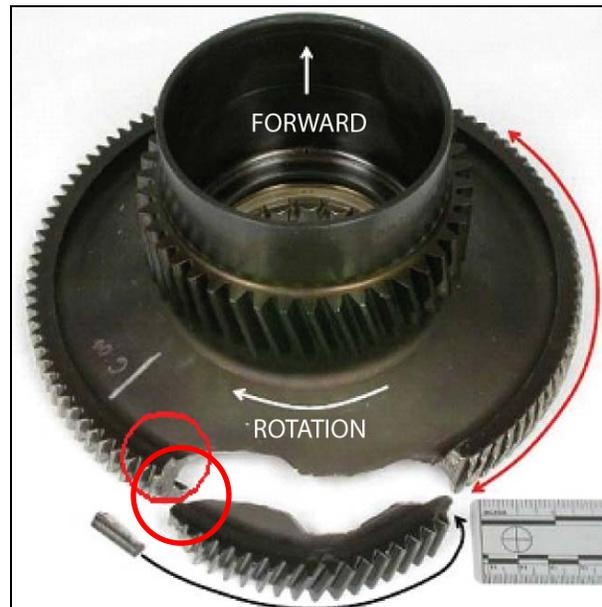
The torquemeter gear (see Photo 1) exhibited significant gear tooth damage (the double-headed arrow marks a 90-degree arc). Microscopic examination of the fractured section of the torquemeter gear identified a fatigue crack originating on the driven surface of a tooth near the forward end (circle marks the location of a fatigue crack), at approximately the centre of the active profile. Damage to the fracture surface precluded detailed fractographic and metallurgical examination of the origin region. The tooth wear was measured and found to be 0.004 inch and, with the exception of damage done after the torquemeter gear failed, there was no spalling¹ or pitting noted. Material analysis determined that the torquemeter gear met the requirements of the engineering drawing.

Photo 1. Broken torquemeter gear

The torque-meter gear failed as a result of an undetected crack that progressed in fatigue. MPI is a method of non-destructive testing used to visually identify cracks originating at the surface in steel components. If an MPI had been carried out on the torque-meter gear before its failure then it is likely that the crack would have been detected. However, the requirement to perform the MPI is based specifically on the time-in-service of the torque-meter gear, and then only if the gearbox is already opened. There is no requirement to track the time-in-service for the torque-meter gear, or for any of the other gears in the gearbox. Therefore, if a serviceable gear is installed during gearbox maintenance, it is possible that the gear's time-in-service may not be determined.

1. The helical torque-meter gear failed as a result of an undetected crack that progressed in fatigue. The failure of the torque-meter gear resulted in the loss of engine power to the helicopter's transmission.

On 17 August 2007, Rolls-Royce issued *Commercial Engine Bulletin* (CEB) 72-6061, which advised customers of the 250-C30 and 250-C47 series engines that the power gears (pinion gear, torque-meter gear, and power take-off gear) had been redesigned to improve the reliability of the new gears. The CEB states that compliance is a customer option.

On 26 March 2008, Rolls-Royce advised that it is developing a visual inspection to be placed into the 2000-hour inspection section in the Operation and Maintenance Manual. Implementation is targeted for the third quarter of 2008.

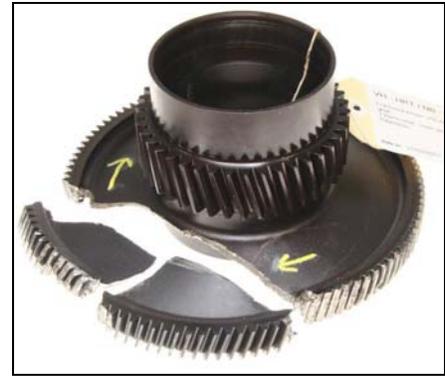
On 02 February 2007, a Bell Helicopter Company model 407 medical helicopter departed Tamworth, New South Wales, Australia, en route to a car accident. The pilot reported that the engine chip detector advisory illuminated on the master caution panel. Approximately five seconds later, he heard a frequency vibration with a complete loss of engine power. Preliminary examination showed that the torque meter gear had fractured due to fatigue cracking from an origin at the root region of a rim gear tooth (see Photo 2). Magnetic particle inspection showed evidence of cracking at the roots of several other gear teeth adjacent to the location of the fracture. Localized gear tooth spalling and uneven surface contact patterns were also observed.

Photo 2. Broken Australian gear
