AVIATION INVESTIGATION REPORT

A08C0171

ENGINE POWER LOSS AND FORCED LANDING

CESSNA 207A C-FBHP

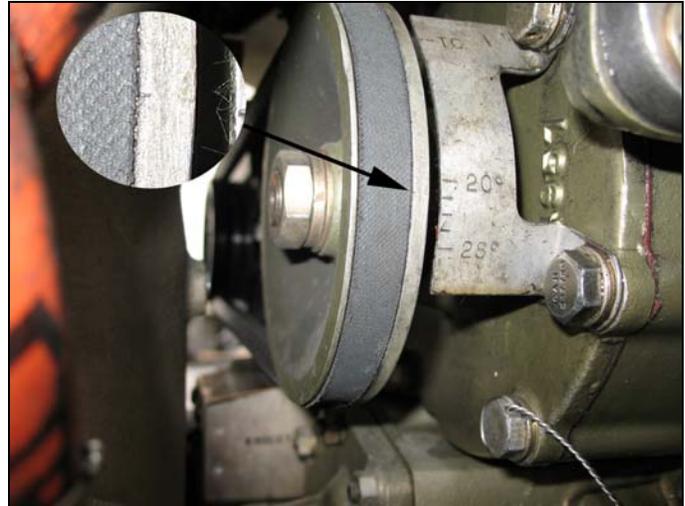
As the engineer rotated the propeller to align the timing marks, the first mark that came into view on the alternator drive pulley was a scratch (see Photo 1) that had snagged debris from the engine washing. The scratch, with the embedded debris, looked similar in appearance to the correct timing mark (see Photo 2). The engineer was not able to discern the red paint colouring to cross-reference the mark and chose the scratch as the timing mark of reference. The correct timing mark was out of view on the opposite side of the pulley. The engineer installed the magnetos using the scratch with the embedded debris as the reference point.

Photo 1. Mistaken timing mark with debris removed

Unable to discern the red paint on the timing mark, the engineer chose a mark, similar in appearance, as a reference for timing the magnetos without having rotated the pulley completely to confirm that selection. The subsequent engine ground run was not of sufficient duration to indicate any timing anomalies. The engineer attributed the lower-than-normal rpm drop on single magneto operation and the higher-than-normal after-run engine temperature as being consistent with the high ambient temperature of the day. The misalignment of the pulley mark with the indicator plate led to a timing discrepancy that resulted in pre-ignition or detonation of the combustion gases in the engine, which, in turn, caused high cylinder head temperatures and engine power loss after take-off.

Although the alignment of the timing marks was verified as correct in this occurrence, the use of an incorrect reference mark (scratch) had the same effect as if the alignment was incorrect to begin with.

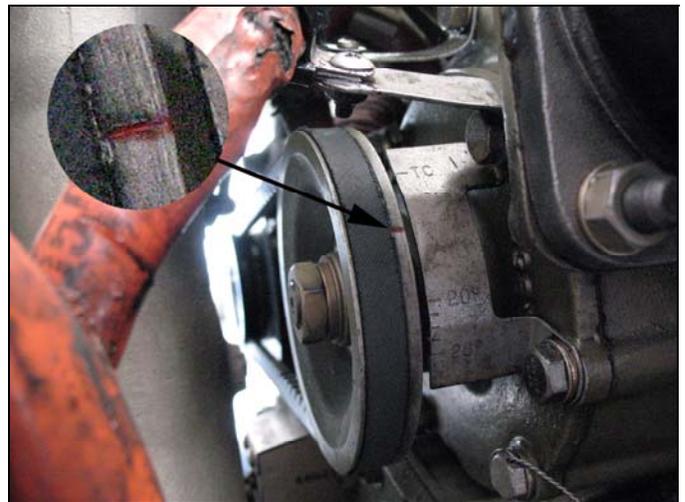
The engineer chose the external engine timing mark reference as the method of timing because the external magneto timing indicator plate was present on the engine. The external magneto timing indicator plate is located on the rear of the engine, in a dimly lit area of the engine bay. The mark on the alternator drive pulley had been painted red for conspicuity during the last engine overhaul.

Photo 2. Correct timing mark
