AVIATION INVESTIGATION REPORT
A09C0167

FUEL STARVATION AND FORCED LANDING

WEST CARIBOU AIR SERVICE INC.
CESSNA 185A C-FBWP
THUNDER BAY, ONTARIO, 10 nm NE
23 OCTOBER 2009

Report Number A09C0167

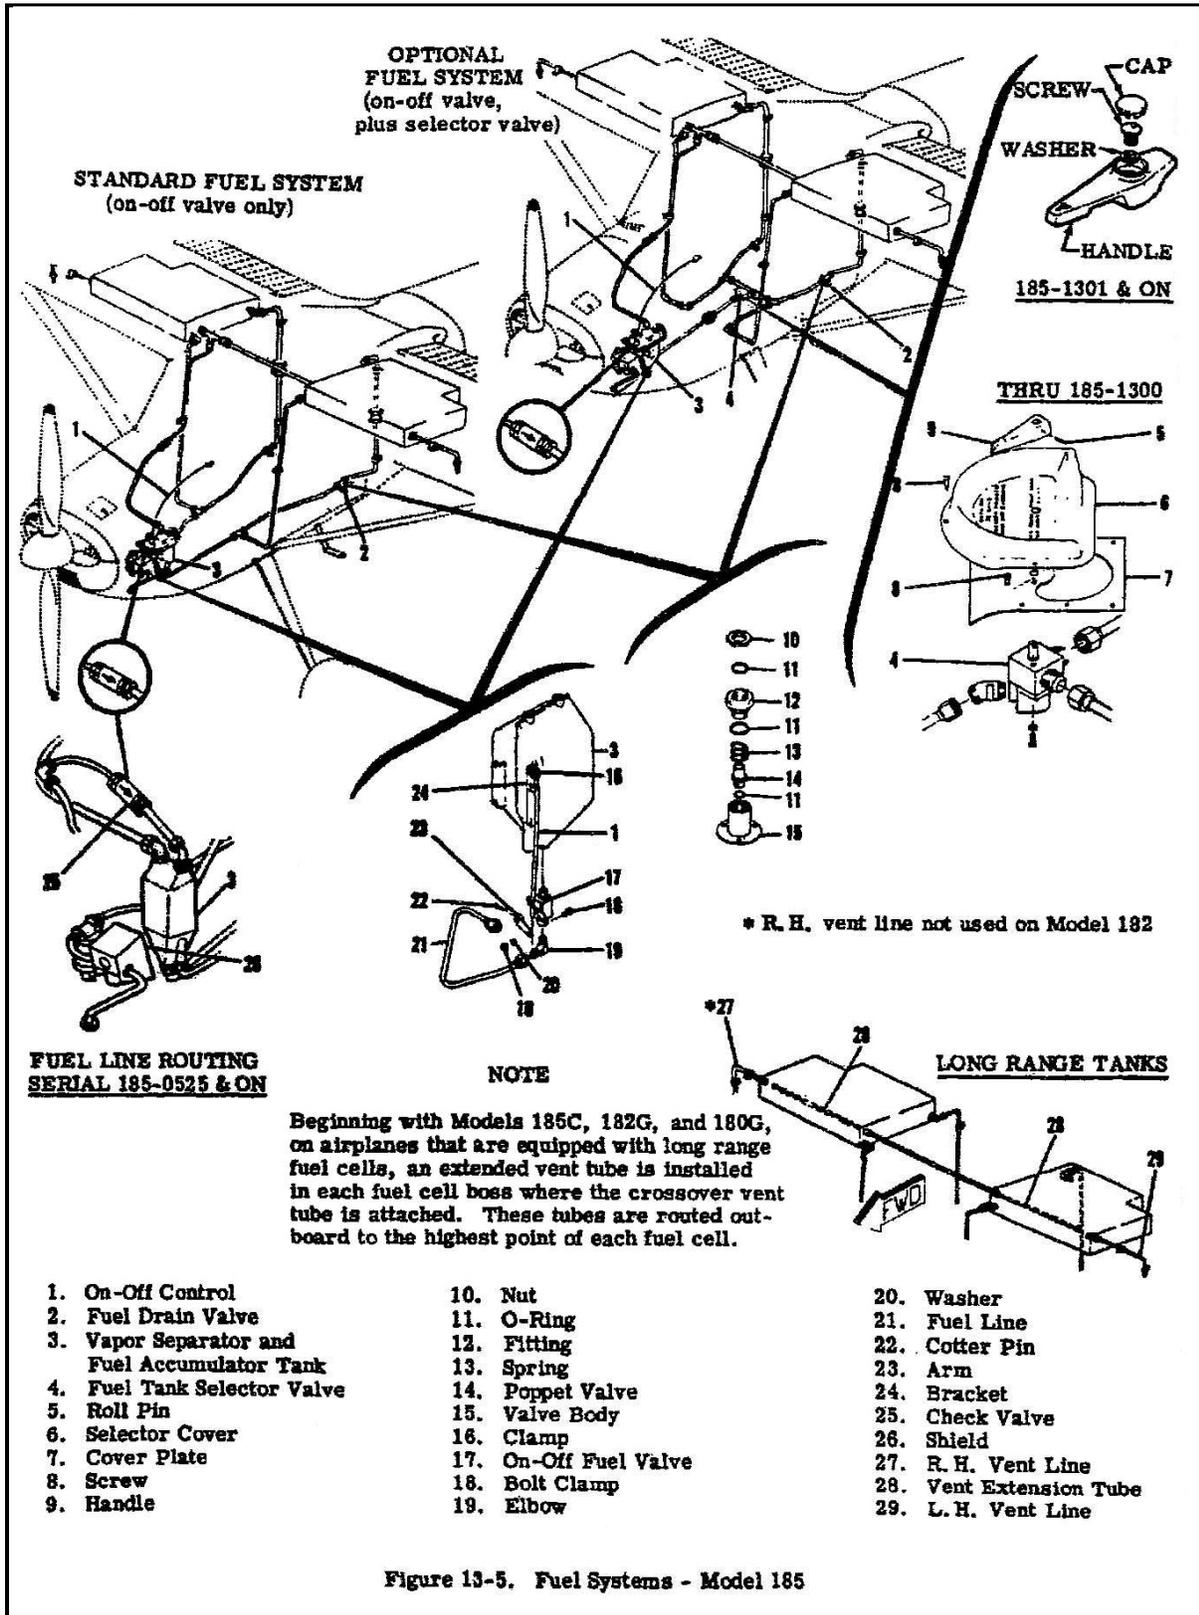
Appendix A - Fuel System Diagram

The fuel tanks are connected by a crossover vent line and vented overboard through a line on the lower surface of each wing (see Appendix A). Sloshing of fuel into the crossover vent line can cause unequal pressure in the tanks, resulting in uneven draining of fuel and fuel imbalance.

A float-type fuel sending unit is mounted in each tank which connects to a fuel quantity gauge on the instrument panel. The aircraft is not equipped with a low-fuel warning system or light. Fuel flows by gravity from each wing tank through fuel supply lines at the forward and aft lower inboard corners of the tank. The fuel supply lines connect to an accumulator tank mounted under the instrument panel on the engine firewall. Fuel from the accumulator tank flows through a fuel shut-off valve, a fuel strainer, and a by-pass in the electric auxiliary fuel pump (when it is not operating) to the engine-driven fuel pump. The electric auxiliary fuel pump is a two-speed HI and LO position pump normally used for engine start or for vapour purging. The HI position is intended for use in an emergency situation if the engine experiences a loss of power.

A fuel imbalance could occur during flight due to unequal draining of the tanks, or movement of fuel from one tank to the other. No fuel was found in the right tank, indicating that the tank had emptied during flight.

The engine power loss occurred during the gradual right turn. With no fuel in the right tank, the fuel remaining in the left wing tank should have been sufficient to maintain engine power. During a coordinated right turn, the usable fuel in the left tank would be expected to feed normally. However, during a skidding right turn, the fuel would have moved outboard, away from one or both fuel supply line pickups in the left tank, leading to a reduction in flow to the accumulator tank. The engine fuel demands exceeded the amount of fuel entering the accumulator tank, reducing the fuel level to the point where there was insufficient fuel feed to keep the engine running.

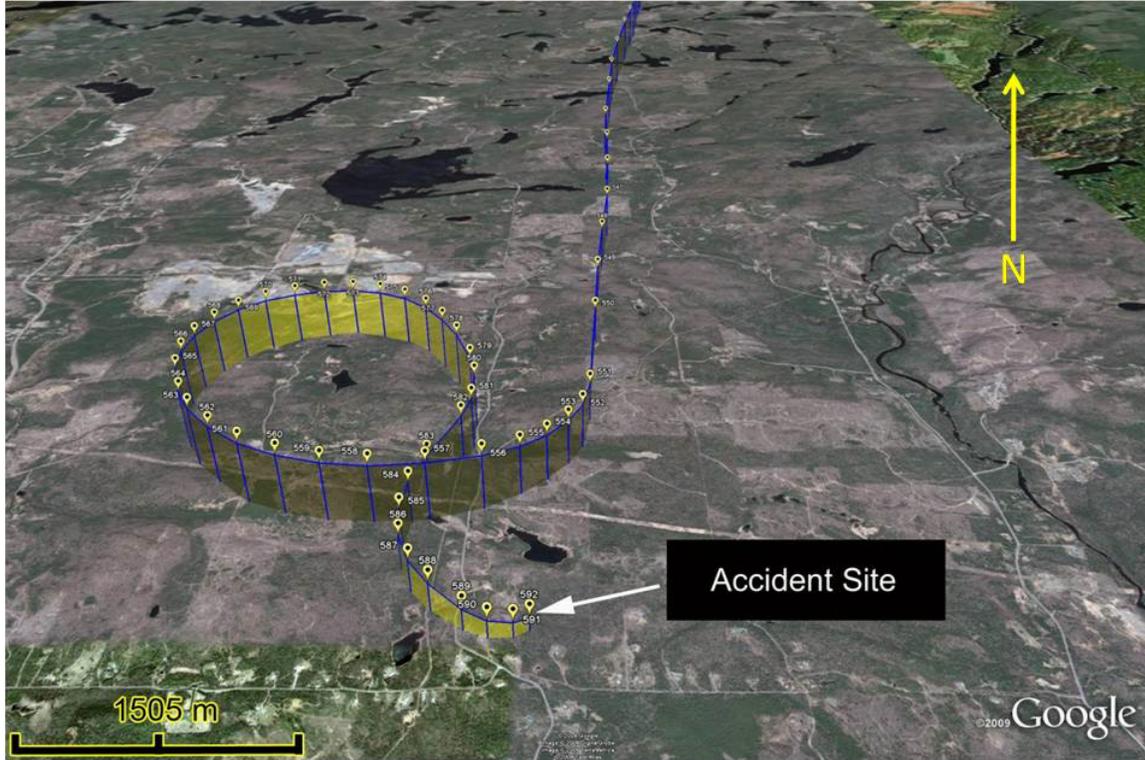
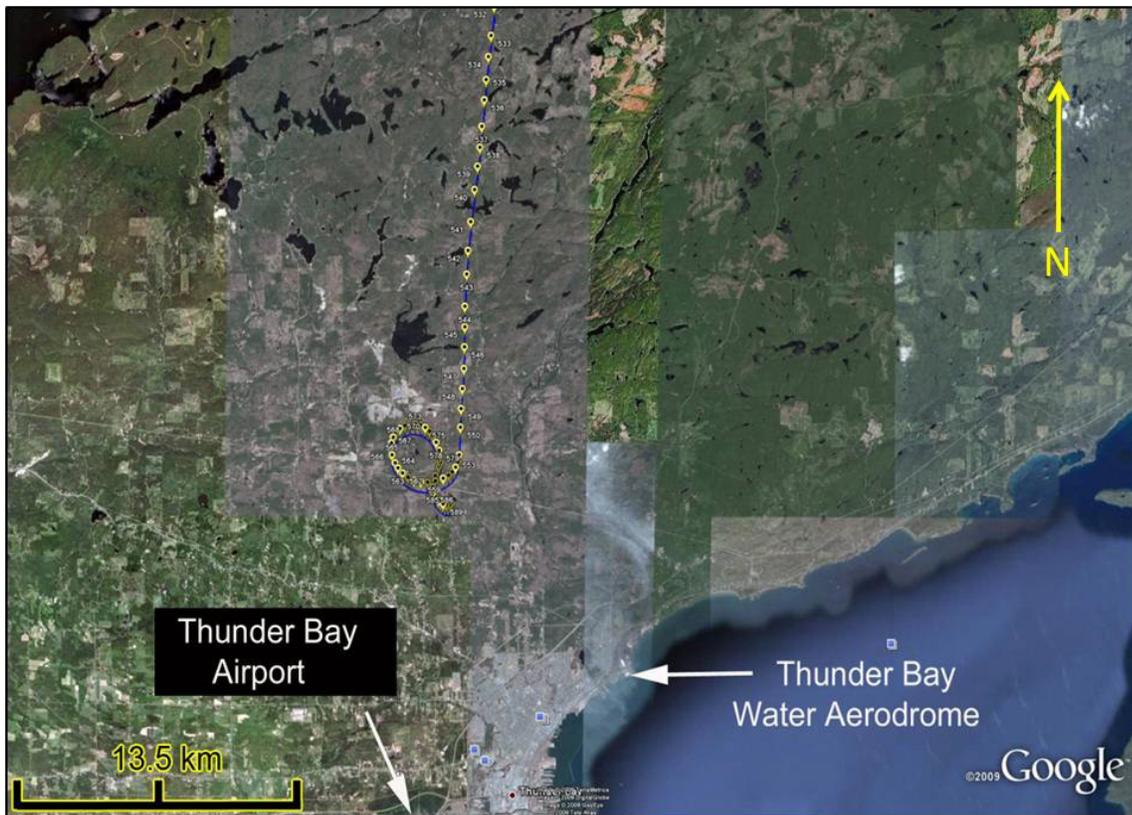
Appendix B – Aircraft Flight Path

Not knowing whether he was cleared to enter the control zone or not, the pilot began a shallow turn to the right ⁷ to avoid entering controlled airspace without clearance. He then repeated his arrival intentions to the tower. Approximately 3 minutes into the turn at 3000 feet asl (1700 feet agl), the engine began to sputter and lose power. The aircraft wings were levelled and the pilot performed the engine power-loss check from memory. The engine mixture was confirmed full rich, with the magnetos set to BOTH. The engine throttle was pumped, but the engine did not respond. The electric auxiliary fuel pump, which was required by the owner's manual to be activated in the event of engine failure during flight, was not turned ON.

The recorded GPS data revealed that, because the groundspeed was lower than the pilot had planned and some departure and arrival manoeuvring was required, the total aircraft operating time was 3 hours and 42 minutes (3.7 hours). Approximately 6 additional minutes would have been required for the flight to reach the Thunder Bay harbour aerodrome, giving a total flight time from Webequie to Summer Beaver to Thunder Bay of 3.8 hours, or 48 minutes longer than the pilot had estimated during pre-flight planning. Additionally, because of the company's full-rich mixture policy, the fuel flow during the flights averaged 16.5 to 17 gph rather than the planned 15 gph. Consequently, the aircraft's fuel reserves were substantially depleted by the time the aircraft reached the Thunder Bay area.
