AVIATION INVESTIGATION REPORT

A09C0172

CONTROLLED FLIGHT INTO TERRAIN

CESSNA 310R, C-GFIT

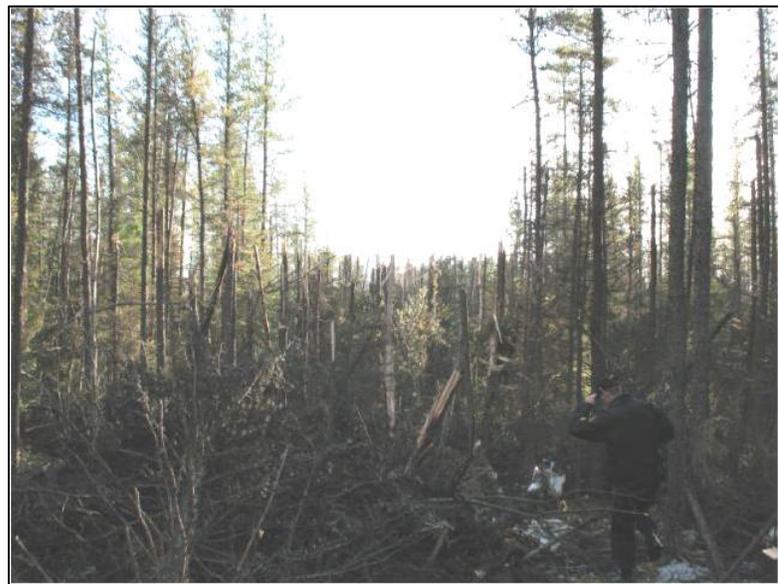
Photo 1. Tree damage

The tree strikes and wreckage information indicated that the aircraft contacted the trees on rising terrain in a near-level flight attitude (see Photo 1). The initial tree strikes involved just the tips of the trees, for approximately 150 yards, and progressed to severe shearing and breaking of the tree trunks for another 150 yards until the remaining aircraft fuselage came to rest (see Photo 2). The direction of the wreckage trail was 340° magnetic, indicating that C-GFIT was tracking away from the village of Cat Lake at the time of impact. The wreckage site elevation was 1460 feet asl.

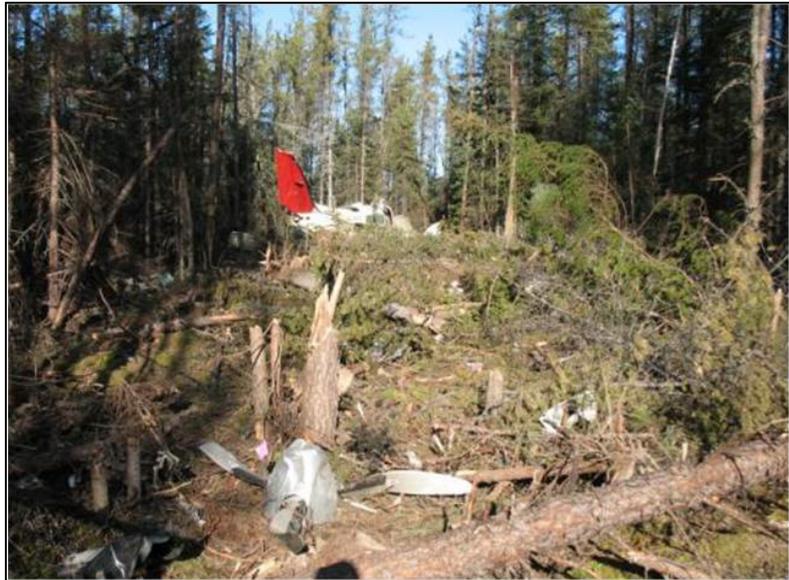
Photo 2. Final impact point

An inspection of the aircraft wreckage including the engines, propellers, and flight controls revealed no pre-impact anomalies. The engine instruments and GPS were removed from the wreckage and sent to the TSB Laboratory in Ottawa. Analysis of the tachometer, oil pressure gauges, cylinder head temperature gauges and manifold pressure gauges indicated that the engines were producing power at the time of impact.

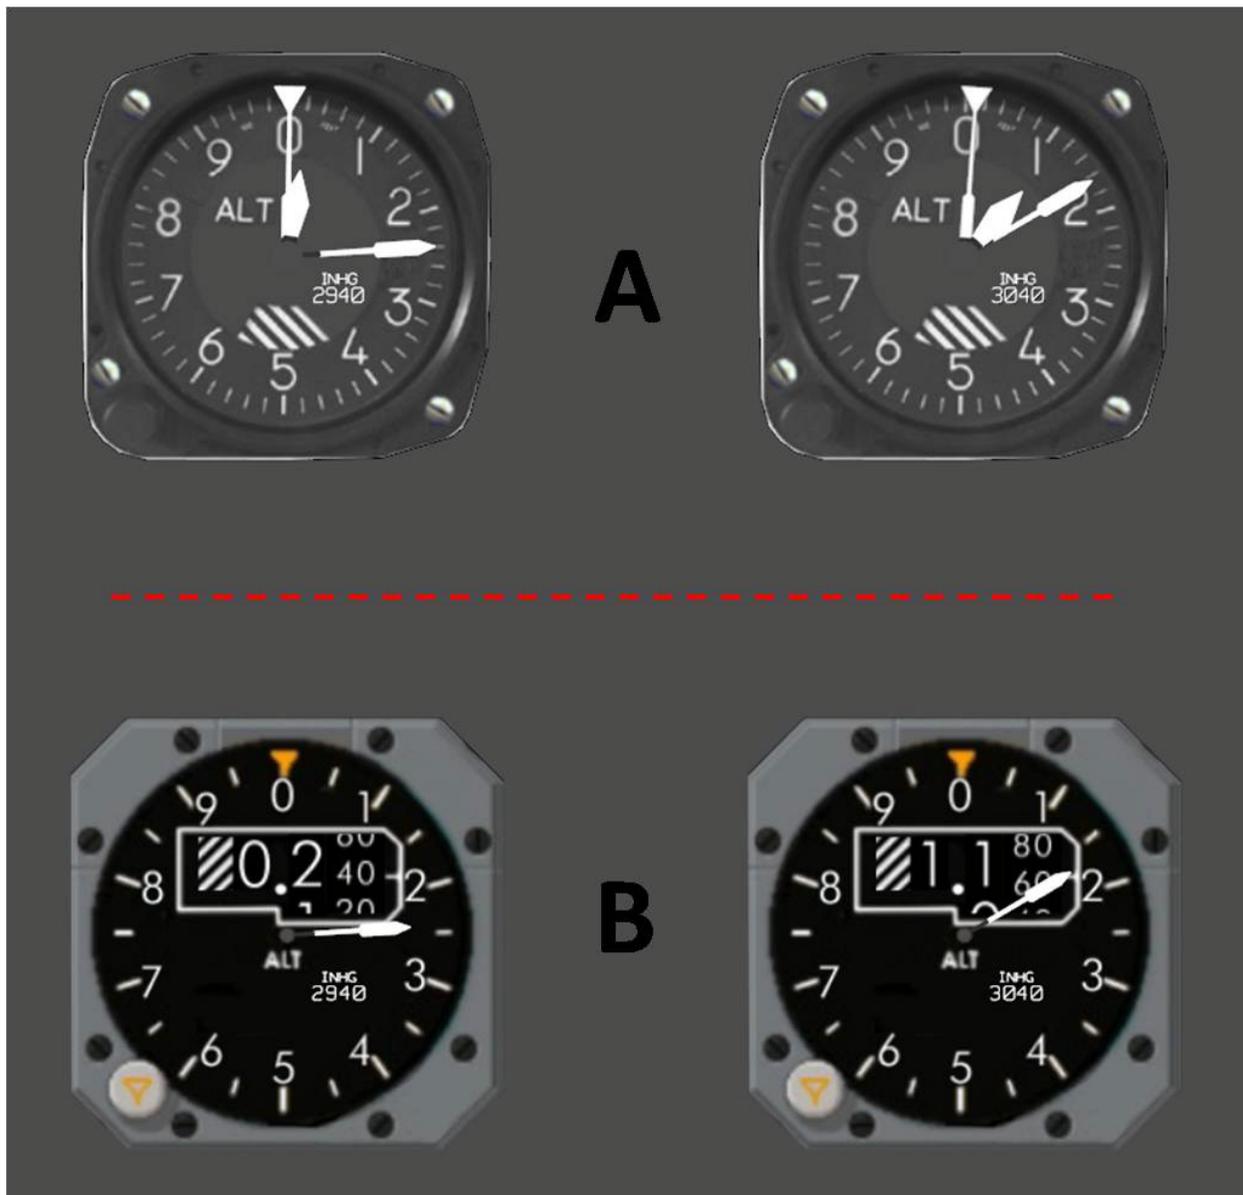
Appendix A – Altimeter Comparison

The aircraft was equipped with two barometric pressure altimeters. Both altimeters incorporated the three-pointer type of display. This display format has a higher potential for being misread, as compared to altimeters incorporating other types of displays, such as the drum-and-pointer type.⁵ Nearly 12 full turns of the adjustment knob are required to effect a one-inch barometric pressure change in the altimeter setting. A one-inch decrease in barometric pressure results in an increase of indicated altitude of about 1000 feet if no adjustment is made. An adjustment of this magnitude is uncommon in day-to-day operations. New, larger, technologically advanced aircraft are increasingly being equipped with a drum-and-pointer type of altimeter system from the factory.

In total darkness and with no visual cues, the pilot would have to rely solely on his altimeters to determine his altitude. A 1000-foot error could be more difficult to detect with the three-pointer type of altimeter installed on the occurrence aircraft because the longer pointers (the ones most often referenced) would be in a similar position at either setting (see Appendix A – Altimeter Comparison). As a result, the pilot likely did not notice the incorrect altimeter settings and, during the downwind leg, descended to terrain height believing that he was descending to the circuit altitude.

- A. Difference in readings between pointer altimeters not obvious at a glance for settings of both 29.40 and 30.40.
- B. Drum counter type representation of altitude easier to read at a glance for settings of both 29.40 and 30.40.
