AVIATION INVESTIGATION REPORT
A09P0156

ENGINE POWER LOSS – FORCED LANDING

AMATEUR-BUILT GLASTAR C-GMDP
CHETWYND, BRITISH COLUMBIA, 6 nm SSW
12 JUNE 2009

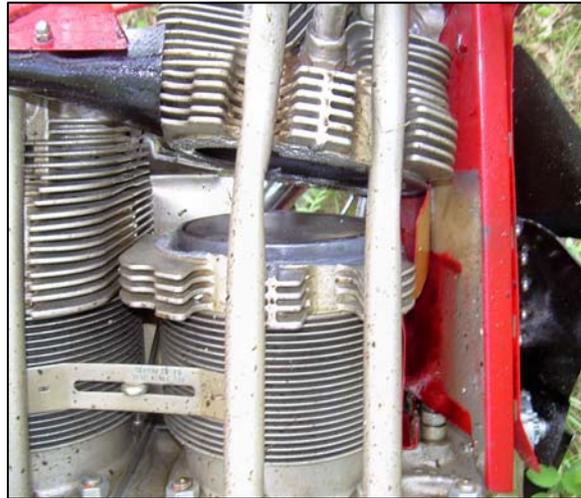
Photo 1. Number two cylinder head

Examination of the wreckage revealed that the number two cylinder head had separated from the base (See Photo 1) and the crankshaft was severed at the propeller flange. The engine had 212 hours total time since new (TTSN) when the failure occurred.

The failed cylinder assembly was sent to the TSB Laboratory for examination. A fracture surface analysis of the number two cylinder and sheared crankshaft was completed. The crankshaft propeller flange showed signs of minor hydrogen embrittlement. The sheared crankshaft was determined to be from overload fracturing due to impact. The minor hydrogen embrittlement was not causal to the accident.

In the fall of 2008, the FAA issued Airworthiness Directive (AD) 2008-19-05 regarding ECi cylinder assemblies installed on the Lycoming engines. The AD addressed a manufacturing defect that caused the cylinder head to separate from the base. It did not, however, address engines with increased compression ratios. Engines that are not type-certificated, such as the Aero Sport Power engines, were not mentioned in the AD. The cylinder head failure fracture surfaces were typical of fatigue failures addressed by this AD.

The failure of the cylinder head occurred at 212 TTSN, well in advance of the 350-hour limit set out in the AD. Compression checks completed 22 hours prior to the accident failed to detect a problem. This is not uncommon because compression tests will not necessarily detect an impending failure. It is possible that the premature failure of the cylinder head was due to the increased compression ratio of the engine.

1. The failure of the number two cylinder caused the engine to lose power.
2. During the attempted forced landing, the aircraft struck power lines, control was lost, and the aircraft collided with trees and terrain.

Aero Sport Power has notified all engine owners potentially affected by Airworthiness Directive (AD) 2008-19-05 and those who have increased the compression ratio.

Danbury Aerospace, the parent company of Engine Components Inc. (ECi), has elected to limit the compression ratio of cylinders sold in engine kits.

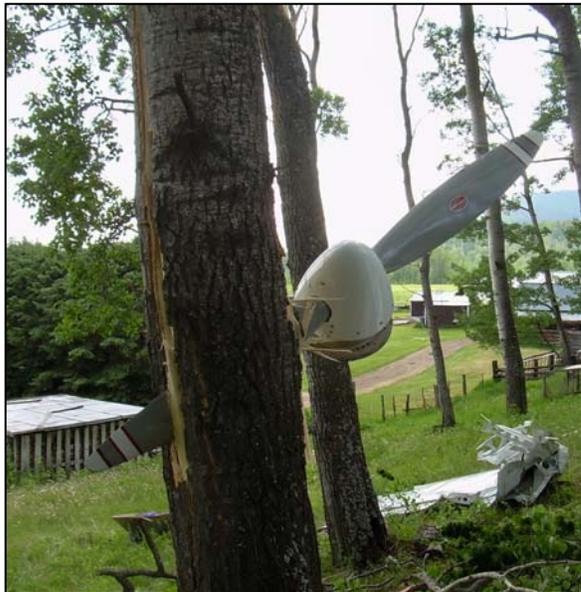
Photo 2. Propeller from C-GMDP

The engine crankshaft sheared at the propeller hub and the propeller was found embedded in a tree at the accident site (See Photo 2). The propeller was nicked and scuffed in a manner consistent with striking the severed power line.

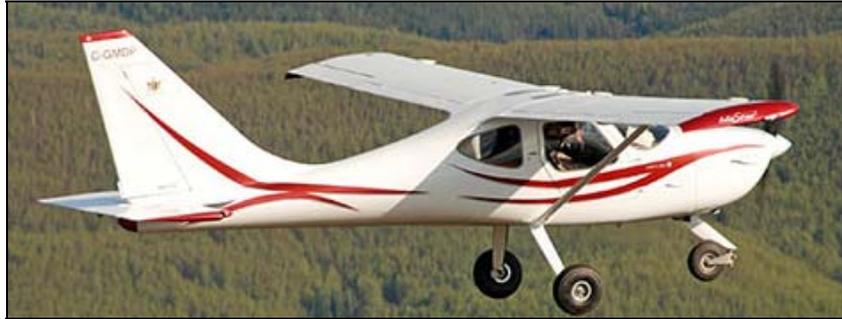
Photo 3. Amateur-Built Glastar, C-GMDP

The Glastar has a high-wing, two seats side-by-side, tricycle landing gear, and a 190-horsepower Aero Sport Power O-360-A2A engine (serial number 0808-SPE). The aircraft was well-equipped and maintained (see Photo 3).
