**AVIATION INVESTIGATION REPORT
A12Q0182**

IN-FLIGHT ENGINE FIRE LEADING TO A FORCED LANDING

**PIPER PA-34-200, C-GNAS
NADEAU AIR SERVICE INC.
VICTORIAVILLE, QUEBEC, 2 NM E
15 OCTOBER 2012**

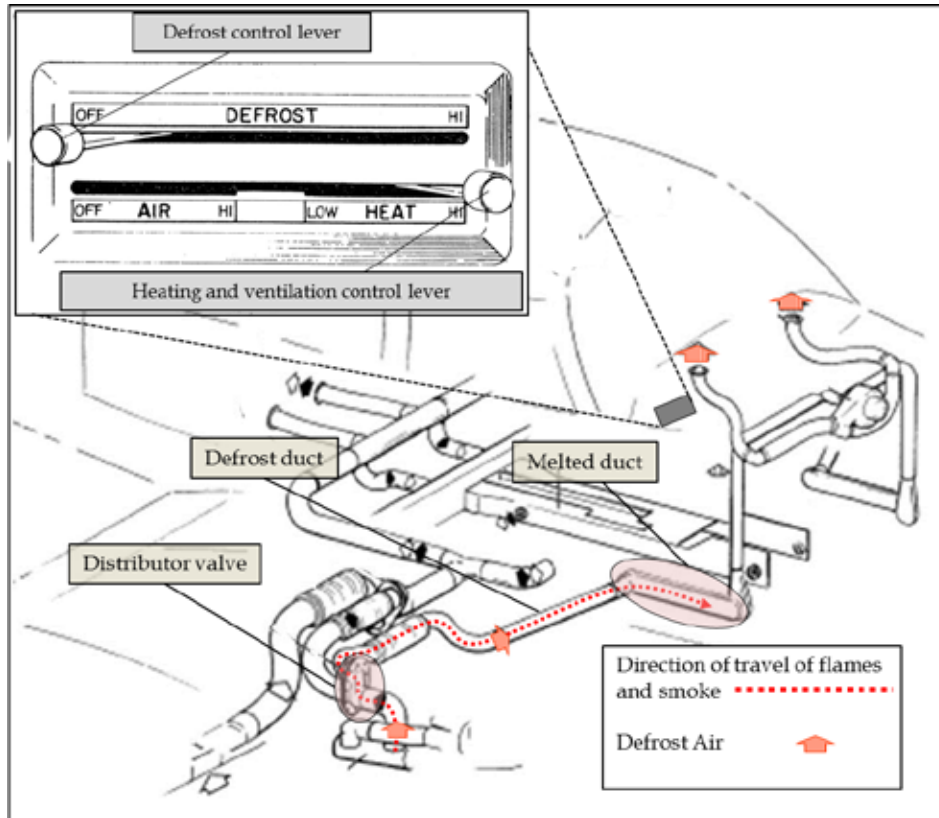
Figure 2. Heating, ventilation and defrost system

- The end of the sliding cable of the right control cable was completely covered in soot.
- The flaps were open.²⁰
- The pattern of the soot on the right flap indicated that the flap was open during the engine fire.
- There was a considerable amount of soot on the inside face of the right defrost ducts.
- The fibreglass fairing of the distributor valve was almost entirely destroyed by the fire.
- The right defrost vent in the cockpit was partially blocked by adhesive tape.

The soot accumulation found in the ventilation system indicates that the smoke and flames entered the cabin through the ducts and conduits of the defrost system on the right side. The smoke spread through the cabin through the vents at first, then through the hole created by the flames in the right side of the cabin, at the instructor's feet.

Significant anomalies were observed in the defrost system. Examination of the system revealed that the 2 control cables were disconnected from the flaps on the right and left distributor valves, and that the flaps were open. As well, the tight bend in the right control cable prevented the flexible cable from moving in the duct and shifting the flap. The fact that the left flap was open while the defrost control lever was in the OFF position may indicate that the cable was detached before the engine fire occurred. However, this cannot be confirmed. The cable may have detached from the flap on impact after the aircraft sustained structural damage.

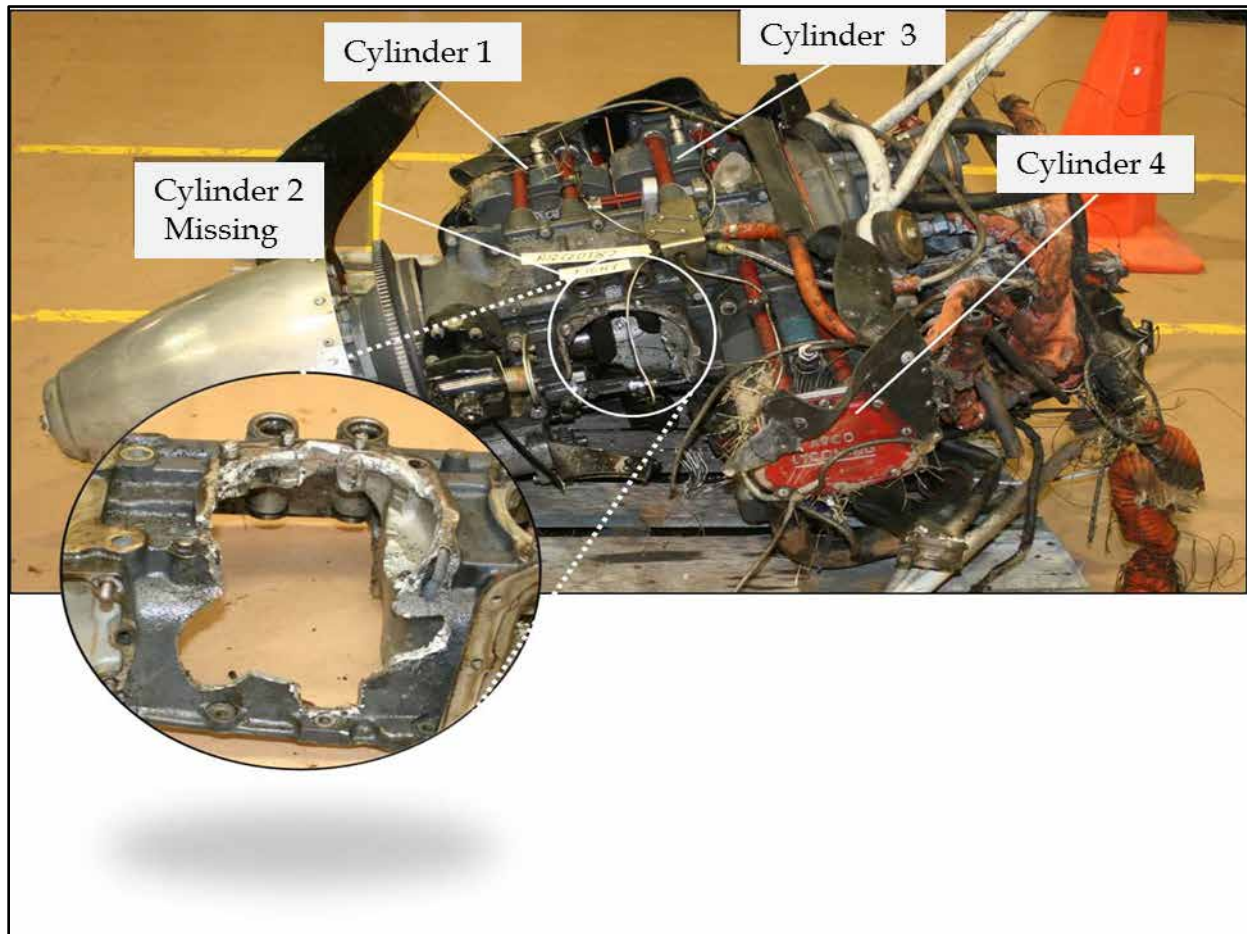
Figure 4. Right engine

The No. 2 cylinder had separated from the engine. The part of the crankcase connected to the No. 2 cylinder was missing, as were studs 3, 7, and 8 (Figure 4). The remaining No. 2 cylinder studs were broken. The broken parts of the studs were missing, as were their bolts.

- The backoff torque for the nos. 1, 3, and 4 cylinders holddown nuts was normal.¹⁵
- All of the recovered¹⁶ studs of the No. 2 cylinder had failed due to fatigue cracks.
- The studs exhibited no manufacturing defect, and the stud material complied with Lycoming's specifications.
- Fretting was observed on the surfaces where the crankcase and the No. 2 cylinder meet.
- The right engine airframe fuel filter was heavily contaminated.

- There was a fatigue crack in the No. 2 through-bolt hole of the No. 2 cylinder. The crack began in a welded area on the surface of the crankcase.
- A porosity that exceeded Lycoming's acceptance limit was found on the contact surface of the right crankcase near the No. 2 through-bolt.
- The crankcase hardness was either at or just below the minimum limit of Lycoming's hardness requirements. The measure of hardness of the repaired areas was less than that of the unrepaired areas. The repaired areas of the crankcases were susceptible to fatigue because they were softer.¹⁷

The engine failure was caused by the separation of the No. 2 cylinder after its tightening studs broke due to fatigue. All of the other damage to the right engine components occurred after the cylinder separated.

The fatigue failure of the No. 2 cylinder studs probably occurred as a result of insufficient preload in at least one stud. However, it was not possible to determine whether this insufficiency was caused by improper torque application during assembly or by loosening in service. Since some mounting studs were not recovered, it was not possible to determine the sequence of No. 2 cylinder stud failures.

The crankcase contained a fatigue crack in the No. 2 stud hole. This crack extended from the welding area to the surface of the case. The metallurgical examination showed that the repaired parts of the crankcase were softer than specified by the manufacturer. In addition, welding defects and porosity that exceeded the manufacturer's standards²² were noted. This would have made the crankcase more susceptible to the formation of a fatigue crack. The fatigue crack in the No. 2 stud hole and the porosity of the contact surface could have contributed to release of the torque of the No. 2 through-stud. Such a release of torque would reduce the stud preload and could contribute to fatigue cracking of this stud. However, the cause of loss of preload could not be determined conclusively.

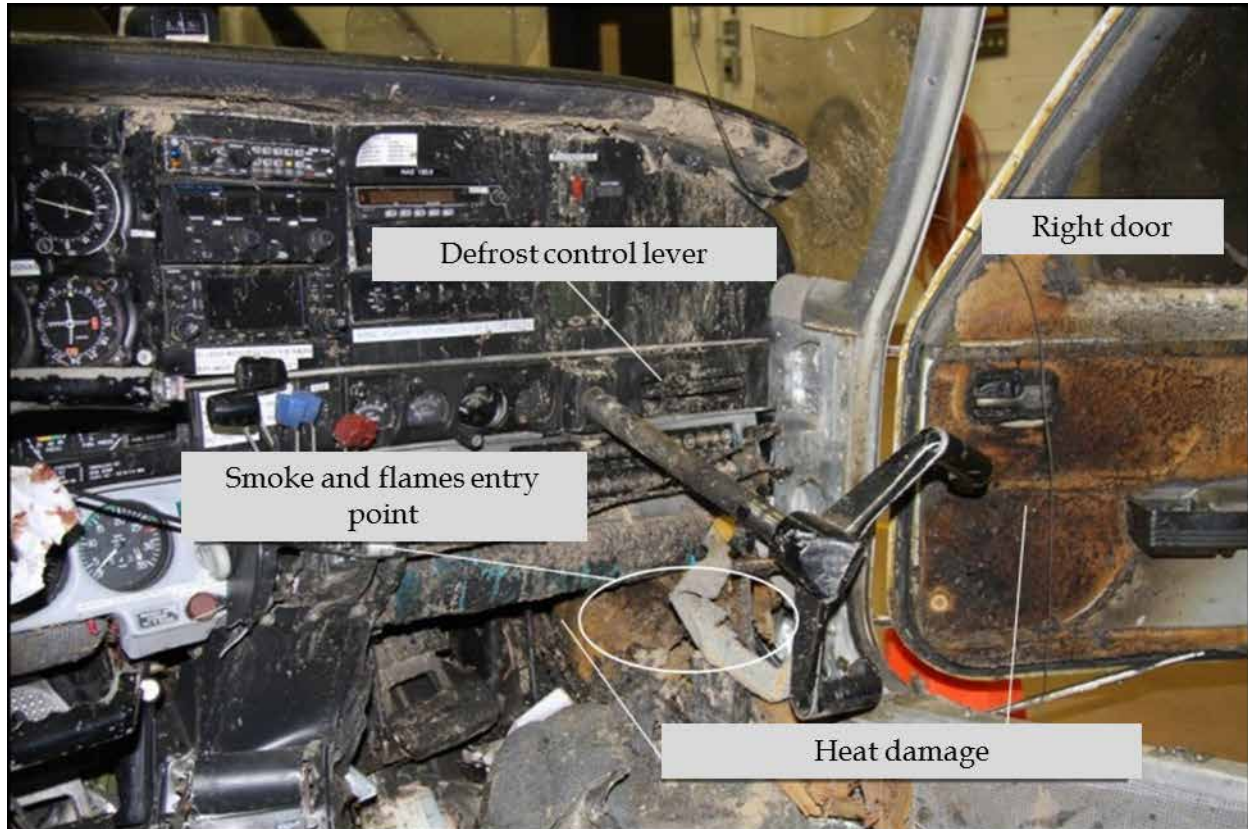
Figure 5. Fire damage to the cockpit

The damage to the cockpit indicates that the fire was concentrated in the space at the instructor's feet (right side), in the front portion of the right door and behind the instrument panel (Figure 5). The fire did not burn through the aircraft skin at any place along the fuselage. There were varying degrees of soot accumulation on the interior surface of some of the elements

in the area of the fire. The fire was partially fuelled by flight documents in a pocket located on the right fuselage wall, at the pilot's feet. The insulation blanket that was located where the defrost air conduit turns at a right angle toward the top suffered the most damage due to the heat; the thermoplastic conduit had almost entirely melted. Part of the insulation blanket installed directly against the right door skin was charred.

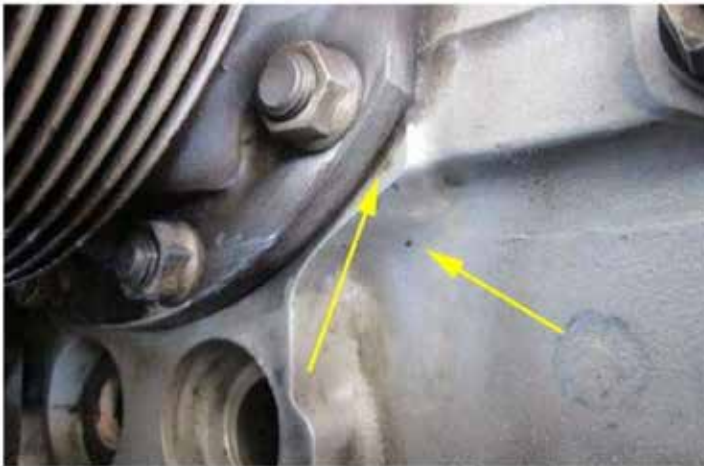
Figure 1 - Failure of a weld-repaired crankcase. Note crack from the cylinder base stud.

Weaker or softer crankcase material in the region of the cylinder retention studs can result loss of stud torque due to the stud partially pulling out of the case and/or via crankcase cracking in the stud retention hole (See Figure 1).
