# AVIATION INVESTIGATION REPORT

## A17W0024

### **Loss of control and collision with terrain**

Tecnam P2006T, C-GRDV

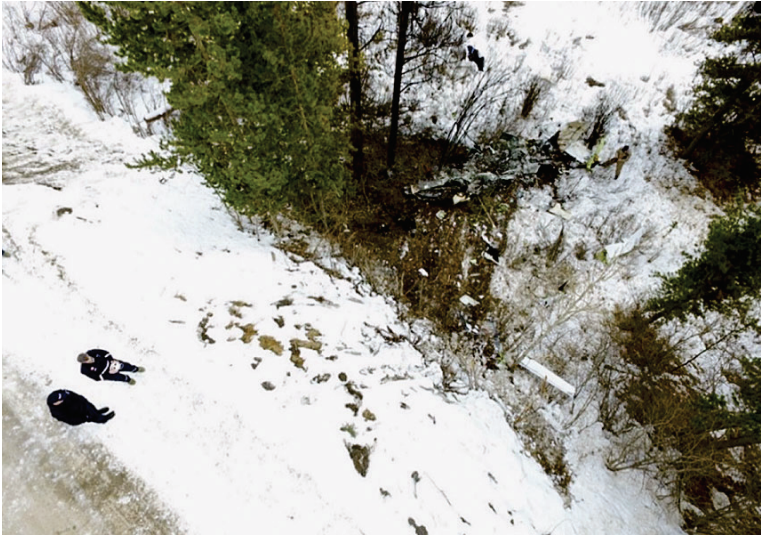
The wreckage was situated near a road, at the foot of an embankment, at an elevation of 4850 feet ASL. The aircraft had been almost entirely consumed by fire. Ground scars and damage to the aircraft were consistent with a high-speed collision with the slope while the aircraft was in a near-vertical attitude. The top of the aircraft had struck the embankment first, and the aircraft had continued down the slope for 50 feet before coming to rest at the foot of the escarpment, where a post-impact fire ignited (Figure 1).

Figure 1. Accident site as viewed from the embankment above, showing the left side of the aircraft and looking south (Source: Alberta Occupational Health and Safety)

All of C-GRDV's major components were accounted for at the accident site. An examination of the wreckage determined that the flaps had been in the up position and the landing gear had been retracted. The remains of the flight control systems were inspected and no indication of malfunction was found.

The post-impact fire had completely destroyed the aircraft's avionics and engine instrumentation. There was substantial fire damage to the majority of the aircraft, with the exception of the empennage and the left wingtip.

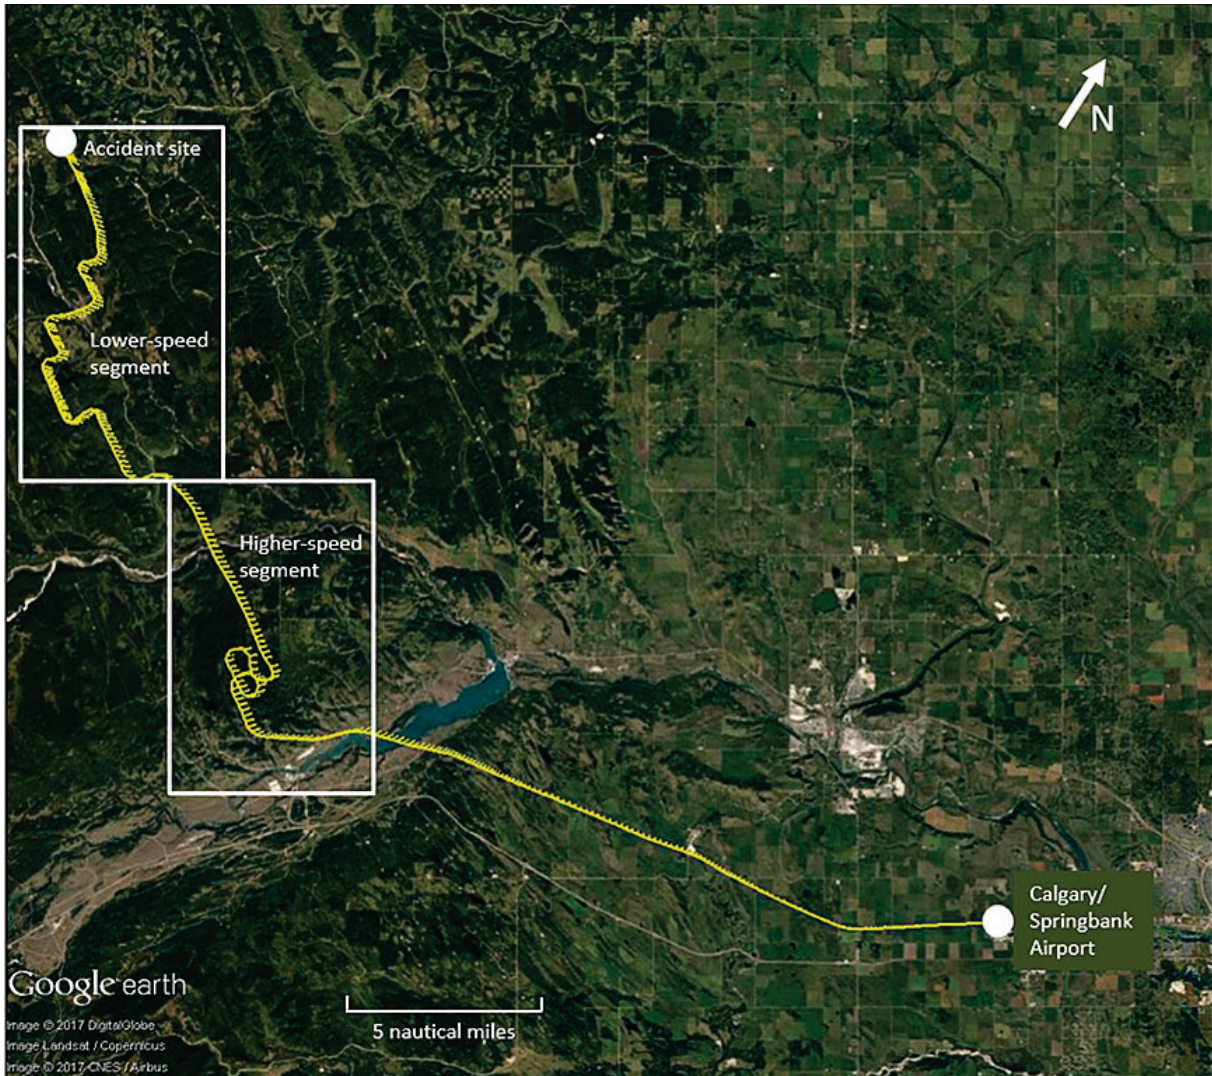
### Appendix A – Occurrence flight path

The training flight was to consist of 2 segments: the first was to be conducted at higher speeds, and the second at lower speeds (Appendix A). Once the desired altitude had been reached, the first flight segment was conducted over a period of 9 minutes, at airspeeds ranging from 100 to 120 knots calibrated airspeed (KCAS).<sup>2</sup> It included a sequence of turns, which were carried out from 1648 to 1650, and consisted of a 360° right turn, a 180° right turn, and a 180° left turn. The turns were flown at approximately 95 to 115 KCAS, with an angle of bank of approximately 45° and vertical acceleration of up to 1.3g.<sup>3</sup> The higher-speed segment of the flight concluded at 1653 with a 90° left-to-right turn sequence with bank angles of about 30°.

At 1701, the aircraft accelerated to about 100 KCAS. At 1702, its airspeed decreased to 65 KCAS before increasing again to 80 KCAS, and its altitude decreased by about 300 feet, constituting the largest reduction in altitude at that point in the flight. The aircraft climbed back to its original altitude at 80 KCAS; then, at 1703, it slowed to 70 to 75 KCAS. This was the aircraft's last secondary-surveillance radar position, at 2800 feet AGL, directly above the accident site.

There were 2 primary-surveillance radar returns over the next 10 to 15 seconds before all radar data were lost. The aircraft's altitude loss from the time of the last radar return to impact equated to a descent rate of between 11 200 and 14 000 feet per minute.

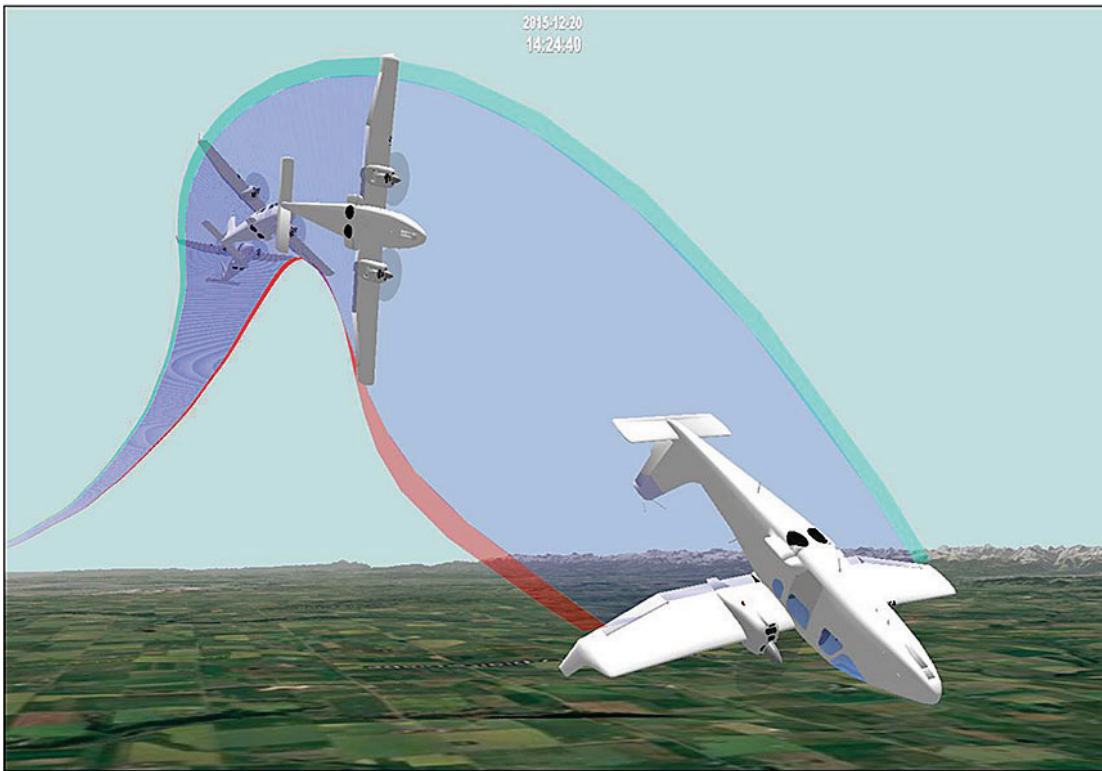
*Appendix B – Flight data analysis: Spin entry sequence of previous training flights*

In contrast with normal stall recoveries, these instances ranged from roll events that were recovered to wings level, to incipient spins that inverted the aircraft, to full spins<sup>14</sup> of up to 1.5 rotations. They generally shared key characteristics (appendices B, C, and D) that had initiated the upsets:

- The aircraft involved had been flown to stall conditions in a nose-high attitude and held there upon encountering stall conditions.
- The aircraft nose had not been lowered to initiate stall recovery.
- The airspeed had continued to decline until the aircraft had eventually rolled and yawed in either direction in an aggravated stall or incipient spin.

Although flight control input and engine power data were not available, it was evident from the motion of the aircraft involved that yaw/roll or engine power control inputs were sometimes being made by pilots during the stalled conditions. The resulting uncoordinated condition in each of these cases had led to an asymmetric aggravated stall and a relatively rapid roll/yaw departure toward an incipient spin.

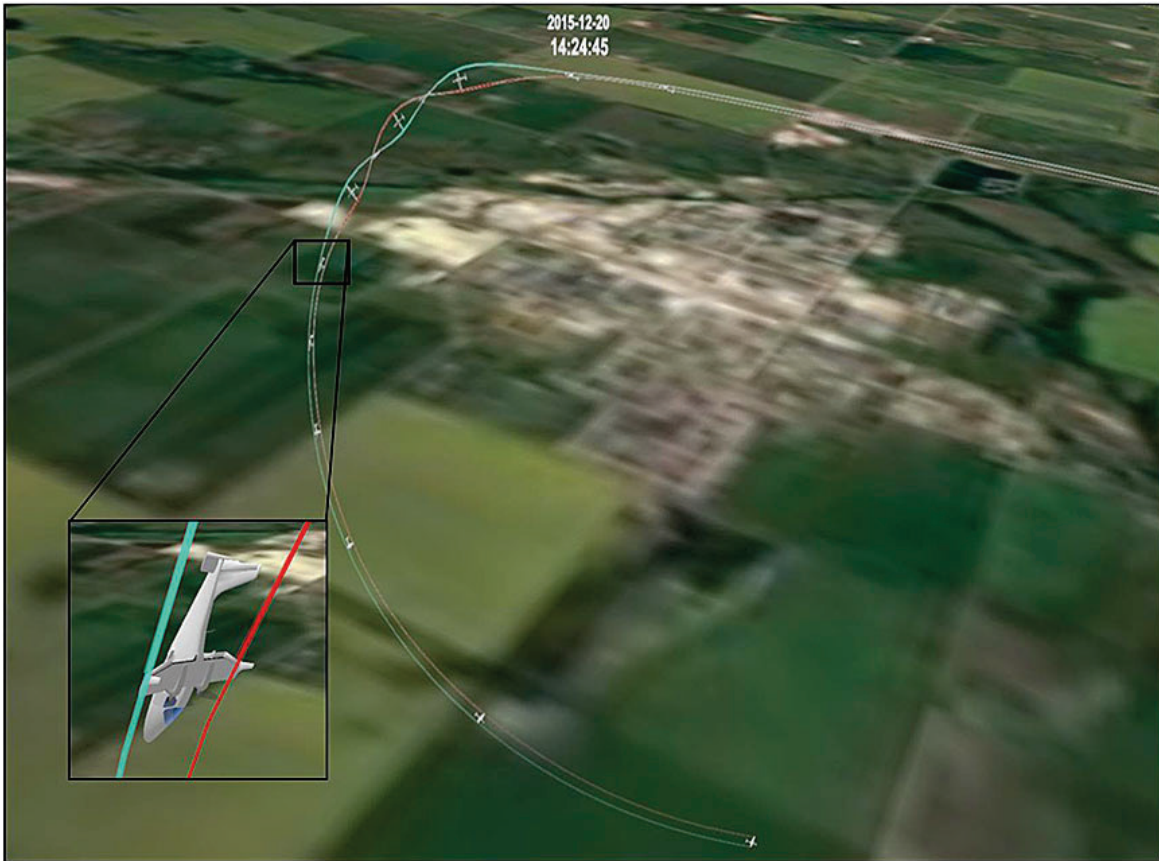
*Appendix C – Flight data analysis: Spin entry and dive recovery of previous training flights*

Among the recorded events was one in which an aircraft exited a spin of 1.5 rotations, became inverted, and was pulled into a steeper dive through a descending half-loop

(Appendix C). This event had the highest descent rate (12 500 feet per minute) and load factor (3.1g) of the upsets that were examined, and the second highest loss of altitude (1400 feet).

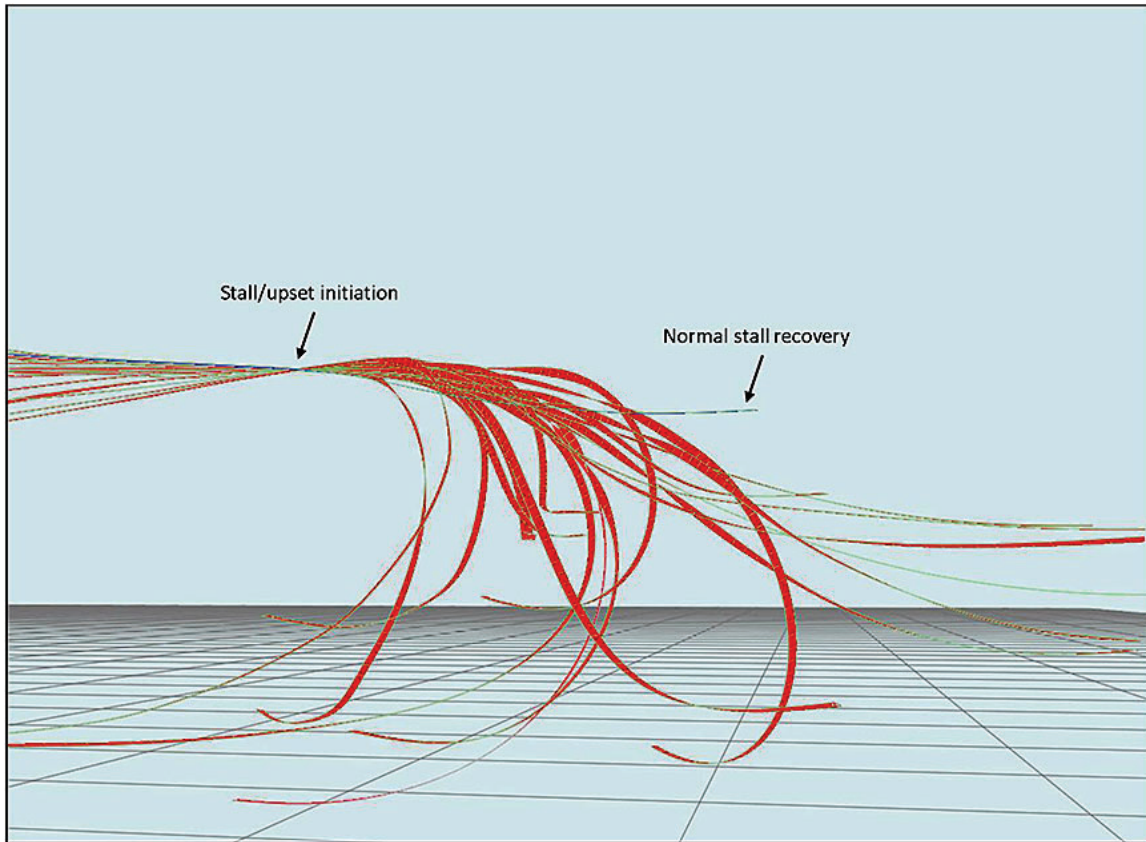
*Appendix D – Flight data analysis: Comparison of flight-path shapes and altitude losses in aircraft upsets during stall-recovery training*

The altitude losses in the examined events ranged from 525 feet to 1500 feet, with an average loss of 960 feet.<sup>19</sup> All of the flights had been conducted at an altitude of just under 8000 feet ASL. The combination of that altitude and the elevations of the underlying terrain significantly reduced the margins for recovery in the event of a spin. The terrain elevations over which the flights had been flown varied greatly; in some cases, local peaks exceeded 5000 feet ASL, leaving as little as 2500 feet in which to recover from an upset.

Appendix D shows the comparative flight-path shapes and altitude losses of the aircraft involved in the upset events; a normal stall recovery is also shown. Among the events examined, the lowest recovery height above surrounding terrain was 700 feet, in an event that also involved the largest altitude loss (1500 feet).
