MARINE INVESTIGATION REPORT

M01C0059

STRIKING

OF TANK BARGE *PML 2501*
BY CHEMICAL TANKER *CORAL TRADER*
ALGOMA STEEL CORPORATION WHARF
SAULT STE. MARIE, ONTARIO
22 AUGUST 2001

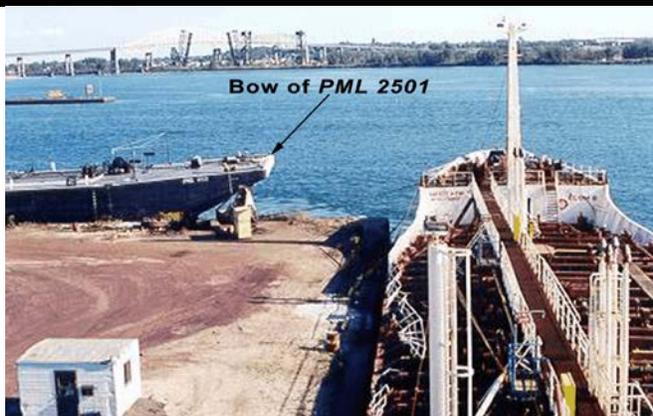
The *PML 2501* is a square-ended, non-propelled petroleum tank barge of steel construction. It was moored in a westerly direction along the southern end of the Algoma Steel Corporation wharf (see Photo 1).

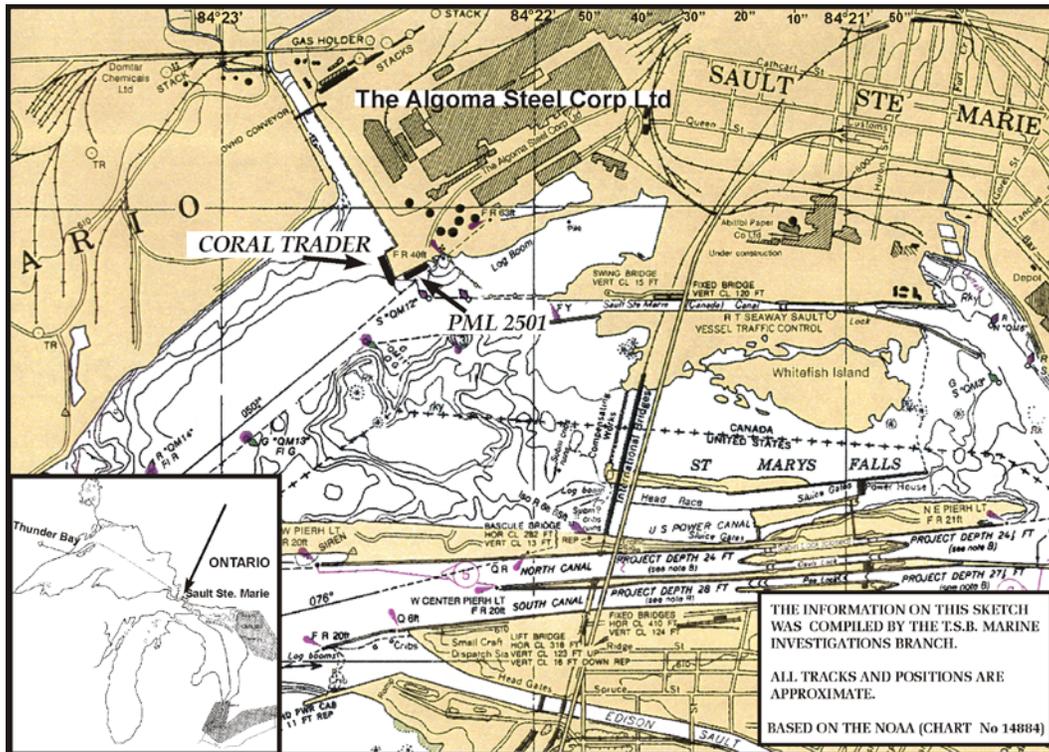
The harbour of Sault Ste. Marie, Ontario is located on the St. Marys River, which is the outlet of Lake Superior, connecting it with Lake Huron. The river is bounded to the north and east by the province of Ontario, and to the south and west by the state of Michigan, United States. The Algoma Steel Corporation wharf is at the north western side of the canal systems which by-pass the St. Marys Falls. The tanker *Coral Trader* and the barge *PML 2501* were berthed at this wharf (see Figure 1).

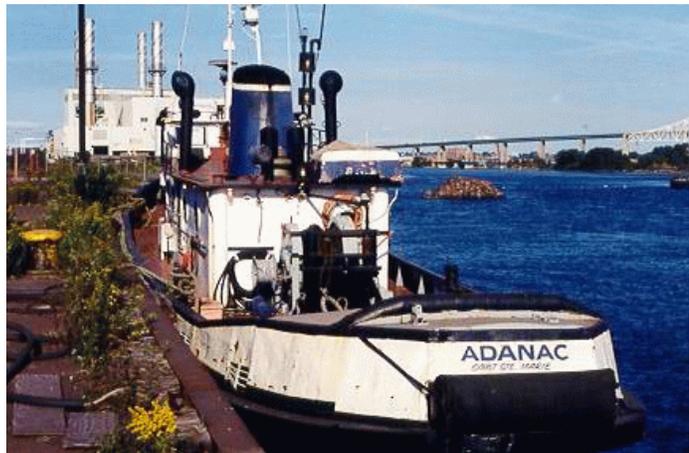
The pilot had taken an average of four or five vessels per season to and from various berths along the Algoma wharf. However, this was his first pilotage assignment from this particular berth at the extreme southern limit of the wharf. He did not fully appreciate the speed of the river current around this end section of the wharf. At the time of departure, the *Adanac* was positioned forward to push on the bow and port shoulder of the *Coral Trader* at about 75° to the tanker's line of direction. There was little room for the tug to manoeuvre between the bow of the barge *PML 2501*, the wharf knuckle, and the forward end of the *Coral Trader*.

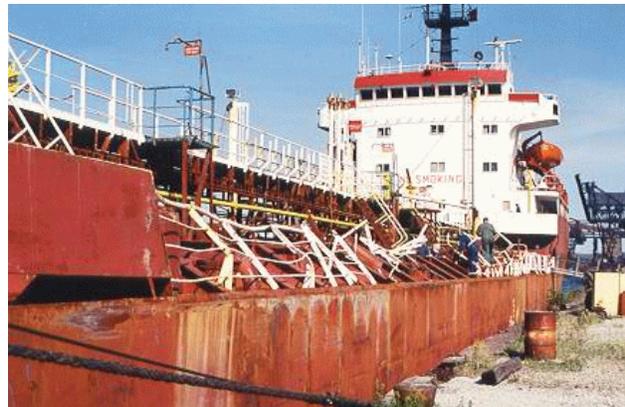
At approximately 2340, the *Coral Trader's* port side made contact with the port corner of the barge's bow. In continuing its astern manoeuvre while sideswiping the corner of the static barge, the *Coral Trader* suffered damage to its railings, manifold fittings and vents along the port side of the open deck (see Photo 3).
