MARINE INVESTIGATION REPORT

M01L0080

GROUNDING

CONTAINER SHIP *CAST PRIVILEGE*
CANADA MARITIME SERVICES LTD.
OFF ÎLE SAINT-OURS IN THE ST. LAWRENCE RIVER
29 JULY 2001

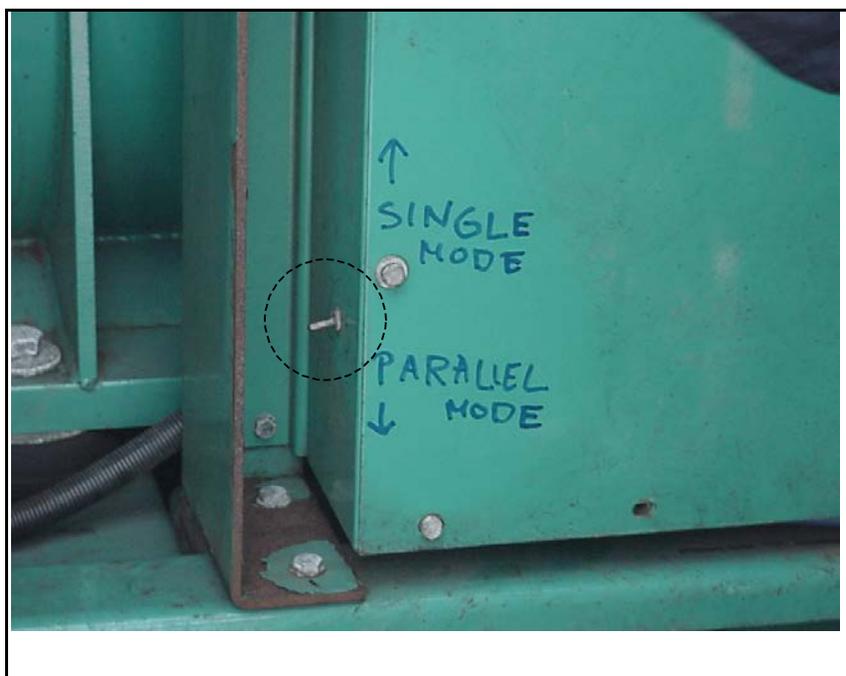
It comprised a Cummins diesel engine driving an Onan single bearing alternator. The self-contained unit is equipped with a fully-integrated Power Command Control (PCC) microprocessor-based system, used for monitoring, metering, governing, and voltage regulation. The PCC manages a parallelling function, however by use of a bypass switch on the generator, it is possible to override the PCC system and operate the genset as a stand alone unit (see Figure 1).

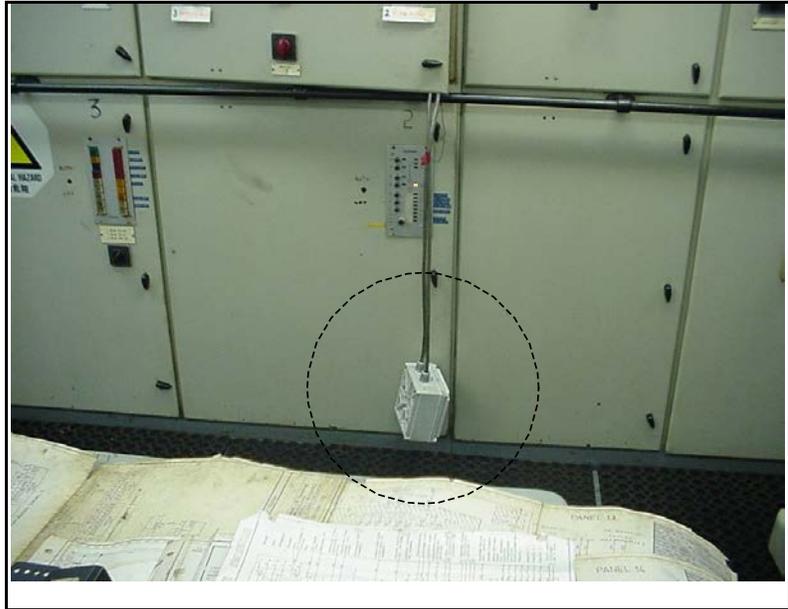
On the vessel's subsequent return to Liverpool on 26 April 2001, additional load and control cables were installed by a shore-based service engineer. This allowed the temporary genset to run at its maximum capacity of 900 kW. As the genset was still not capable of automatically sharing electrical load when running in parallel with the other SSGs, a potentiometer was installed on the main switchboard (see Figure 2), which allowed the crew to balance the load by controlling the genset's governor manually. Parallel tests up to 700 kW were conducted. A written procedure, detailing both stand-alone and parallel operations², was posted at the main switchboard. LR was not requested to attend the vessel at this time and was not made aware of the changes in the installation of the temporary genset. LR was still under the understanding that it would be used only in the stand-alone mode. Characteristics of the electronic PCC, however, were such that the temporary genset was unable to automatically share and balance the load when working in parallel with the other SSGs.

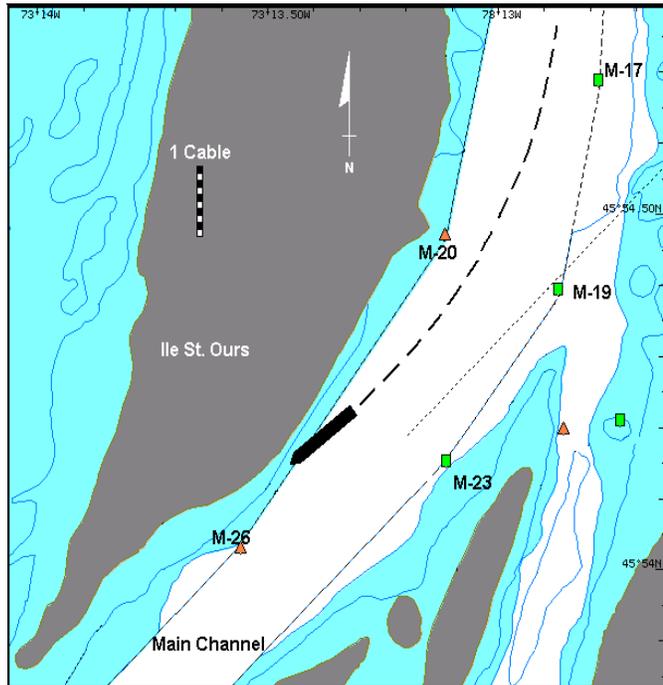
At the time of the blackout, the vessel was proceeding at 9.5 knots and on a starboard course alteration into Bellmouth curve (just southeast of Île Saint-Ours). The rudder, which was already to starboard due to the course alteration, caused the vessel to swing out of the channel and run aground in position 45° 54' 10"N; 073° 13' 26"W (see Figure 3).
