MARINE INVESTIGATION REPORT
M04C0037

STRIKING OF ST. LAWRENCE SEAWAY BRIDGE 12

BULK CARRIER *FEDERAL MAAS*
ST. LAWRENCE SEAWAY, ONTARIO
15 AUGUST 2004

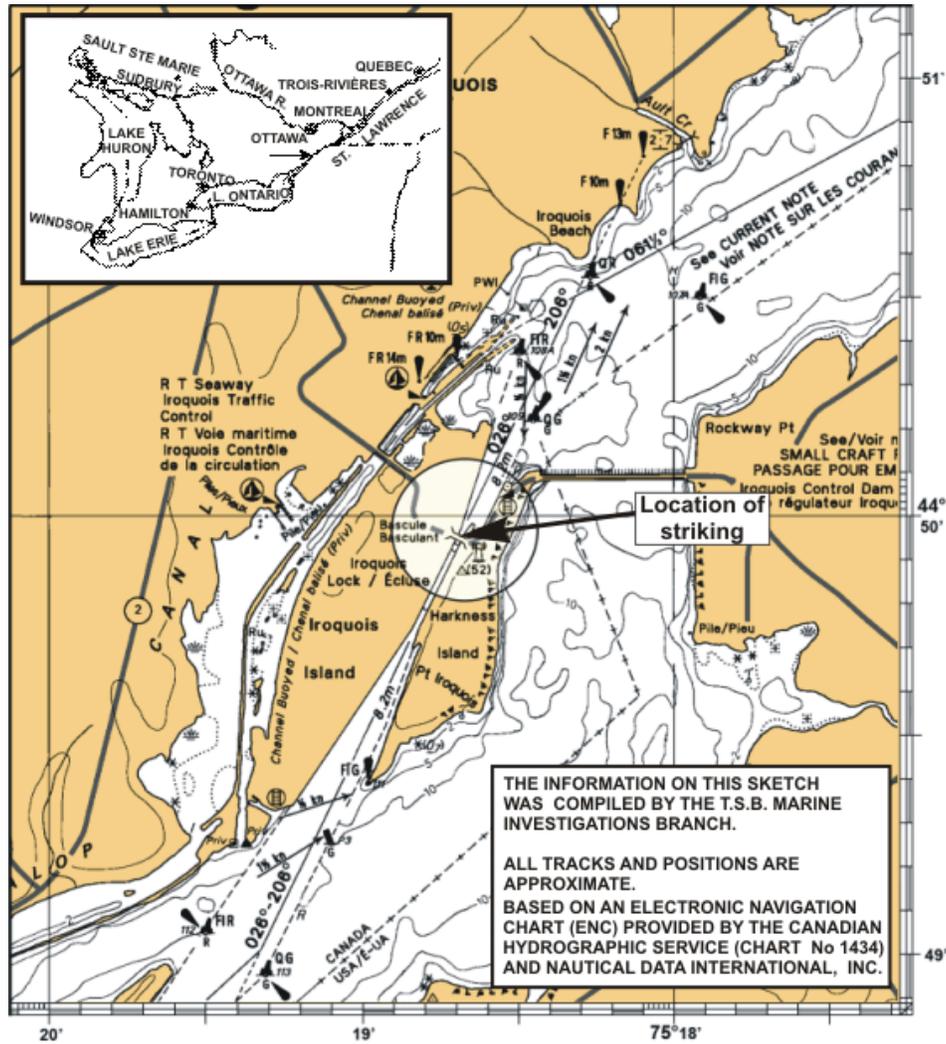
The vessel exited the lock proceeding at 1.5 knots along the lower approach wall. Both the pilot and master were on the starboard side of the vessel's bridge; as such, Bridge 12 was not clearly in view. As the vessel's accommodation structure passed Bridge 12, the port bridge wing struck the centre of the span of Bridge 12.

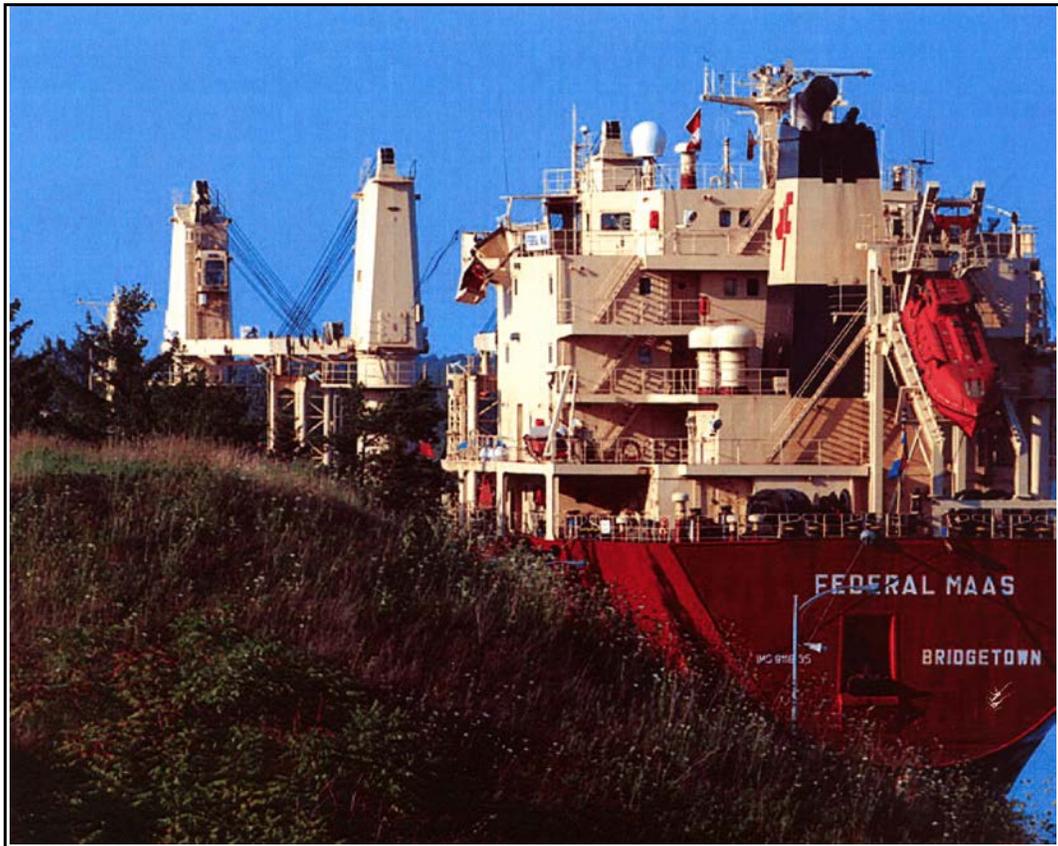
Damage to the vessel was confined to the port extendable section of the bridge wing and aft bridge wing bulwark. Damage to Bridge 12 was minor, and was limited to a light fixture and associated wiring at mid span.

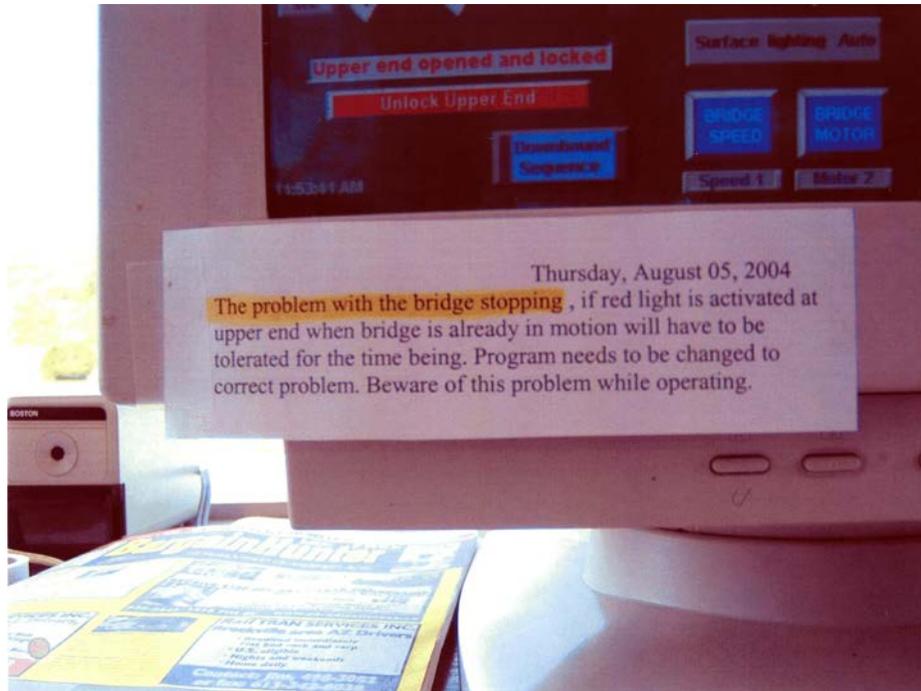
Before the computer control modifications in 2004, a bell would sound until Bridge 12 was in its fully raised position. Subsequent to the modifications, however, the bell stops ringing when the bridge stops moving, regardless of its position. As the bridge opens, the mimic display at the control stations shows a bridge animation that diminishes in size relative to the angle of bridge opening. The display is such that the animation is not readily discernable during the final 10 degrees of bridge opening; however, the percentage of bridge opening is indicated at all times, throughout its range of motion. There are no interlocks to prevent the gates or arrester boom from opening should the bridge not be fully raised.
