**MARINE INVESTIGATION REPORT
M04C0043**

COLLISION

**BETWEEN THE PLEASURE CRAFT *SHEDDEY-O* AND THE
WORKBOAT *ELMER H* AND BARGE
ADOLPHUS REACH, LAKE ONTARIO
14 AUGUST 2004**

Report Number M04C0043

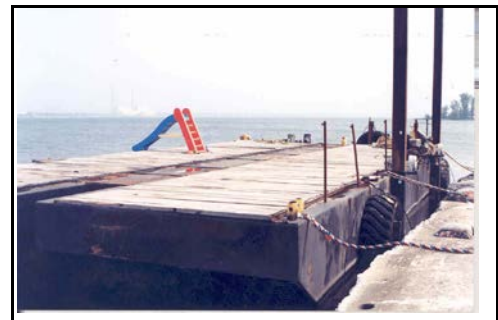
The barge was constructed of two steel floating sections measuring 3.66m by 16.76m joined together by 0.66 m-wide angle irons along the longitudinal centreline. It had a freeboard of 1.52 m. Two spuds were attached to the port side. The barge was used for commercial purposes during daylight hours only, up to the time of the occurrence. There were no fixtures or brackets to which navigation lights could be attached.

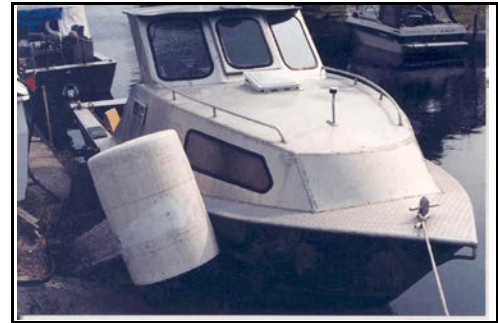
The small aluminum workboat was used mostly as a commercial fishing vessel, only occasionally pushing or towing a barge during daylight hours (see Photo 2). The operator's station was located starboard and aft of a small cuddy cabin that was partially enclosed by a hard canopy. The top of this cabin had a flat open area with railings on the perimeter, and a small lower main deck flat that tapered to the bow.

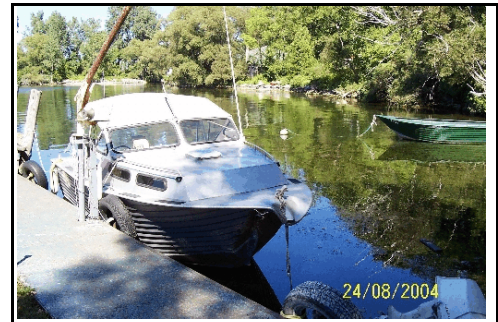
The pleasure craft was constructed of aluminum and had an overall design similar to the workboat. The operator's station was located starboard and aft of a small cuddy cabin. A convertible canvas top extended aft from the control station (see Photo 3).

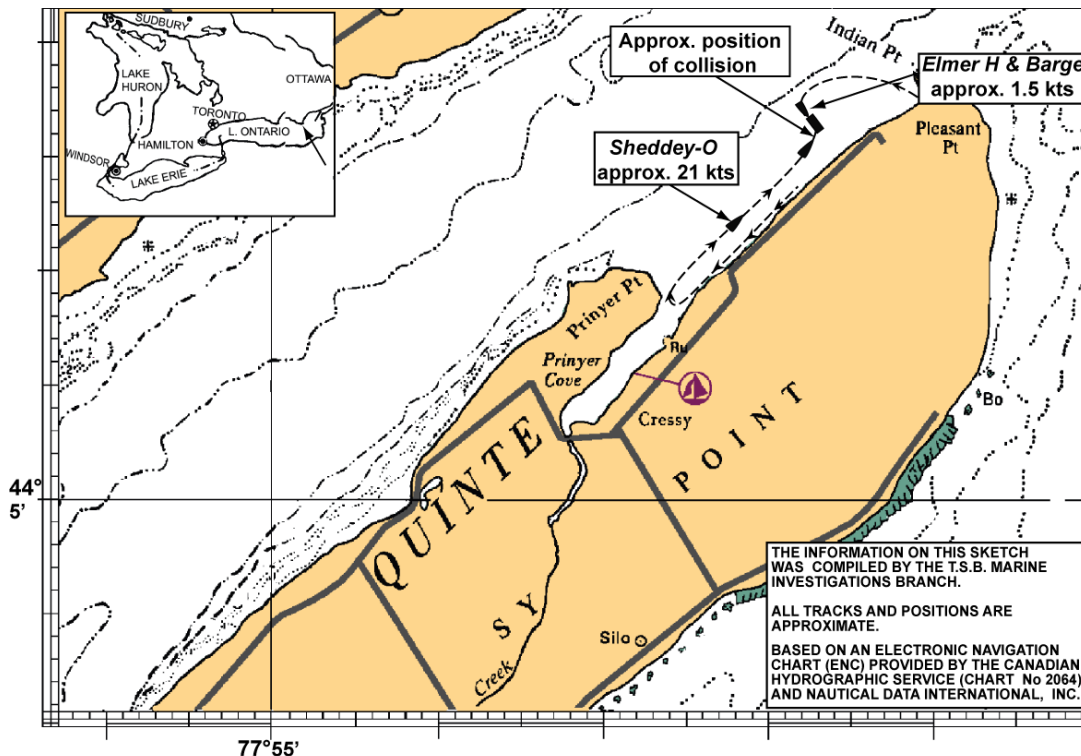
The operator of the *Sheddey-O* attempted to alter course to starboard at the last moment, but at 2125, the vessel's bow struck the starboard side of the barge at an approximate 90-degree angle, in position $44^{\circ} 06' 47''$ N latitude, $076^{\circ} 51' 12''$ W longitude (see Figure 1). The three people on the *Sheddey-O*'s forward deck were thrown forward by the impact; two of them landed on the barge and the third person bounced off the barge and over its port side. This person's personal flotation device then became snagged on the underside of the slow-moving barge, whereupon the operator of the *Elmer H* stopped the engines and dove into the water to perform a rescue.

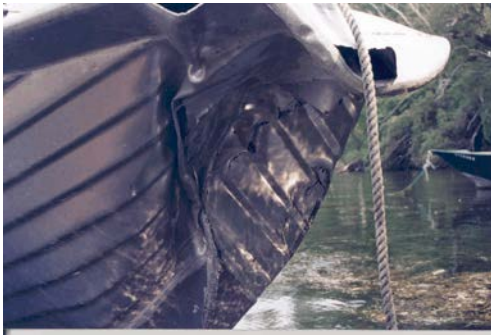
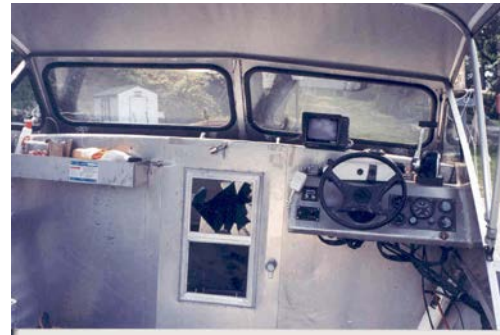
The *Sheddey-O* suffered structural deformation at the bow; this consisted of main deck plate damage, hull deformation, and plate separation from the framing (see Photo 4). The cuddy cabin also suffered minor damage (see Photo 5). Damage to the barge was limited to minor paint scrapes.

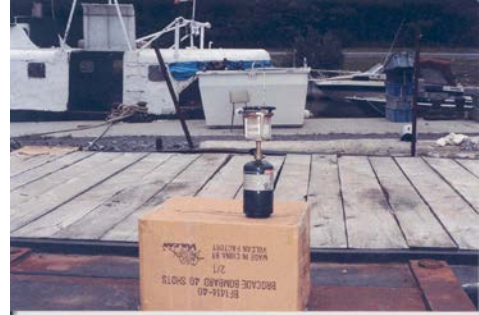
The barge was required to exhibit port and starboard sidelights at or near the forward end, a white light at each

end with an arc of 225 degrees, and a special flashing light at the forward end – all of which were to be visible at two miles.³

At the time of the collision, these lights were not fitted on board the barge. To light the deck, a propane lamp typically used for camping was placed on top of a 0.3 m-high cardboard box some 2.5 m aft of the bow. Luminosity tests revealed that this light could be seen to a maximum distance of 0.9 to 1.1 nautical miles.⁴
