MARINE INVESTIGATION REPORT
M05L0203

GROUNDING

BULK CARRIER *CANADIAN LEADER*
OFF CAP À LA ROCHE, UPSTREAM OF
DESCHAILLONS-SUR-SAINT-LAURENT, QUEBEC
26 SEPTEMBER 2005

Report Number M05L0203

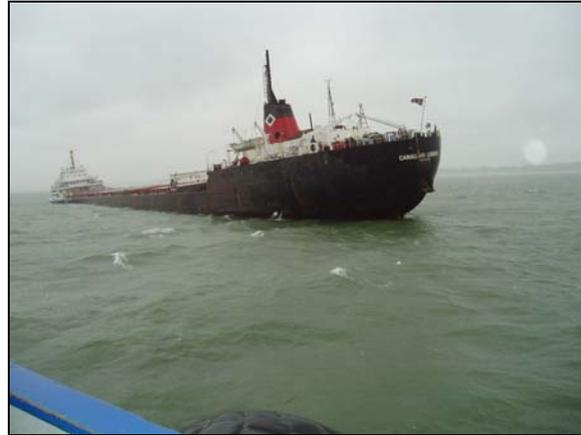
Photo 2. The *Canadian Leader* aground off Deschaillons-sur-Saint-Laurent

In the afternoon, divers and the SMT naval architect arrived on scene. An underwater survey confirmed that the vessel was resting on the bottom from the bow to frame 181 (aft end of cargo hold No. 2) on the starboard side. Divers were unable to see any damages to the hull due to a strong tidal current that affected visibility.

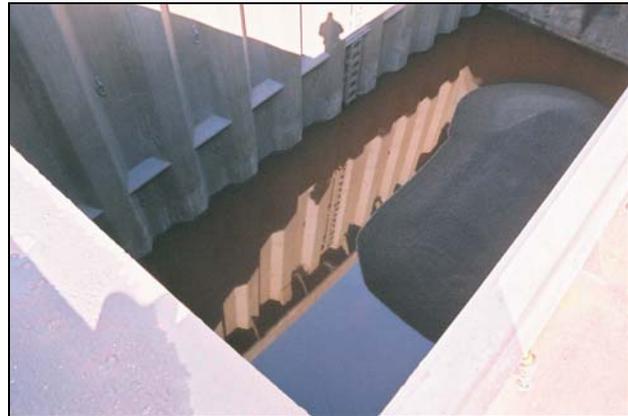
Photo 3. Water in the No. 2 cargo hold

At about 0800, the vessel's list had noticeably increased. Around 1000, a crew member opened a booby hatch giving access to the cargo hold and discovered the presence of water (see Photo 3). The master immediately phoned SMT, and arrangements were made to have the salvage company, Groupe Océan, deliver portable pumps to the vessel.

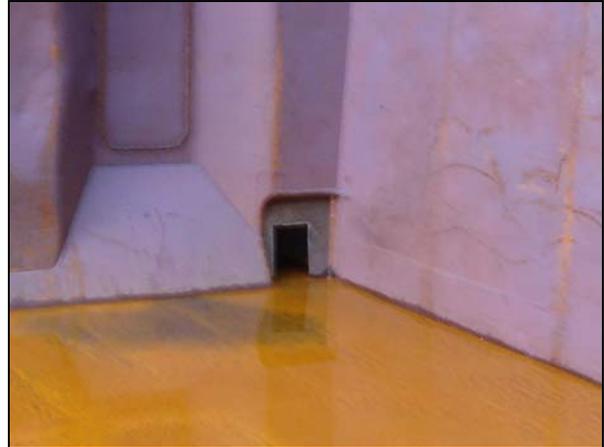
Photo 4. Screen bulkhead drainage opening

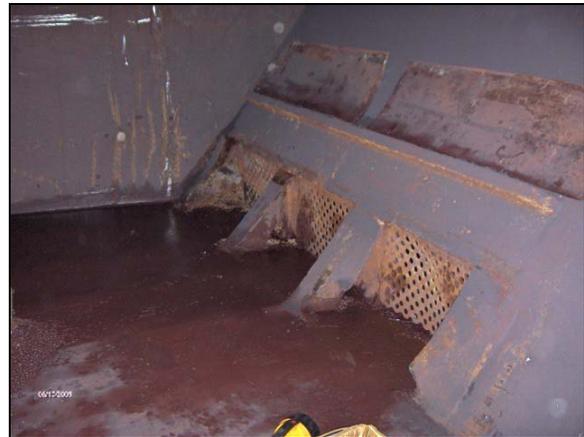
The vessel's pumping arrangement includes two bilge wells in the aft end of the single watertight cargo hold. The bilge wells are located on the port and starboard sides of the hold, adjacent to the aft bulkhead (in the aft end of cargo hold No. 6). The bilge wells are situated on the tank top, within the hopper, at the cargo hold's side and extend from the aft bulkhead to 4 m forward. The cargo hold pumping arrangement is linked to the ballast pumping system by a 455 mm pipe. Each bilge well has three strainer plates; 550 mm by 450 mm, with 25 mm perforations (see Photo 5).

Photo 5. Strainer plates in the aft port cargo hold

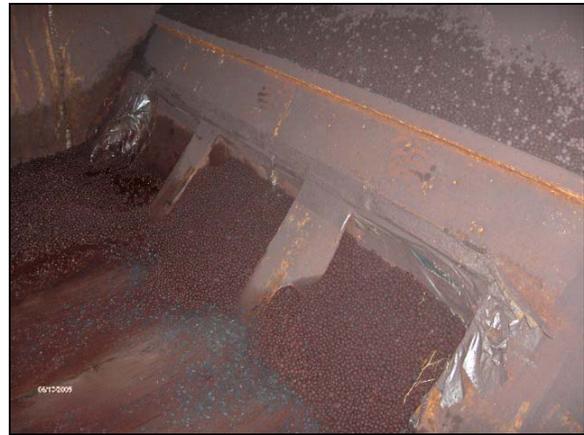
To prevent ore pellets from entering the bilge wells, the crew sealed the strainer plates using cardboard, plastic sheeting, and duct tape (see Photo 6). This was not a written procedure; however, it was common practice on board the vessel when similar cargo was carried.

Photo 6. Port bilge well, with strainer plates sealed off

On 15 November 2006, TC updated an earlier response, stating that the size of the holes in the strainer plates was not relevant in this occurrence and that covering the strainer plates with plastic ensures that bilge and ballast arrangements are free of debris. Furthermore, in relation to water ingress detection, TC states that, due to the rarity of a ruptured tank top, the present system of detection is considered adequate for existing vessels.

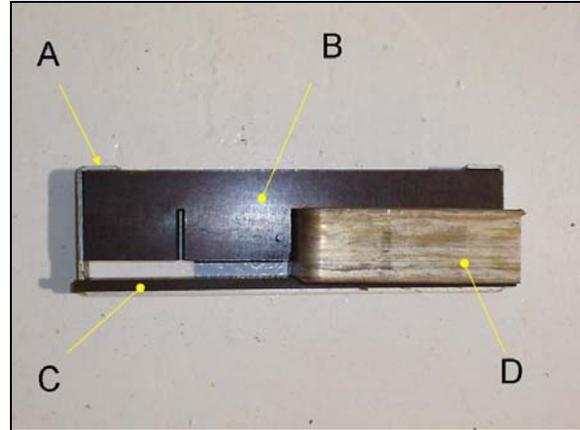
Photo 8. A. Steel bracket. B. Horizontal bakelite insulation block with the three notches. C. Vertical 6 mm flat bakelite insulation piece. D. Bus bar in the centre notch.

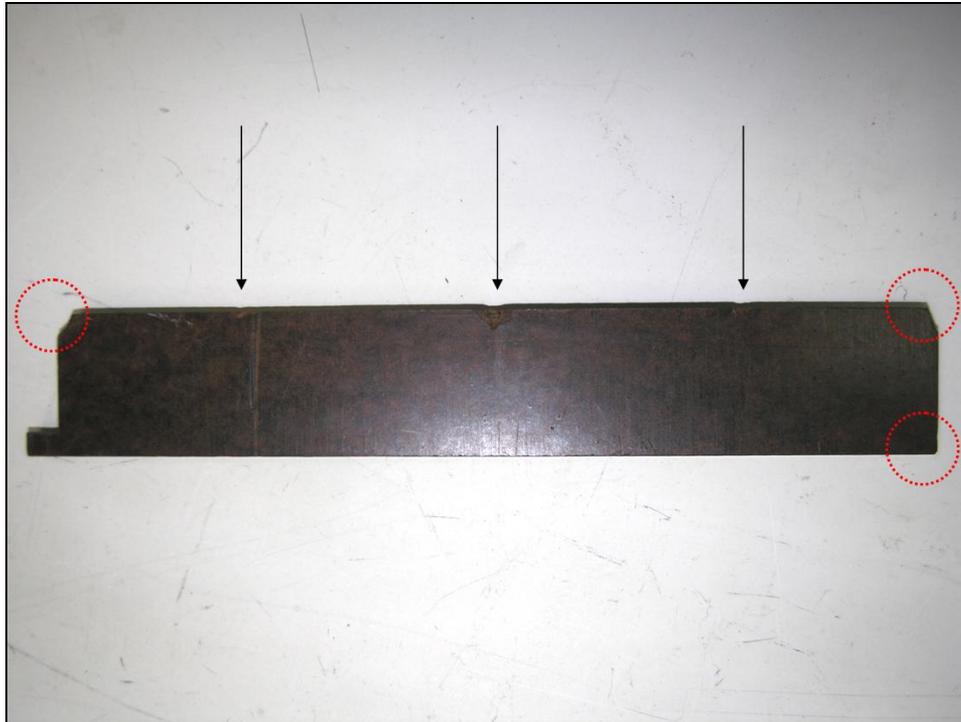
The vertically mounted 6 mm flat bakelite insulation piece was discovered later on the deck inside the switchboard casing covered with a fairly uniform layer of dust, indicating that it had fallen away sometime earlier. Also, three tabs out of four were missing and marks of indentations were visible in way of the three bus bars, indicating that the bars had had a tendency to press the bakelite insulator against the steel bracket (see Photo 9).

Photo 9. View of the 6 mm "H"-shaped bakelite insulation piece as found on the switchboard deck. Arrows show indentations in way of bus bars. Circles show missing tabs.

The H-shaped piece of bakelite from the insulation arrangement that rests against the steel bracket between the three bus bars was missing at the time of the blackout. This piece had fallen out of place some time before the occurrence. This insulation piece, which is approximately 6 mm thick, showed signs of indentation where the bars rested, indicating that the bars had a tendency to move toward the bracket as the breaker mated with the bus bars. Given the absence of the insulation piece, the spacing (gap) between the edge of bus bars and the bracket would have been less than 6 mm on each such occasion.

Similarly designed switchboards and breakers on other SMT ships were identified. During the winter layup period of 2006, a detailed inspection of the insulation was carried out to identify any defects for correction. None were found and these identified ships are now on a similar inspection program as the *Canadian Leader*.

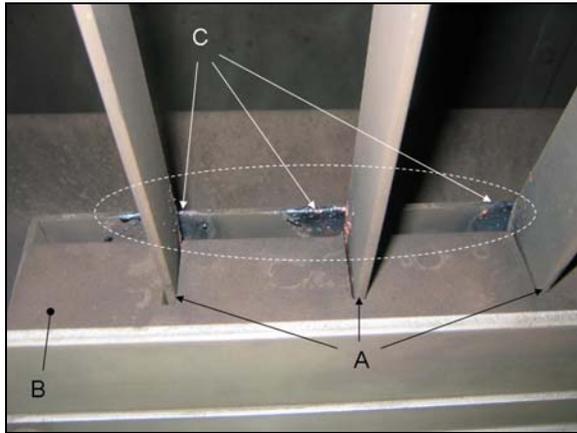
An examination revealed that arcing took place between the bus bars and the steel bracket (see Photos 10, 11, and 12), not directly between the bus bars.¹⁵

Photo 10. View from above of: A. Three bus bars.
B. The bakelite insulation block.
C. Indication of arcing in way of the bus bars.

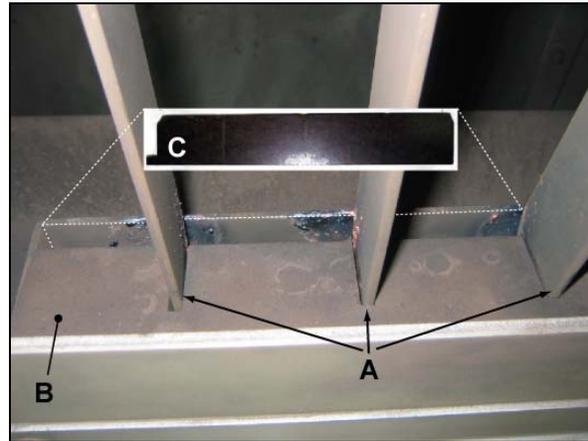
Photo 11. View from above of: A. Three bus bars.
B. The bakelite insulation block.
C. Normal location of the 6 mm flat bakelite insulation piece (insert).

According to TP 127, an air gap of at least 22 mm would be required to prevent arcing between the bus bars and the adjacent bracket; however, since the bakelite insulation piece was missing, the maximum air gap distance between bus bars and ground would have been only 6 mm.

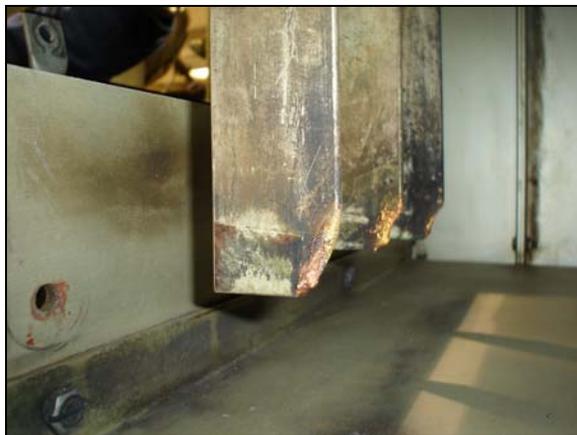
Photo 12. End view of bus bars showing result of arcing

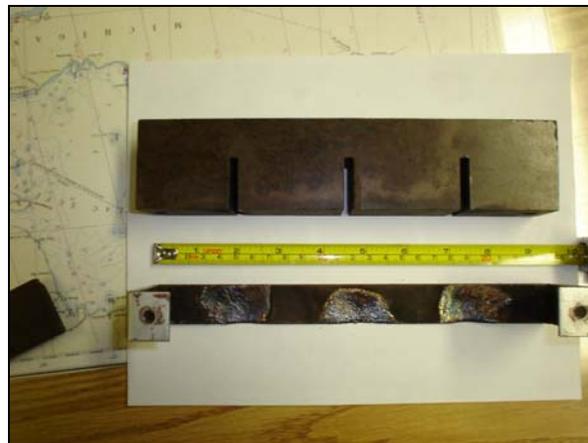
Photo 13. View of steel bracket showing result of arcing and bakelite insulation block

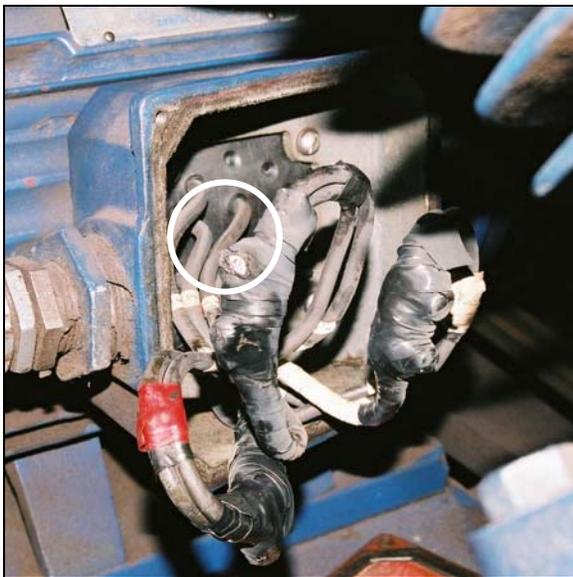
Several hours after the power was restored subsequent to the blackout, the second engineer noticed a dead phase ground fault while closing the circuit breaker connecting the aft air compressor set. One of the wires in the connection box of the electrical motor was later found to have been in contact with the inside top of the casing (see Photos 15 and 16).

Photo 15. Wire terminal covered with electrical tape, but showing bare screw

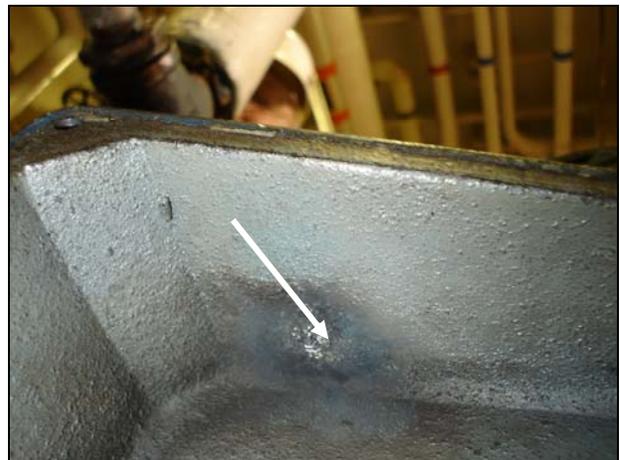
Photo 16. Contact point on inside top of connection box

The marking inside the connection box of the aft air compressor (see Photo 16) was fresh, indicating that a single contact followed by repulsion may have created a build-up of electrical potential within the ship's structure in way of the switchboard steel bracket. This condition appeared new at the time of the occurrence.

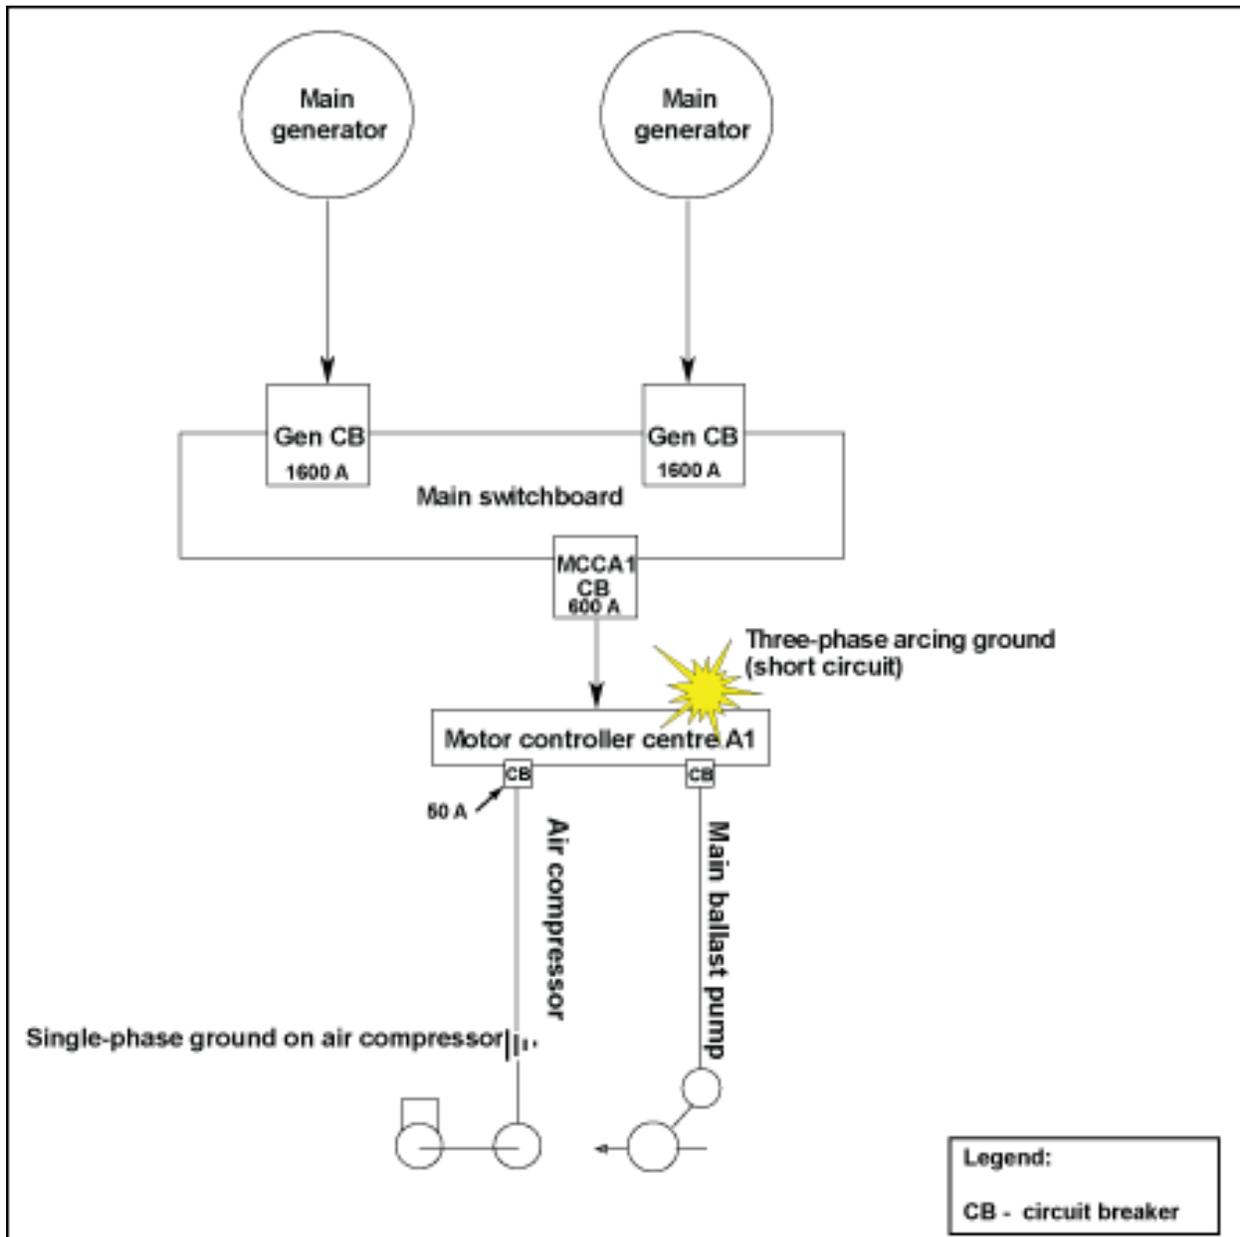
Figure 2. Circuit breaker line diagram

The fault in the air compressor likely triggered an arc short circuit on the No. 1 ballast pump bus bar. The upstream MCC A1 breaker tripped. However, both generator circuit breakers also tripped simultaneously as a result of this short circuit, indicating inadequate breaker coordination. The resulting blackout left the vessel without steering.

SMT informed the TSB that electrical inspection procedures for switchboards and feeder breakers have been enhanced to include testing in conjunction with the main generator breakers every five years. SMT has since issued Circular Letter 77-2005 to all chief engineers; infrared scans are now performed yearly fleet-wide as a preventative action and regular inspections and cleaning to detect and correct any switchboard defects have also been put in place. The company will consider upgrading the MCC’s breaker protection with electronic trips, similar to those on the main breakers if tests indicate a potential problem.
