**PIPELINE INVESTIGATION REPORT
P02H0052**

REFINED PRODUCT PIPELINE RUPTURE

**TRANS-NORTHERN PIPELINES INC.
273.1-MILLIMETRE-DIAMETER MAINLINE
KILOMETRE POST 63.57
NEAR SAINT-CLET, QUEBEC
07 DECEMBER 2002**

Report Number P02H0052

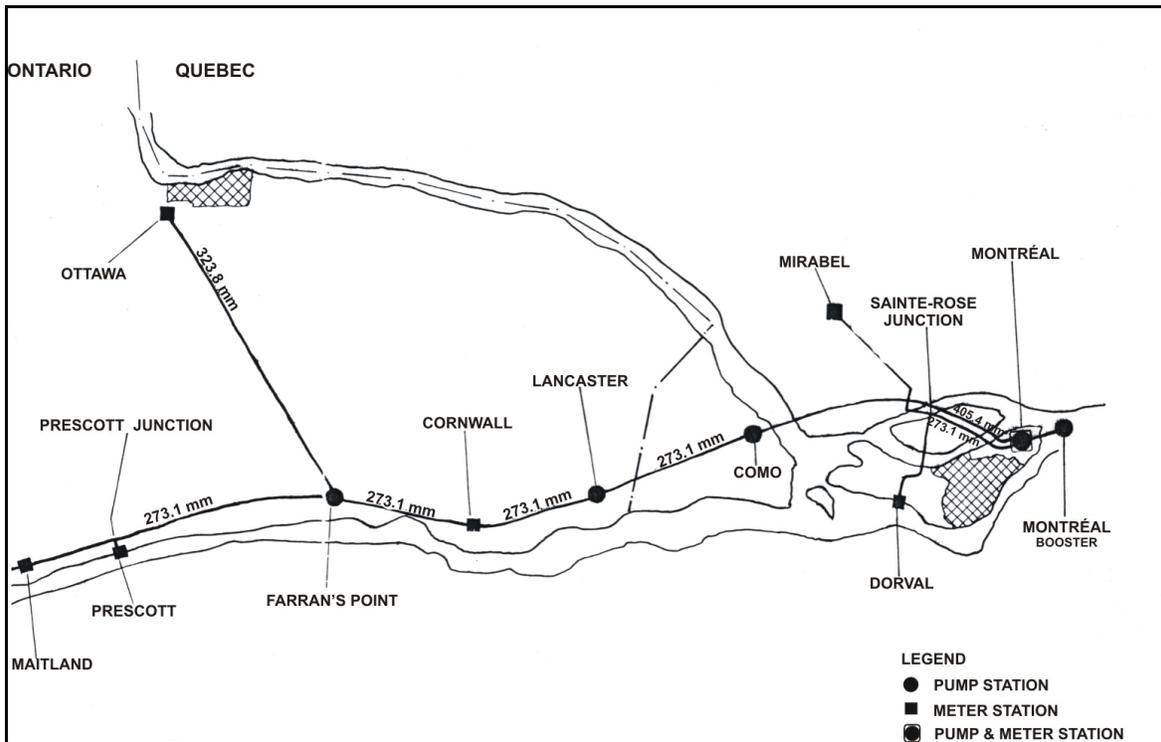
Appendix A – Schematic of the Trans-Northern Pipelines Inc. Pipeline System from the Montréal Pump Station to the Ottawa Terminal

On 07 December 2002, Trans-Northern Pipelines Inc. (TNPI) was delivering refined petroleum products from the Montréal, Quebec, refining basin into the Ottawa, Ontario, terminal storage facilities. This movement of product had originated from the company's Montréal pump station, with the pipeline pressure then being boosted at the Como, Quebec, and the Lancaster and Farran's Point, Ontario, pump stations (see system schematic in Appendix A).
