**PIPELINE INVESTIGATION REPORT
P06H0061**

IN-LINE TOOL OCCURRENCE

**ENBRIDGE PIPELINES (WESTSPUR) INC.
323.9-MILLIMETRE OUTSIDE DIAMETER PIPELINE
RECEIVING TRAP AT CROMER TERMINAL
NEAR CROMER, MANITOBA
23 NOVEMBER 2006**

Report Number P06H0061

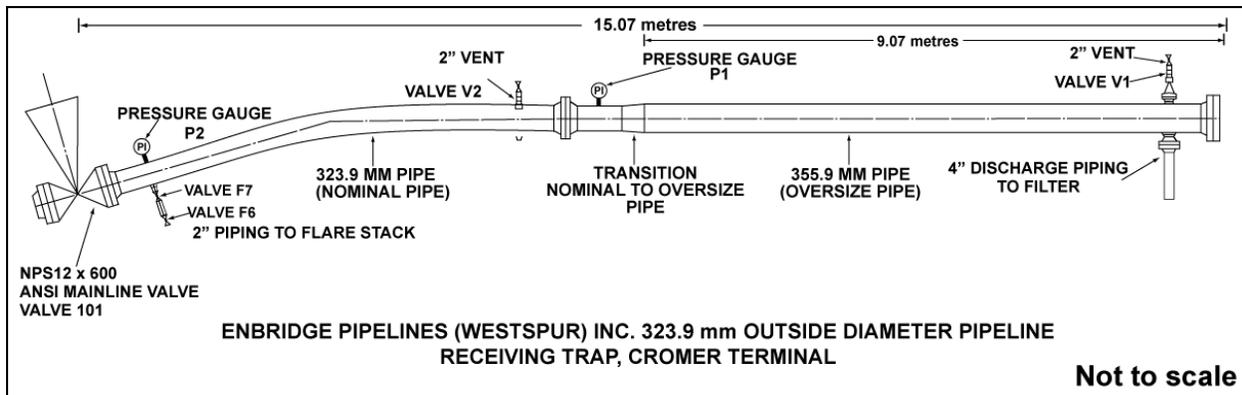
Figure 1. Temporary receiving trap

A temporary receiving trap, as shown in Figure 1, had been constructed for this ILI. The outside diameter of the oversize pipe of the receiving trap was based on EPSI standards for gathering lines and was 355.6mm OD with an inside diameter of 336.55 mm. Each displacement pig had an outside diameter of 323.85 mm. Since the oversize pipe was long enough to accommodate the four displacement pigs simultaneously, a puller that could reach towards the back of the oversize pipe and remove the last displacement pig had been constructed for this project. It was 9.1 metres (m) long and made of square metal tubing with a 12.7 mm hook inserted into the end. There was no detailed written procedure for the use of this puller.

The contamination of the NGL by the natural gas, as evidenced between the arrival of the second and third displacement pigs at Cromer, would have resulted in the accumulation of black powder. Contaminants may have been left in the pipeline following the last cleaning run. The black powder along with other contaminants and the natural flaring of the displacement pig cups from the back pressure in the pipeline combined with the small spacing around the displacement pigs could have created an effective seal around the third and/or fourth displacement pigs so that pressure from the nitrogen purge or any entrapped NGLs could not dissipate around those tools. The resulting pressure differential was sufficient to move the third and fourth displacement pigs backwards in the receiving trap until the third displacement pig became lodged at the transition between the nominal and oversize pipes and the fourth displacement pig was in the nominal pipe of the receiving trap, either just upstream of, or spanning, valve V2.

Following the closure of valves F6 and F7, a small amount of liquid NGLs probably remained in the receiving trap behind the fourth displacement pig. With the pressure in the trap less than 689.5 kPa, the NGLs would have gasified at a ratio of approximately 255:1. Since the fourth displacement pig was either just upstream of, or spanning, valve V2, the pressure could not dissipate through that valve and the valve could not function as designed in ensuring that the receiving trap was depressurized. The third displacement pig became dislodged when the crew pulled on it with the puller. Once the third displacement pig had become dislodged, the pressure behind the fourth displacement pig was sufficient to expel both displacement pigs from the receiving trap.

Since the crew believed that the third and fourth displacement pigs were in the oversize pipe of the receiving trap, they were not aware that valve V2 was blocked and could not function as designed in ensuring that the receiving trap was depressurized. In addition, once the crew was aware that the third and fourth displacement pigs had moved out of the oversize pipe of the receiving trap, they did not recognize the hazards associated with this change in location.

Although the crew verified that pressure gauges P1 and P2 were reading 0 kPa, those gauges were scaled from 0 to 6895 kPa and may not have been capable of displaying the relatively low pressures of 103 to 138 kPa required to move the displacement pigs.

4. Because the fourth displacement pig had become lodged either upstream of, or spanning vent V2, that vent could not function as designed.
5. Pressure built up behind the fourth displacement pig, possibly due to the gasification of NGLs behind it, until the pressure differential was sufficient to expel the third and fourth displacement pigs from the receiving trap.

Following an internal investigation by Enbridge Pipelines Inc. and Enbridge (Saskatchewan) Operating Services Inc. of the events surrounding the November 2006 occurrence, the 355.6-millimetre (mm) temporary receiving trap was replaced by a 406.4 mm temporary trap to land the four displacement pigs that were used when the 323.9 mm outside diameter mainline was re-filled with natural gas liquids (NGLs). A detailed procedure for loading and removal of those tools was developed. Enbridge Pipelines (Westspur) Inc. (EPWI) has indicated that it is committed to implementing the following recommendations made by the internal investigation team:

- adopt a new gathering system standard that requires 101.6 mm oversizing of traps for all lines of 323.9 mm or greater and ensure that existing traps meet this new standard;
- continue to implement a hazard assessment program;
- develop formal procedures for verifying the isolation and depressurization of receiving traps when NGLs and natural gas have been used;
- review existing manuals to ensure that proper procedures and guidance is provided when considering all aspects of the operation of NGL pipelines;
- initiate training for all operations personnel on the policies and procedures, both new and existing, relating to the operations of NGL pipelines; and
- ensure that policies, procedures and facilities cover the formation of hydrates and how to eliminate or deal with them and that personnel are trained with regard to hydrates.
