**PIPELINE INVESTIGATION REPORT
P13H0013**

**CRUDE OIL PIPELINE LEAK
ENBRIDGE PIPELINES INC.
LINE 21, KILOMETRE POST 391
NEAR WRIGLEY, NORTHWEST TERRITORIES
08 FEBRUARY 2013**

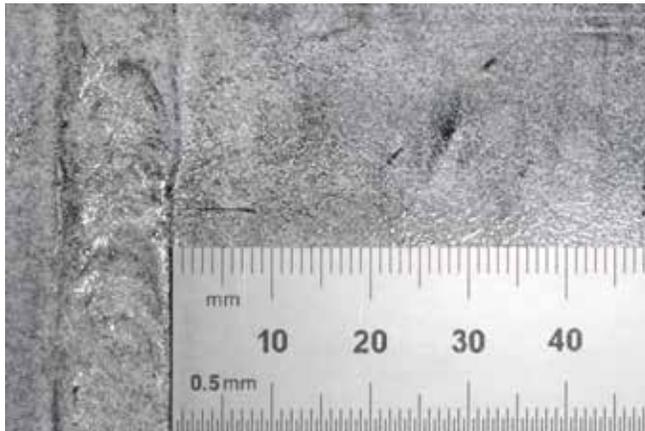
- The leak occurred at a through-wall crack, which originated in the base metal on the internal surface of the pipe in close proximity to the girth weld. The crack measured 3.4 mm in length at the outside diameter of the pipe (see Photo 1) and 18.8 mm in length at the inside diameter of the pipe (see Photo 2).
- The crack morphology was intergranular through 98% of the wall thickness (see Photo 3) and was consistent with internal stress corrosion cracking.
- The residual welding stresses were the most probable source of tensile stresses governing the cracking behavior.
- Crack propagation was by fatigue for the remaining 2% of the pipe wall thickness.

Photo 1. The crack as viewed from the outer pipe surface

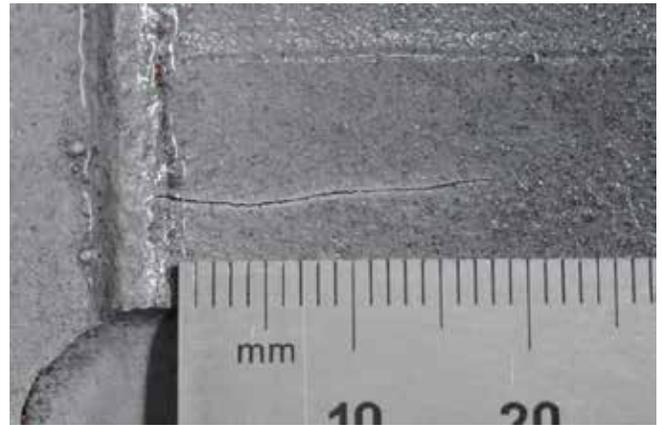
Photo 2. The crack as viewed from the inner pipe surface

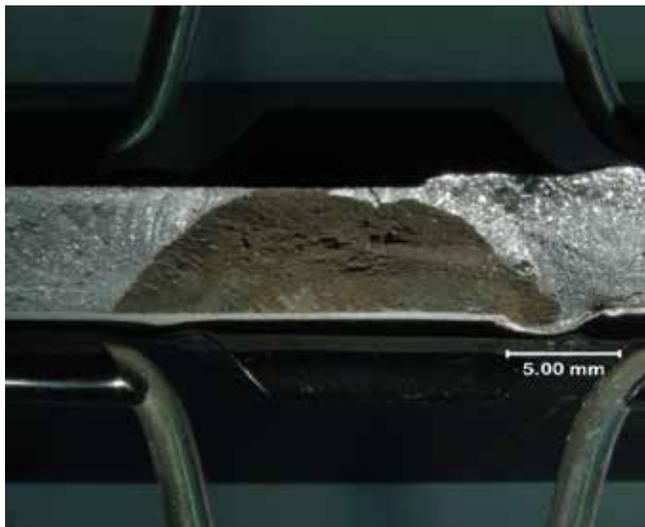
Photo 3. The crack face

1. The pipeline failure at kp 391 occurred at a through-wall crack located near a girth weld.
2. The defect was a result of internal stress corrosion cracking through 98% of the pipe wall thickness.
3. The defect had likely initiated prior to Line 21 being commissioned in 1985.
4. The methanol used following the pneumatic test at the time of construction had likely produced an internal pipe environment that was conducive to the initiation and propagation of stress corrosion cracking.
5. Cracking originated near the girth weld due to the high residual tensile stresses on the pipeline inner diameter at that location.
6. The defect propagated through the remaining 2% of the pipe wall thickness as a result of fatigue caused by normal pipeline operations.

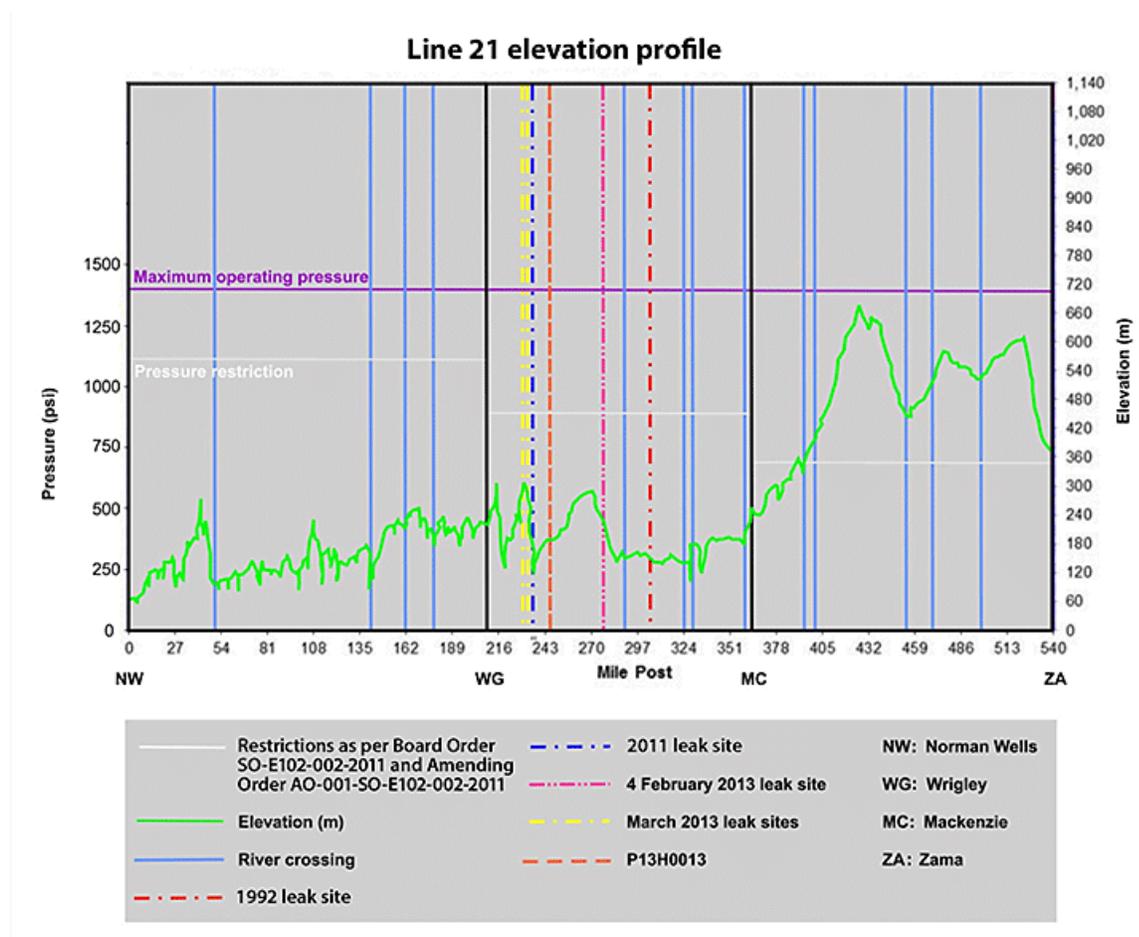
Figure 2. Elevation profile showing leak locations

During the winter 2012–2013 excavation program, contaminated soil was found at 3 other targeted locations (kp 382, kp 387, and kp 457) in addition to the contaminated soil found at kp 391. These other 3 locations had through-wall cracks, although none of the cracks were leaking at the time of excavation. The cracks were axially oriented, relatively short, and located in close proximity to a girth weld. A section of pipe containing the crack at kp 457 was cut out for further testing. The remaining 2 locations, kp 382 and kp 387, were sleeved and were to be used for calibration and verification purposes (i.e., during subsequent in-line inspections).

Figure 2 provides a graphical presentation of Line 21 (Norman Wells to Zama), including the elevation, maximum operating pressure, pressure restrictions imposed by NEB, and locations of the recent (i.e., 2011 to 2013) pipe sections with contaminated soil.
