PIPELINE OCCURRENCE REPORT

P96H0012

NATURAL GAS PIPELINE RUPTURE

TRANSCANADA PIPELINES LIMITED
LINE 100-2, 864-MILLIMETRE (34-INCH) MAINLINE
KILOMETRE POST MAINLINE VALVE 39-2
+ 6.07 KILOMETRES
ST. NORBERT, MANITOBA
15 APRIL 1996

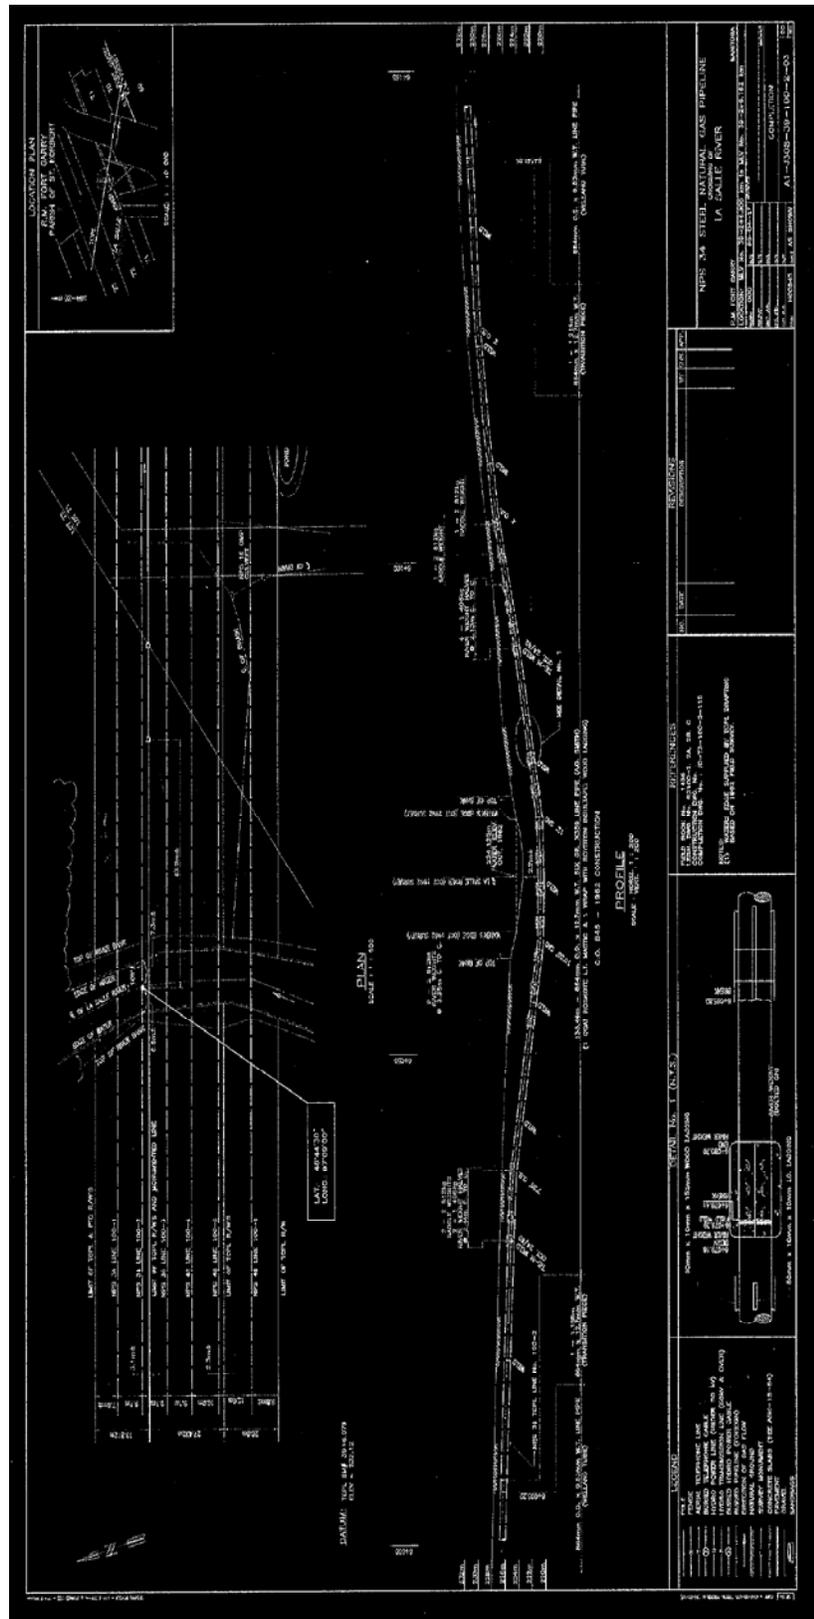
Appendix A - Plan and Profile of the River Crossing (from TCPL)

TCPL's records indicate that, at the site of the rupture, the limits of TCPL's right of way measure 67.244 m (220.62 feet), and that the six pipelines run parallel to each other (see Appendix A). Within the TCPL right of way, the spacing between the north edge and Line 100-1 is 7.6 m (24.93 feet). The spacing between Lines 100-1, 100-2, 100-3, 100-4 is 9.1 m (29.85 feet), between

The results of the geotechnical examination indicate that, on the east bank of the La Salle River crossing, Lines 100-1 and 100-2 pass through an area of pre-existing slope instability. A pre-1959 construction profile of the crossing illustrates classic slope instability features, such as a bulging slope toe, an up-slope slump and indications of a concave slope surface. Previous ground movement was evident as surface features on the slope area near the occurrence site, and included arc-shaped tension cracks and vertical displacement of the ground surface up-slope of the rupture site.
