RAILWAY INVESTIGATION REPORT

R01Q0010

MAIN TRACK DERAILMENT

CANADIAN NATIONAL TRAIN NO. G-894-31-14

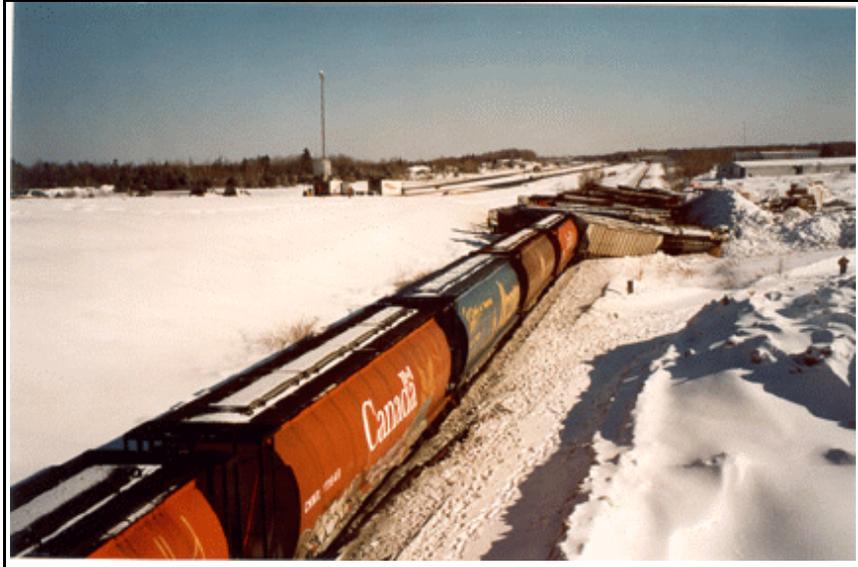
The 57th car remained upright, 788 metres east of the main derailment area; its trailing truck derailed on the south side of the main track. The 23 cars that followed derailed in an accordion pattern (see Figure 1) over a distance of 64 metres, directly east of the M-211 turnout, on property belonging to a construction materials business adjacent to the right-of-way. The last derailed car remained upright, with its truck derailed on the south side of the track. The signal bungalow, located east of the M-211 turnout, as well as a communications tower belonging to CN, were destroyed. The underground fibre-optic cable was severed.

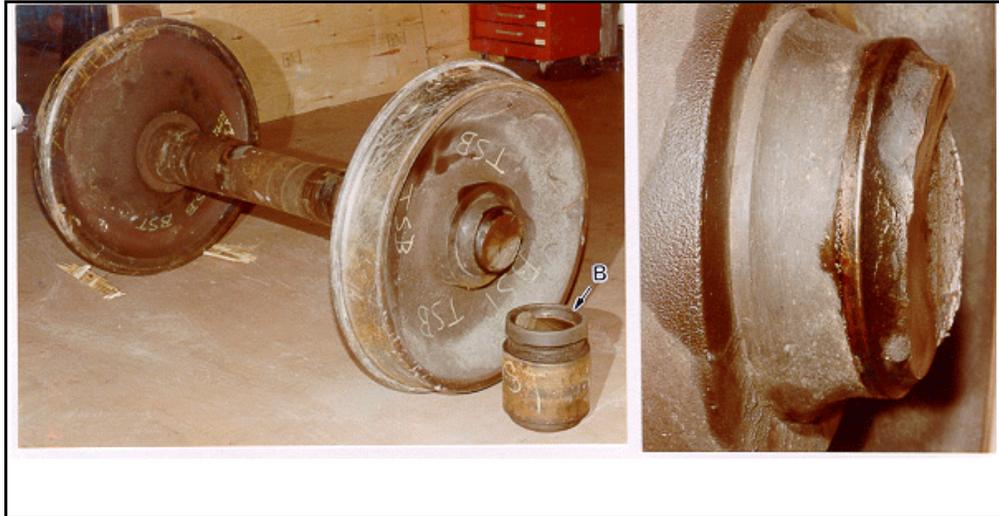
A section of a broken axle journal, with its roller bearing (see Figure 2), was found in the ditch on the south side of the track, at Mile 16.25; it originated from car CNWX 107921, the second derailed car. The car in question was a covered hopper car made of aluminum, with a light weight of 41 000 lb (20 045 kg) and maximum loaded weight of 220 000 lb (100 000 kg). The car's shipping record indicated that it was at its maximum load weight at the time of the derailment.

The fracture of the axle probably took place at the point where the end of the broken axle journal was found, at approximately Mile 16.25. Since it was not attached to the truck side frame, the end of the axle journal broke free at the time of the fracture, detached from the car and fell into the ditch. Since it no longer had any support, the side frame slumped onto the rail surface. The truck was then dragged along the rail surface until it reached switch M-211, causing the derailment of the other cars.

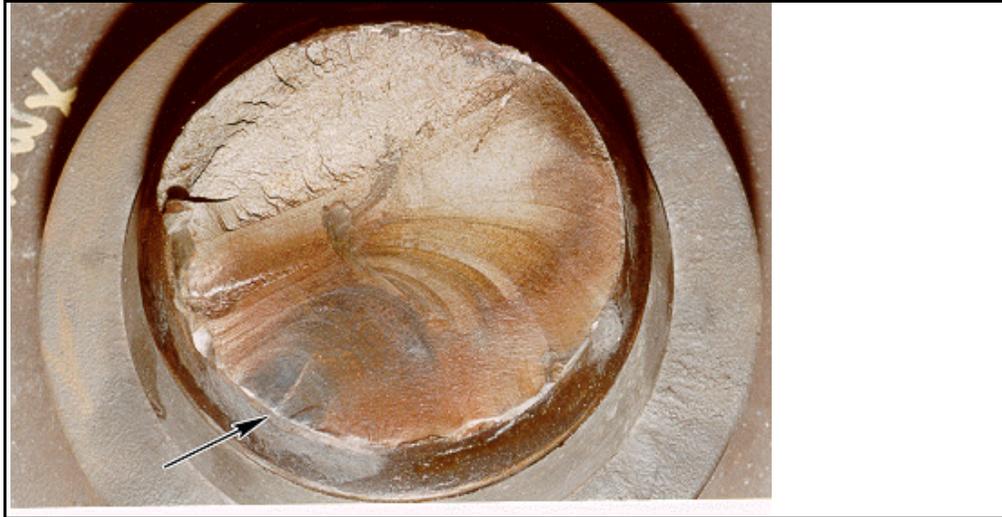
The sections of axle were sent to the Transportation Safety Board of Canada (TSB) Engineering Laboratory for analysis. An examination (Report No. LP 11/01) revealed the presence of a fatigue fracture covering over 65 percent of the fracture surface (see Figure 3). This fracture was first found in numerous crack initiation sites in the axle journal fillet and in the journal box dust guard (axle journal fillet), and coincided with corrosion pitting. The fracture surfaces were highly oxidized, but there were no signs of overheating on any of the components. According to the TSB database, 7 axle fractures occurred in Canada in similar circumstances to this accident between 1998 and 2000 (corrosion pitting which led to fatigue cracking and ultimately to axle failure).³

According to the results of the analysis conducted by the TSB Engineering Laboratory, the axle broke as a result of a fatigue fracture that originated in the axle journal fillet and that coincided with corrosion pitting. Since the axle fillet area is subjected to high stresses, and corrosion pitting acts as stress raisers, the number of loading cycles that the axle could withstand was decreased, leading to the initiation and development of fatigue fractures, and consequently, the failure of the axle.

Corrosion pitting on the axle journal fillets, as well as spalling on the bearing ring, cones and axle roller bearings, indicate that moisture penetrated and accumulated in the area. This moisture could have been the result of condensation that forms while the bearings cool down, but it could also have penetrated through the protective coating, which had completely dried out and become susceptible to moisture. For this reason, quality
