RAILWAY INVESTIGATION REPORT
R08M0002

LEVEL CROSSING ACCIDENT

MILE 181.24, MONT-JOLI SUBDIVISION

19 JANUARY 2008

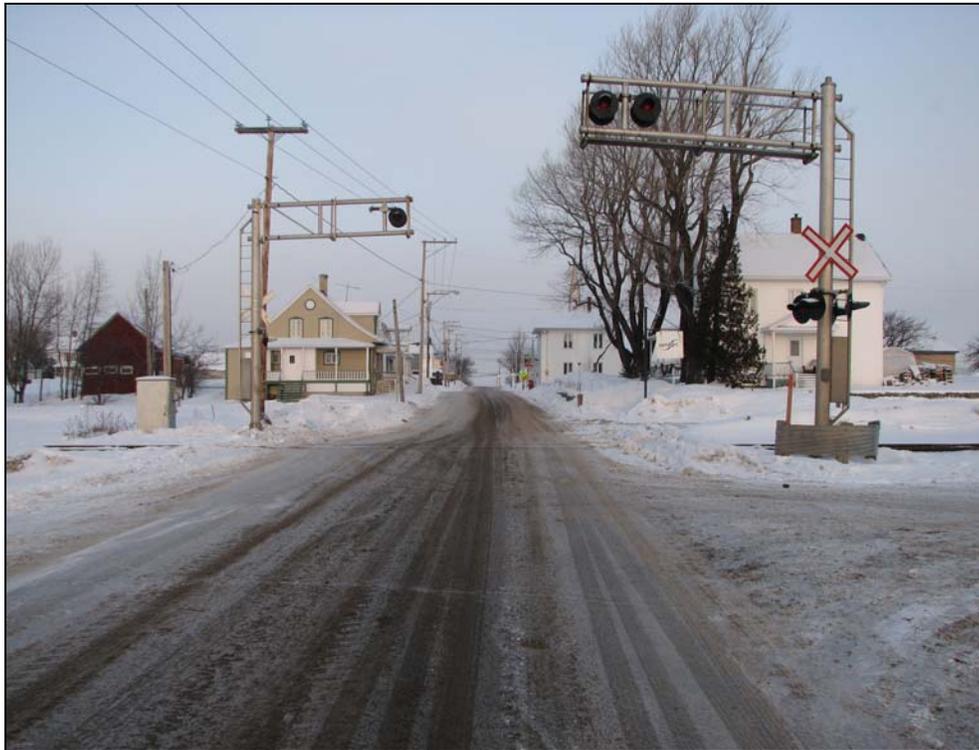
The rue de l'Église crossing warning system, installed in 1959 under Board of Transport Commissioners for Canada Order 98554, consisted of cantilever signals equipped with flashing lights and bell. The configuration of the lights on the cantilever structure was as per a Board plan dated 04 October 1979, approved by the Canadian Transport Commission. For northbound traffic, there was one set of front and back lights, mounted on the cantilever and focused at a distance of approximately 140 metres. Because of the presence of two access roads parallel to the rail line, in 1979, the mast lights below the crossbuck were rotated and aimed along those two roads, leaving the signals on the cantilever aimed towards northbound traffic (see Photo 1).

Photo 1. View of the crossing looking north (photo taken the day after the accident)

The flashing light signals used the standard railway power supply, with 18-watt incandescent bulbs. These lights use searchlight-style beams, to ensure high light visibility for approaching drivers. They were flashing around 50 flashes per minute (that is, 0.8 flashes per second (Hz)). In bright weather, sunlight shining on the light units can wash out, or diminish, the lights' visibility. During a TSB simulation, where a similar minivan was operated under similar conditions, it was observed that the front and back lights of the automatic warning device were visible during an approach from the south. The light units were clean.

Recognition memory is acquired through experience, and it strongly influences visual search without conscious awareness. Applied to the typical signalized level crossing situation, most drivers will unconsciously learn from exposure to the road environment that signals are located just below the crossbuck. Because the mast-mounted crossing lights under the crossbuck were aimed towards the access roads, it is possible that the driver unconsciously identified them as not operating, resulting in the assessment that no train was approaching.

- The driver may already have determined from the apparently inactive mast-mounted lights that no train was coming, making the state of the cantilever signals irrelevant.
- The slow flash rate, which was well below the most attention catching flash rate of 10 Hz,⁵ would have allowed the driver to fixate on the signals and look away before either light changed (a fixation can be as short as 200 milliseconds).
- The winter sun was low in the sky and could have had an effect on the relative brightness of the cantilever-mounted flashing signals.

1. The driver only became aware of the approaching train when the front seat passenger alerted him, at which time it was too late to avoid the collision.
2. The minivan was struck because the driver was unable to stop safely before the track, or to accelerate clear from the track.
3. Because the mast-mounted crossing lights under the crossbuck were aimed towards the access roads, it is possible that the driver unconsciously identified them as not operating, resulting in the assessment that no train was approaching.
4. The internal noise level in the minivan, along with the masking of the train and whistle sound by houses along the road, removed additional cues that could have alerted the driver to the presence of the approaching train.

- Chemin de fer de la Matapédia et du Golfe inc. added extra mast lights.
- The province of Quebec agreed to perform street realignment.
- Transport Canada is considering funding the grade crossing improvement from its Grade Crossing Improvement Program.

As part of its annual meeting with interested railways on potential improvements to crossings, the Transport Canada Quebec Region raised the issue of the lack of lights on the mast with the intent that the railway companies identify similar crossings.
