RAILWAY INVESTIGATION REPORT
R09D0012

MAIN-TRACK DERAILMENT

CANADIAN PACIFIC RAILWAY

MILE 41.93, WINCHESTER SUBDIVISION

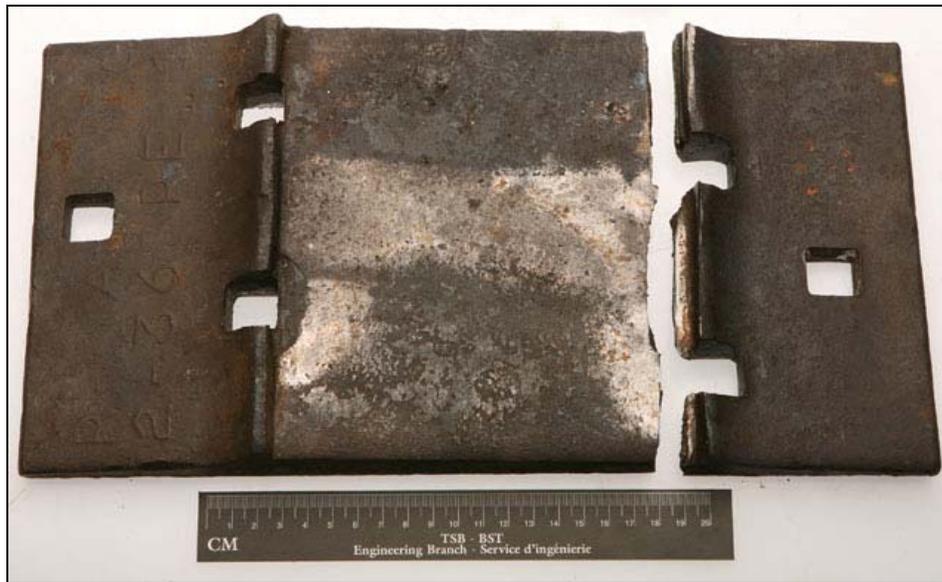
The tie plate directly supporting the joint was fractured along the gauge side shoulder (see Photo 1). The tie immediately to the west of the joint was unevenly crushed beneath the tie plate.

Photo 1. Tie plate under the compromise joint

The placement of a tie directly under the end of the 130-pound rail rather than near the end of the 115-pound rail, as recommended by CPR Engineering Standards, resulted in the 115-pound rail being cantilevered for about 14 inches. This, together with the higher rigidity of the 130-pound rail, increased the difference in stiffness between the two rails. Consequently, high dynamic forces were caused by westward trains, generating high stresses in the 115-pound rail, damaging the head and the first tie supporting the rail.

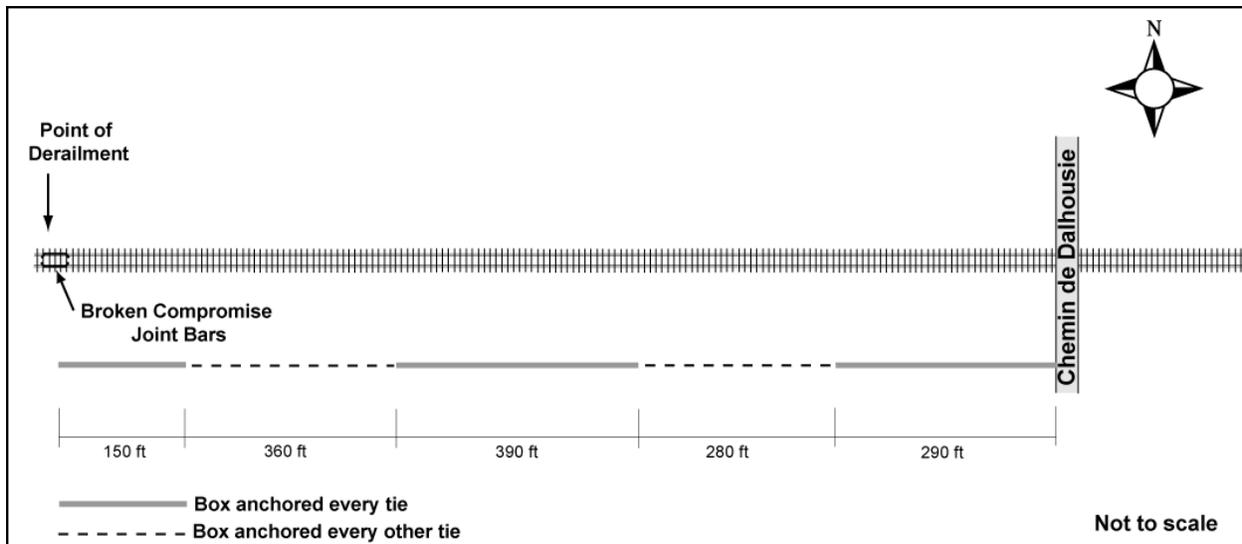
Figure 2. Placement of rail anchors

East of the joints, no wheel or dragging equipment marks were observed on the track structure. In addition, the ties and the rail were in good condition, but rail creep was observed east of the compromise joint where the rail anchors had moved westward approximately one inch. On the section of track located between the compromise joint and the Chemin de Dalhousie crossing, the placement of rail anchors was as shown in Figure 2.

The gap between the rail ends observed in the joints located east of the compromise joint and the movement of rail anchors east of the compromise joints indicate that the rail was subjected to longitudinal tensile stress. The removal of the bolts during the replacement of the broken joint bar allowed the rail ends to pull apart despite box anchoring every tie leading up to the compromise joint and frozen ballast conditions.

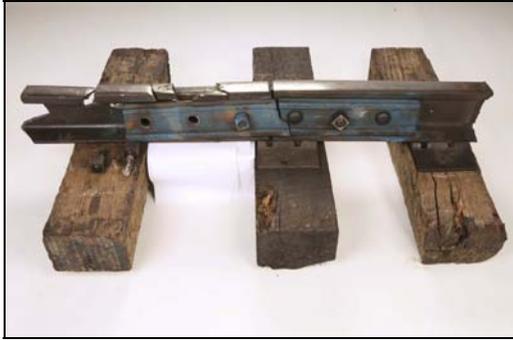
Several broken components from the compromise joint area (Mile 41.93) were sent to the TSB Laboratory for analysis. Although most of the fractured pieces were recovered, one six-inch section of the 115-pound rail head and some bolt fragments were missing (see Photo 2). The examination of the fractured pieces indicated the following:

- The 115-pound rail fracture surfaces exhibited a significant amount of rubbing and pounding damage.
- The chevron markings observed on the rail web fracture surfaces were pointed towards the bolt holes. The fractures were oriented at approximately 45 degrees.
- The running surface of the rail showed spalling and had been previously weld repaired.
- The tie plate fracture surfaces had pre-existing oxidized fatigue cracks.
- The fracture surfaces on two of the bolts from the 115-pound rail showed pre-existing fatigue cracks.
- The joint bar fractures revealed a dark pre-existing fatigue crack at the upper inboard corner (see Photo 3). The remainder of the fractures displayed bright coarse features and chevron markings consistent with fresh overstress rupture, and some secondary rub damage.

Photo 2. Field side view of the reassembled compromise joint (train direction was from right to left)

The chevron pattern and the orientation of the web fractures observed on the broken pieces of the 115-pound rail indicated that the fractures initiated at the bolt holes. Under the repetitive dynamic loading of each passing wheel and the amplification of the impacts caused by the joint and the shelling on the rail surface, the cracks propagated in an upward direction and caused the rail to break. As the train continued over the broken rail, further wheel impacts caused the fracture of the joint bars, derailling the train.

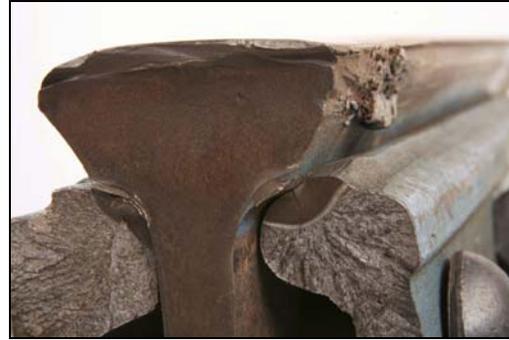
Photo 3. Fatigue crack at the upper inboard corner of the joint bars

An examination of the joint bar installed during the joint repair showed that it had been installed with an existing fatigue crack. Although the bar received a visual inspection at the time of installation, the fatigue crack was not detected. The surface expression of these cracks can be very difficult to detect with the naked eye. Moreover, periodic testing by the rail flaw detection car probes the head and web of the rail but does not probe the joint bars. The digital imaging system is more effective in detecting joint bar defects; however, the testing may not be performed immediately after installation. Therefore, joint bars with existing cracks may be left in service without being tested for several months. Non-destructive test methods that can be conducted before the reinstallation of joint bars are available to aid in the detection of these fatigue cracks and would mitigate the risk of cracked joint bars being placed into service.

2. The requirements of both CPR's *Red Book of Track Requirements* and Standard Practice Circulars must be observed to ensure the integrity of the track.
3. Non-destructive test methods that can be conducted before the reinstallation of joint bars are available to aid in the detection of fatigue cracks and would mitigate the risk that cracked joint bars are placed into service.
