**RAILWAY INVESTIGATION REPORT**  
**R10E0056**

**CROSSING COLLISION**

**VIA RAIL CANADA INC.**  
**PASSENGER TRAIN NUMBER 1**  
**MILE 10.76, EDSON SUBDIVISION**  
**WINTERBURN, ALBERTA**  
**04 MAY 2010**

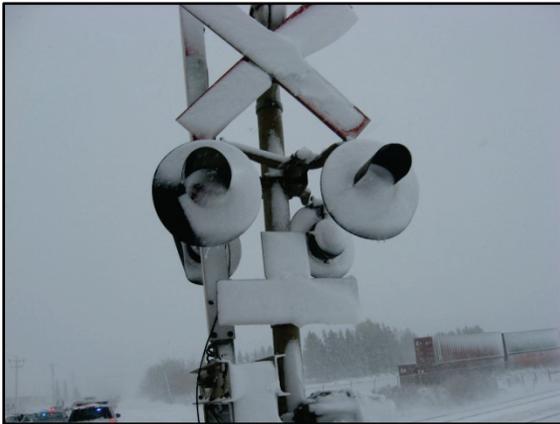
**Photo 1.** North signal, northward-facing lights

- For southbound vehicles, the presence of ice and snow was noted on the northward-facing warning lights, gate lights, and reflectorized materials. With the crossing protection operating, it was difficult to see light emitted from the northward-facing signals.<sup>14</sup>

On 18 May 2010, CN replaced the DC crossing protection system at Winterburn Road with a constant warning system with LED lights. Data from the new crossing protection system was examined. It was determined that nuisance operations at this crossing were significantly reduced as no warning times greater than 1 minute were recorded over a 2-week period. In comparison, approximately 36% of the warning times were greater than 1 minute prior to the installation of the new system

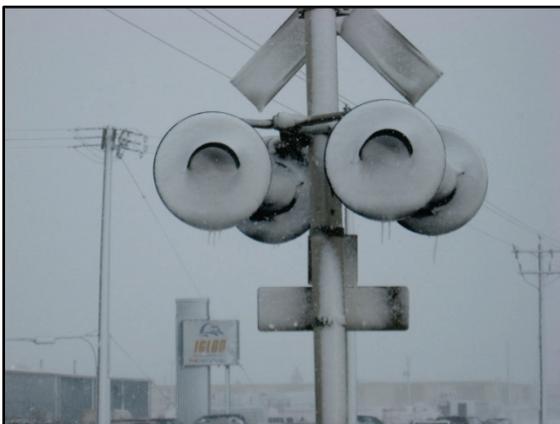
**Photo 2.** South signal, northward-facing lights

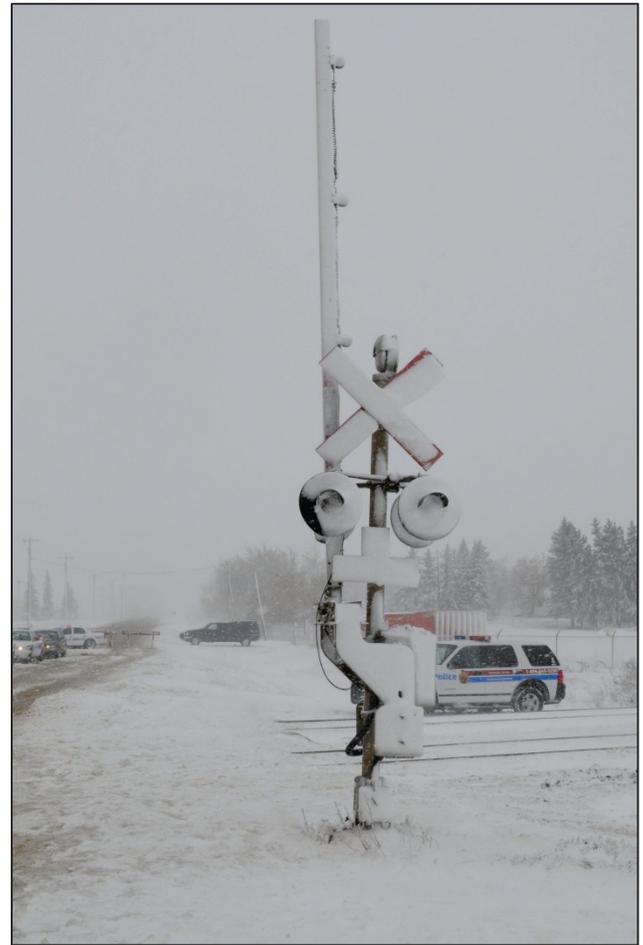
**Photo 3.** Northward-facing signals and gate

- An inspection of the north gate did not show any indication of recent damage or contact with a vehicle.
- Upon completion of the activated crossing inspection, the test switch was closed and the remaining operational tests were conducted in accordance with company maintenance procedures (i.e., S&C GI-301(Q), SCP-701 and Western Canada S&C Operational Test Procedures).

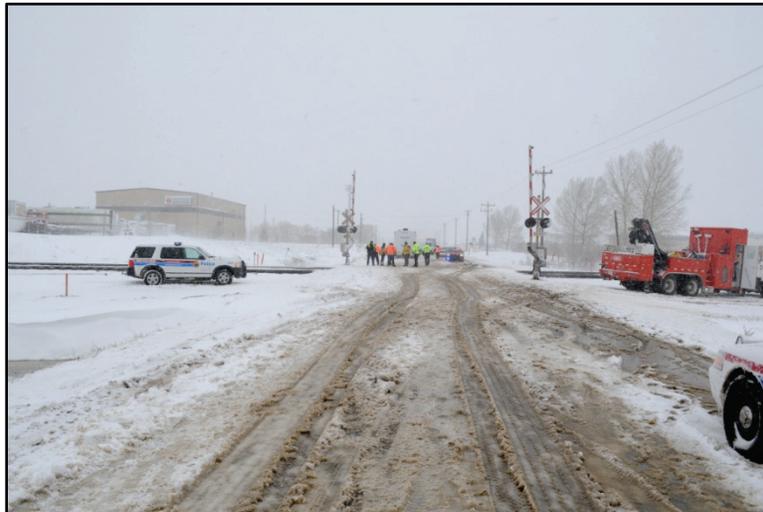
At the time of the accident, the temperature was just below freezing with high winds from the north to northwest at approximately 40 km/h, gusting up to 68 km/h with blowing and falling snow. It had rained throughout the night, turning into freezing rain and then snow in the early morning. Driving conditions and visibility were poor; the road surface was wet, slippery, and covered in fresh snow (see Photo 4). The crew reported that the north-facing right side window of the locomotive was iced up and covered with snow, and that the wipers had little effect in clearing the front window. Poor visibility prevented a clear view of the north side of the crossing.

**Photo 4.** Winterburn Road crossing, looking north

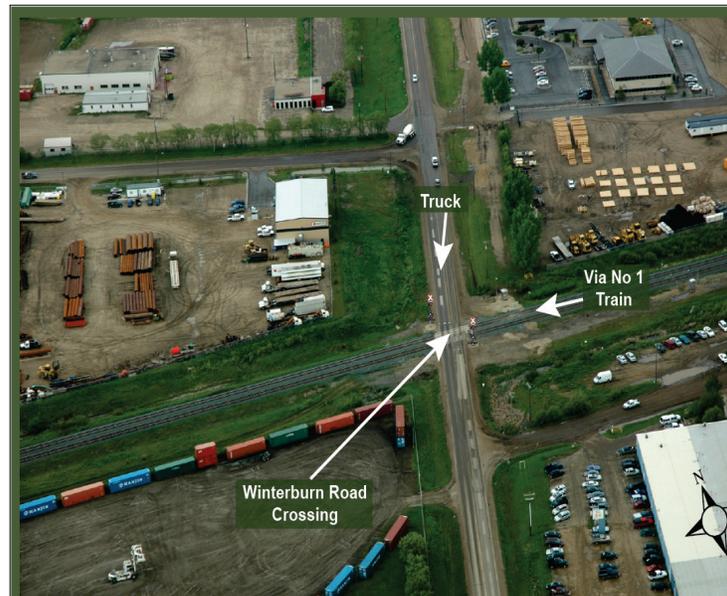
Photo 5. Winterburn Road crossing

Winterburn Road is a north-south, undivided two-lane arterial road that crosses the tracks at approximately 70-degrees on level grade (see Photo 5).
