**RAILWAY INVESTIGATION REPORT
R10E0080**

**NON MAIN TRACK TRAIN COLLISION
CANADIAN NATIONAL RAILWAY AND VIA RAIL**

**CN Q101 31 04 AND VIA NO. 1
MILE 0.16, ALBREDA SUBDIVISION
JASPER, ALBERTA
06 JULY 2010**

Report Number R10E0080

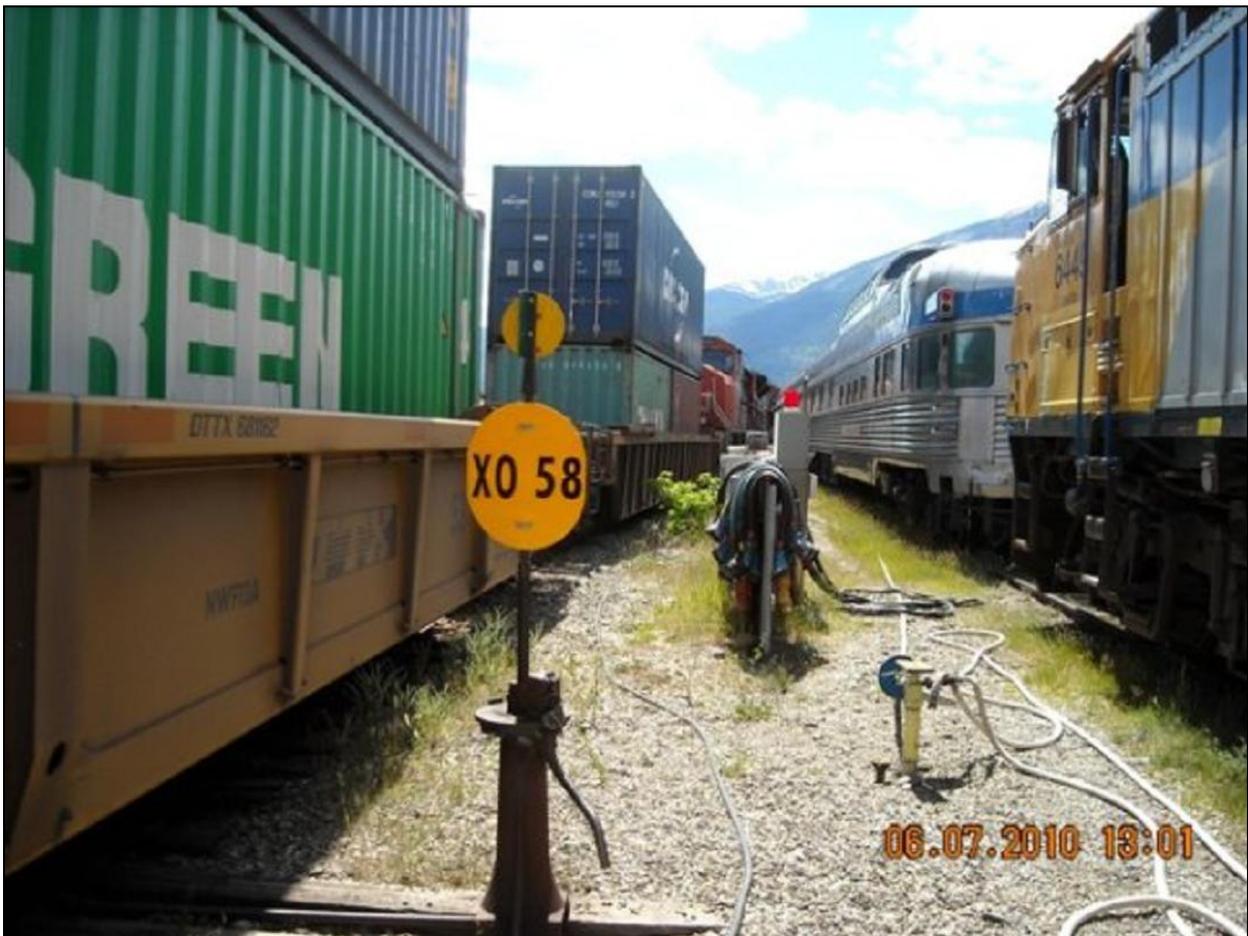
Photo 1. View of east connecting track switch in track YC-01 looking west

The VIA supervisor was preoccupied with various operational tasks and did not restore the east connecting track switch to normal after VIA No. 1 arrived. The VIA No. 1 locomotive engineer, who detrained at the connecting track, did not restore the east connecting track switch to normal. The east connecting track switch displayed a yellow target for the diverging route, but CN 101's crew did not identify the reversed switch as it approached. The conductor was communicating with CN 101's outbound crew, as well as completing his paper work and the locomotive engineer was watching out for VIA servicing employees on the adjacent track. At the connecting track, once CN 101's crew realized that it was diverging, the locomotive engineer put the train into emergency, but could not stop before colliding into the side of the VIA train. Train 101's crew did not observe the reversed connecting track switch in time to avoid the collision.

3. Despite the existence of administrative defenses (i.e., the Canadian Rail Operating Rules (CROR) for the handling of switches), distraction and increased workload led to reduced cognitive capacity resulting in the VIA supervisor inadvertently leaving the east connecting track switch in the reversed position.

Effective immediately and until further notice, locomotive engineers will be responsible for the handling of all switches in Jasper yard.

For the departure of Train 001 at Jasper, the inbound locomotive engineers will be responsible for restoring the switch after the departure of 001 and the engineer responsible for handling the switch must be located at the switch to immediately restore the switch to normal upon train departure.

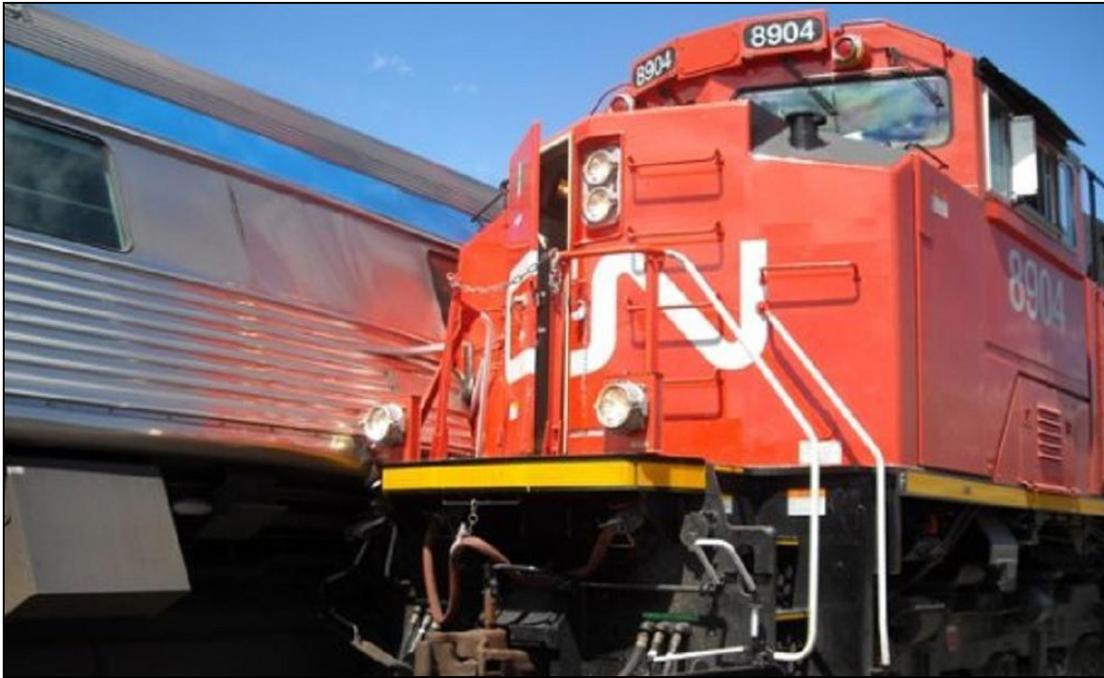
Photo 2. Side Collision between CN101 and VIA No. 1

Post-accident examination of the site revealed that the CN 101 lead locomotive (CN 8904) had collided into the side of VIA No. 1's 20th passenger car (VIA 8328). The force of the impact knocked VIA 8328 to an approximate 30° angle damaging the exterior and interior structure of the coach. CN 8904 sustained damage to the front right of the locomotive.

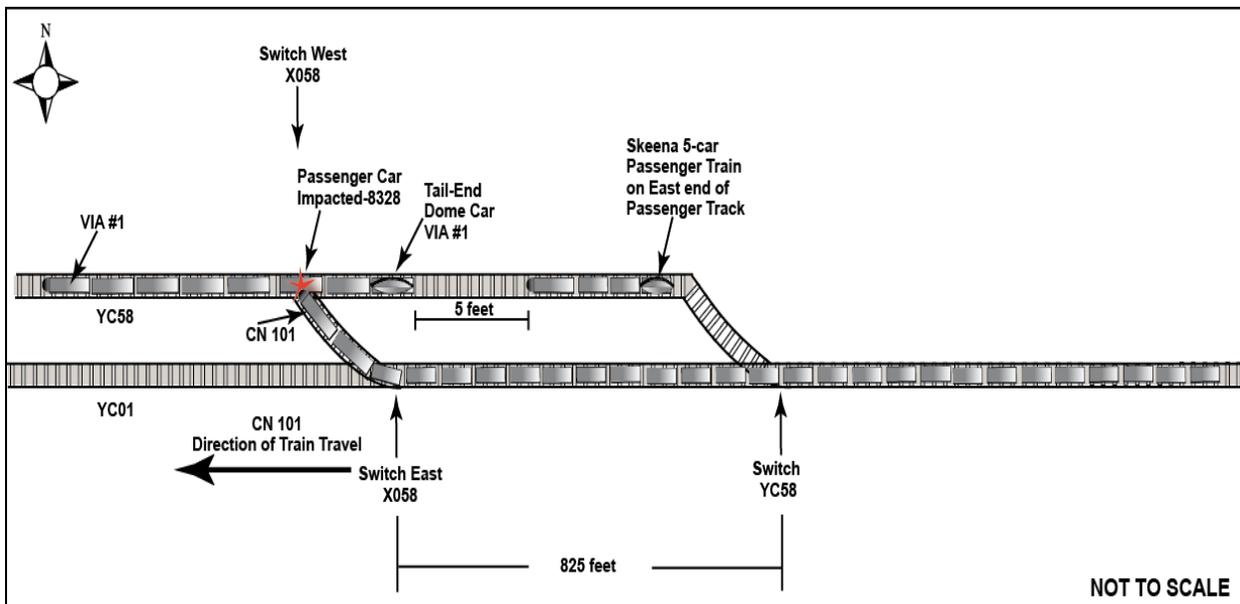
The station track at Jasper is designated as track YC58 and can be accessed from track YC01 through the east and west end YC58 switches or through the connecting track switch XO58 East.

Figure 1. Accident Site Diagram
