RAILWAY INVESTIGATION REPORT R15V0191

Grade crossing collision

Canadian National Railway Company
Langley, British Columbia
11 September 2015

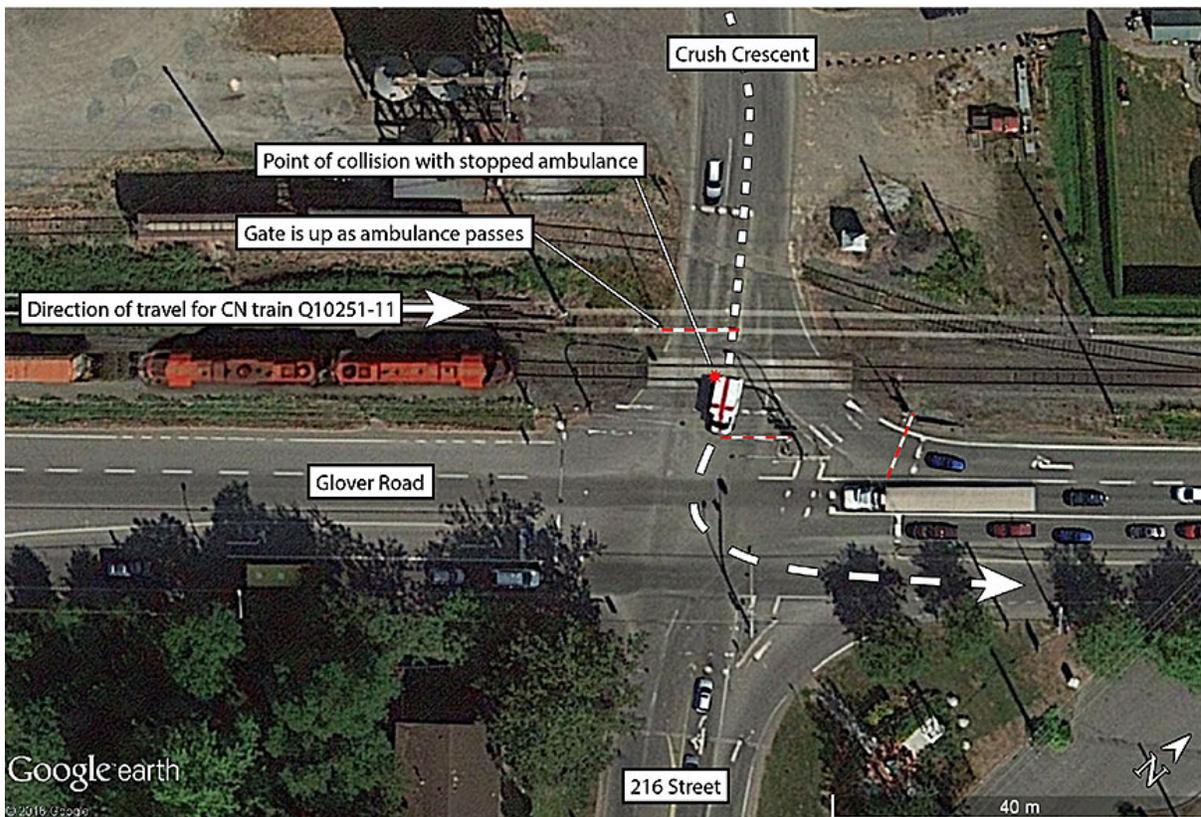
Figure 2. Occurrence site showing the location of the train and the ambulance prior to the collision (Source: Google Earth, with images of train and ambulance, as well as annotations, added by TSB)

During the approach to the crossing, the grade crossing warning system (GCWS) activated. The crossing bell was ringing, the flashing lights were activated, and the gates were descending. The ambulance stopped, but was on the track. Shortly after, with the gates fully descended for the train's arrival, the ambulance was moved forward to a position between the south rail of the main track and the crossing gate for the opposing traffic (westbound vehicles). However, even at this location, the ambulance was foul of the main track (Figure 2).

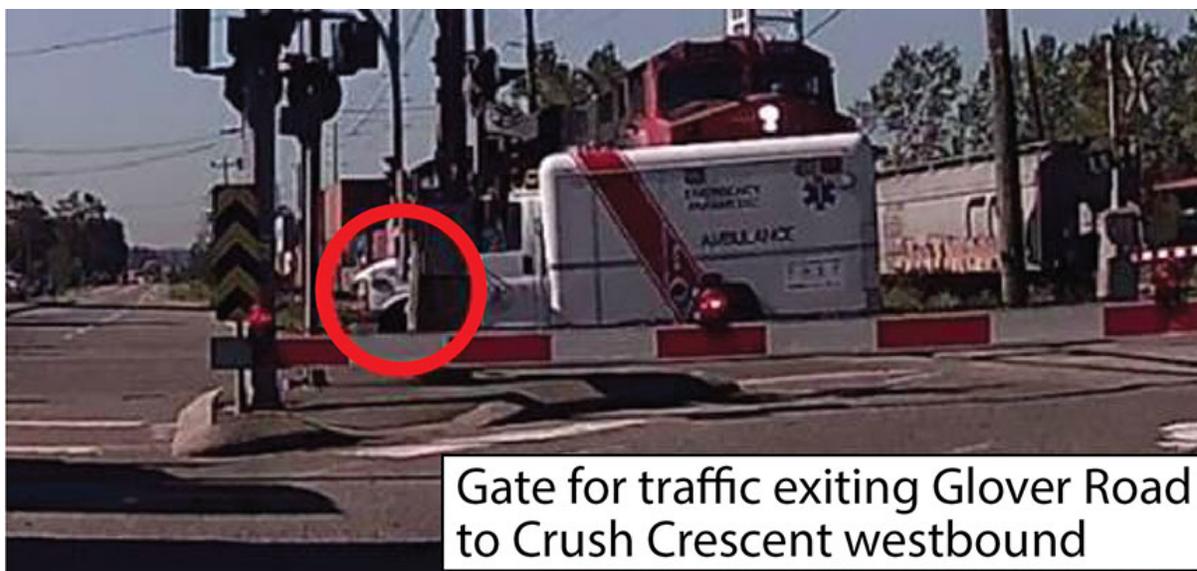
Figure 3. Front of ambulance beyond descended gate (Source: Dash-cam video)

- As the ambulance approached the main track, the crossing gate for the westbound traffic from 216th Street traversing Glover Road for Crush Crescent had already begun to descend.
- The ambulance, which was stopped foul of the main track, moved forward slightly twice (at 1120:22 and at 1120:28).
- Although the crossing gate closest to the front of the ambulance (the gate for westbound traffic) was down, the gate did not extend beyond the front of the ambulance and did not impede the ambulance's forward progress (red circle in Figure 3).

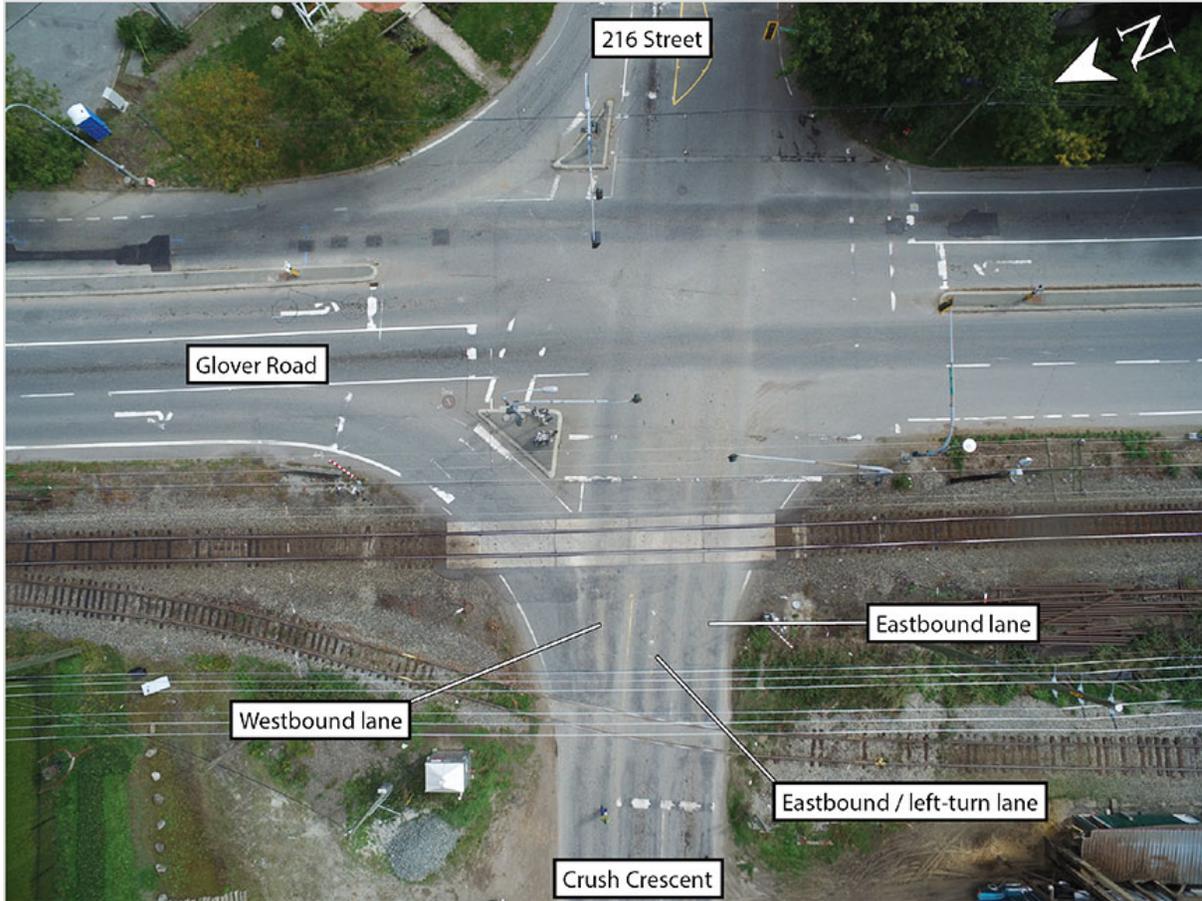
Figure 4. Faded road markings at the occurrence site (Source: RCMP, with TSB annotations)

At the time of the occurrence, the roadway markings on Crush Crescent were faded and not clearly visible (Figure 4). The 3 lanes (eastbound, left turn, and westbound) at the crossing were not clearly marked with lines and arrows. The stop line for eastbound traffic (located west of the Milner storage track crossing) was visible but severely degraded.

Roadway lane markings are designed to keep vehicles on the correct portion of the roadway. The roadway markings at the crossing at the time of the occurrence were worn and degraded, making it difficult for vehicle drivers to appropriately position their vehicle for the intended route. It is likely that the ambulance was out of position in part due to the lack of a clearly marked left-turn lane, leading to the ambulance coming in close proximity to the westbound gate arm. If roadway lane markings at railway crossings are not clearly visible, vehicles may be out of position when traversing the crossing, compromising the effectiveness of the GCWS and the traffic signals, and increasing the risk of a crossing accident.

To highlight the roadway lane marking deficiencies at the crossing, BCEHS sent a letter to the Township of Langley on 11 December 2015, and to the Ministry of Transportation and Infrastructure on 03 August 2016.

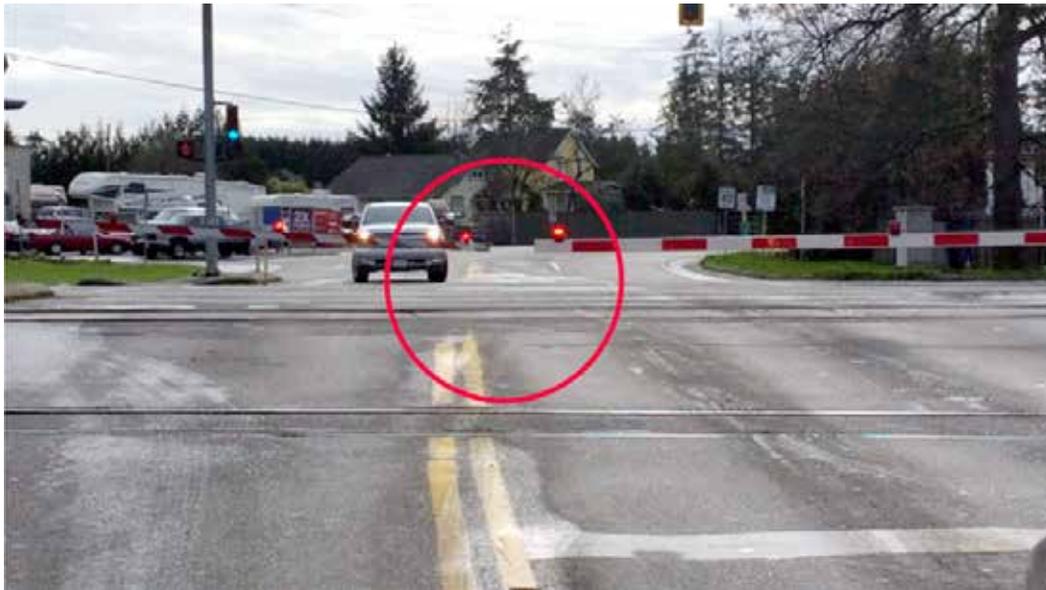
Figure 5. Crossing gate extending past centreline

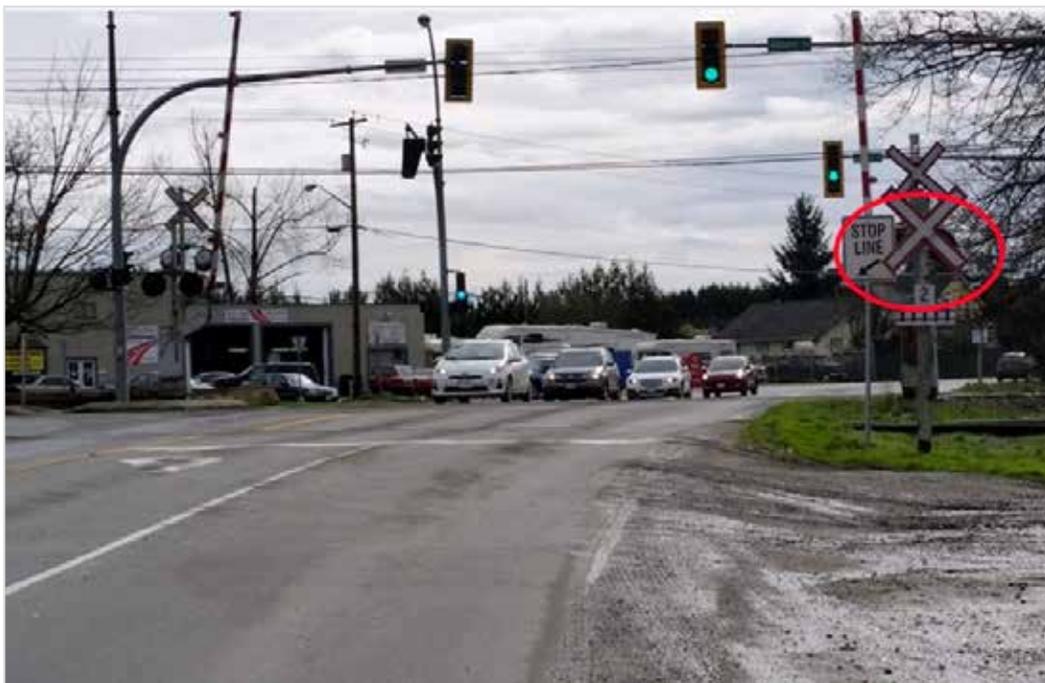
Figure 6. Partially obscured grade crossing warning system at crossing for approaching eastbound traffic

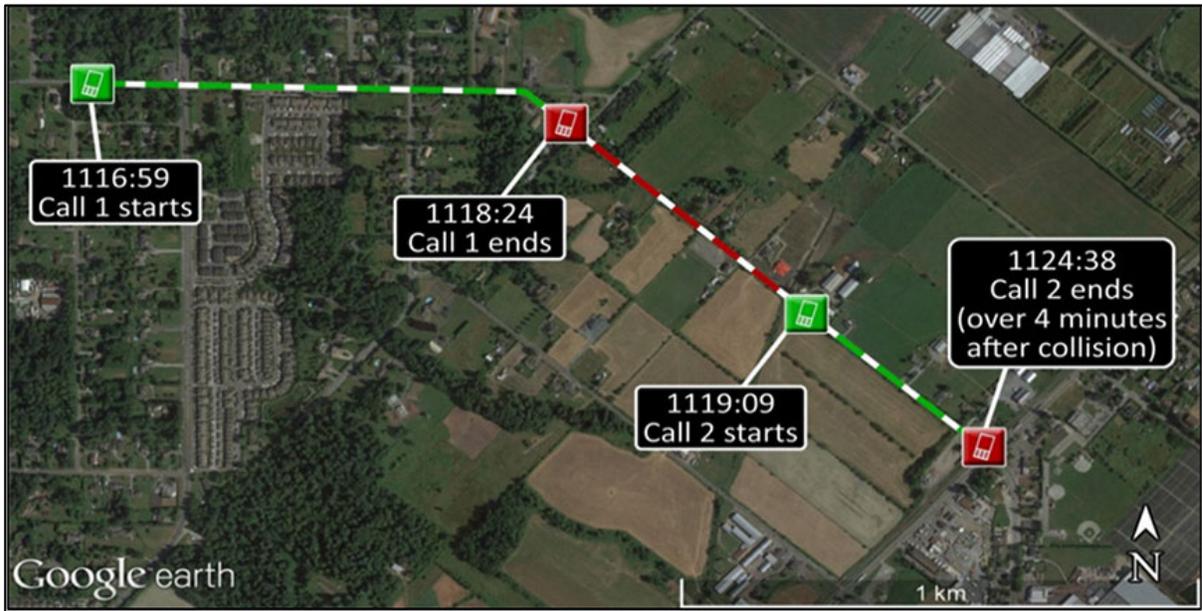
Figure 8. Cellphone calls and locations (Source: Google Earth, with TSB annotations)

While operating the vehicle, the ambulance driver made 2 phone calls on the approach to the crossing (Figure 8).

Both calls were made using a personal cellphone with which the driver was not familiar. It could not be definitively determined whether a hands-free device was used. The subject of both calls was considered to be complex. Tables 3 and 4 summarize the 2 phone calls and related communications earlier in the morning.

When operating a motor vehicle, a complex conversation can result in cognitive distraction both during the call and after the call. Due to the proximity of the calls to the occurrence crossing, the ambulance driver had likely become cognitively distracted while approaching and traversing the crossing. This distraction would have reduced the driver's capacity for visual scanning and visual processing. Other performance effects on driving included potential inattention blindness with "looked but failed to see" errors and slowed reaction times. In addition, the driver's lack of familiarity with the particular model of cellphone would have contributed to the level of distraction. The distraction of cellphone use likely decreased the driver's ability to detect warning stimuli in the environment while traversing the crossing.

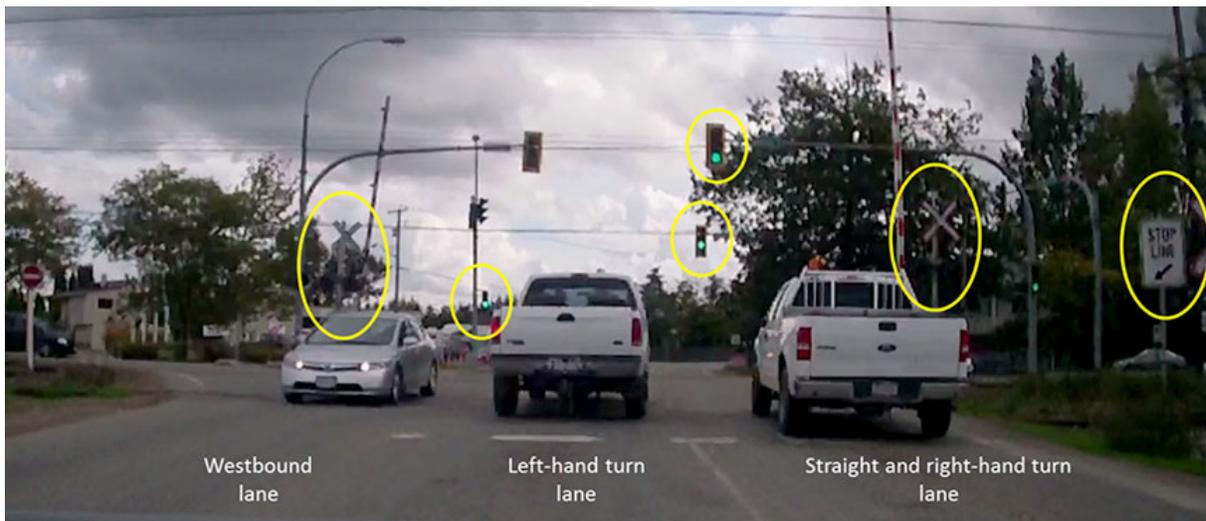
Figure 10. Drivers' cues eastbound

2. an RCS and stop line sign (just prior to the Milner storage track)
3. Milner storage track
4. GCWS positioned on the right side, including cross-buck sign, gate, lights, and bell
5. the main track
6. GCWS positioned on the left side, including cross-buck sign, gate, lights, and bell
7. a 4-way traffic intersection
8. multiple traffic signals, including the left-turn traffic signal
9. oncoming traffic from 216 Street

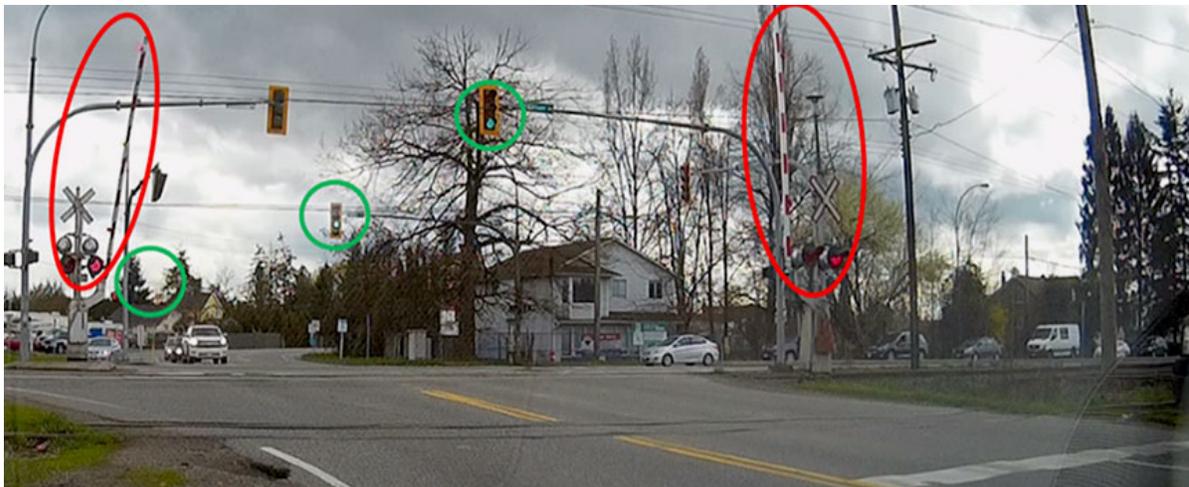
Figure 11. Visual cues with grade crossing warning system active

Approaching the crossing, a driver was presented with many different visual and auditory cues, which were dispersed across the driver's field of view. The GCWS flashing red lights and bell positioned initially to the right of the driver, and then subsequently to the left, had to compete for the driver's attention in the presence of other prominent cues, such as the traffic signals and movement of traffic in the intersection. In addition, as there was no stop

At the occurrence location, even with the interconnected traffic signals working as intended, drivers approaching the crossing eastbound can be presented with conflicting information. During site examination, it was noted that the traffic signals at the intersection remained green after the GCWS had initiated. In some situations, the traffic signals remained green throughout the GCWS sequence, and even upon arrival of a train at the crossing. There were also situations when the GCWS initiated at the same time as the traffic signals turned green, presenting stop and go indications simultaneously. Further, not only did red GCWS lights flash when there was an approaching train, but so did the green left-turn signals, indicating that both signal types were important.
