RAIL TRANSPORTATION SAFETY INVESTIGATION REPORT R18W0007

MAIN-TRACK TRAIN DERAILMENT

Canadian National Railway Company

Mile 166.33, Redditt Subdivision

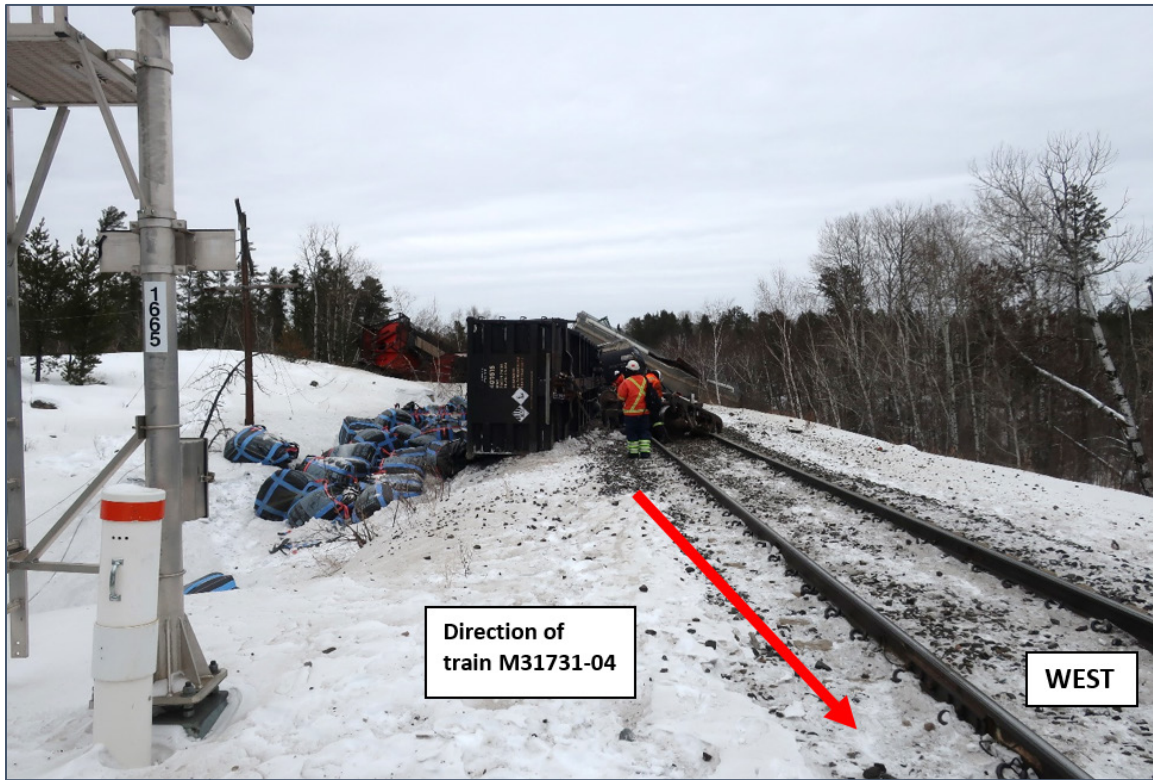
The first 2 derailed cars were the 38th and 39th cars from the head-end, which had overturned to the north side of the track. Both were open-top gondola cars, loaded with bags of nickel sulphides that spilled onto the railway right-of-way (Figure 2). However, no product was released from the bags.

Figure 2. Nickel sulphide bags spilled from first derailed car (Source: TSB)

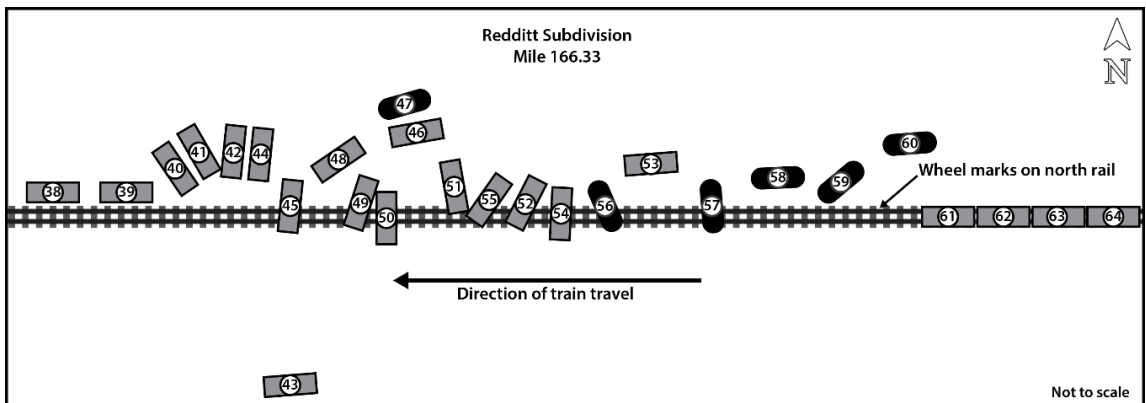
The following 21 cars had derailed and come to rest either to the north of, or along, the track in various positions over the following 650 feet (Figure 3).

Figure 3. Site diagram showing location of derailed cars after the accident (Source: TSB)

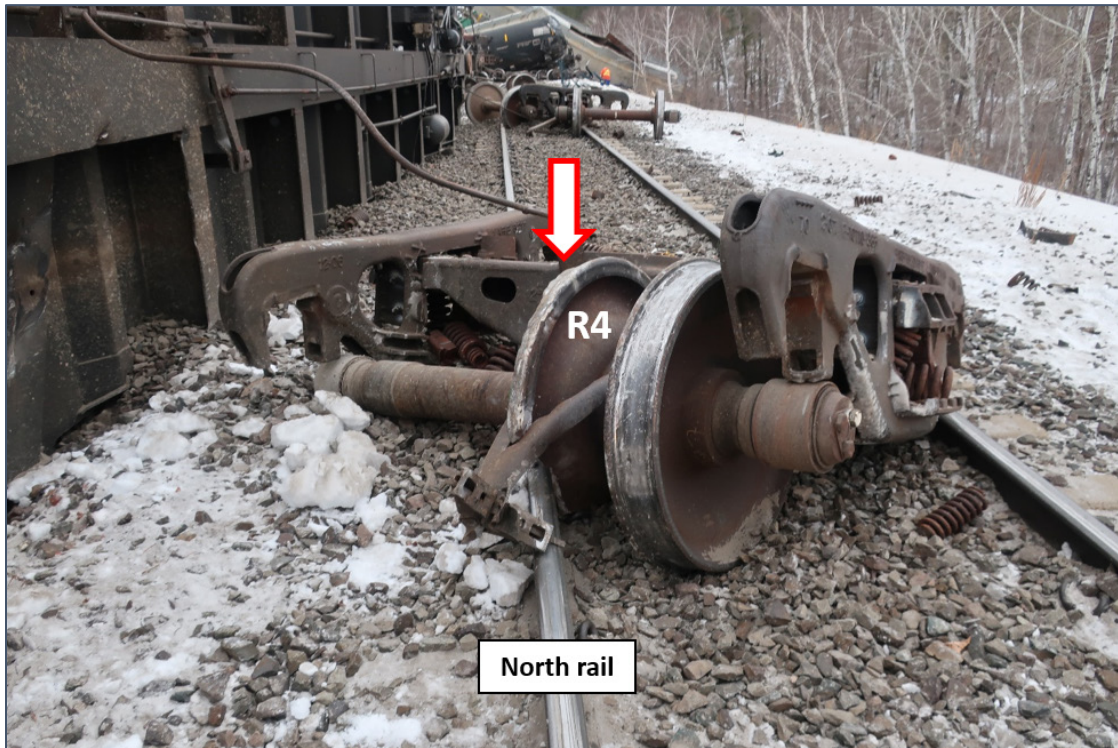
The 38th car (car ATW 400515), the first derailed car, had come to rest at Mile 166.48. The car's trucks were on the track next to the ends of the car. The R4 wheel from the leading A-end truck of the car had broken, come off its axle wheel seat, and moved inboard along the axle body before coming to rest against the L4 (mate) wheel (Figure 4).

Figure 4. The R4 wheel of car ATW 400515 (indicated by the arrow) had been displaced from the axle wheel seat and had moved inboard adjacent to the L4 wheel, coming to rest on the north rail. (Source: TSB)

The R4 wheel rim had fractured circumferentially. The outer portion of the rim was not recovered. The tread and flange were damaged, and a section of the wheel tread and plate had broken away. Two additional pieces of the wheel were found between the rails about 100 feet and 190 feet east of the truck, respectively. A 6-inch portion of the wheel rim/tread was never located. The wheel and recovered wheel pieces were forwarded to the Transportation Safety Board of Canada (TSB) for detailed examination.

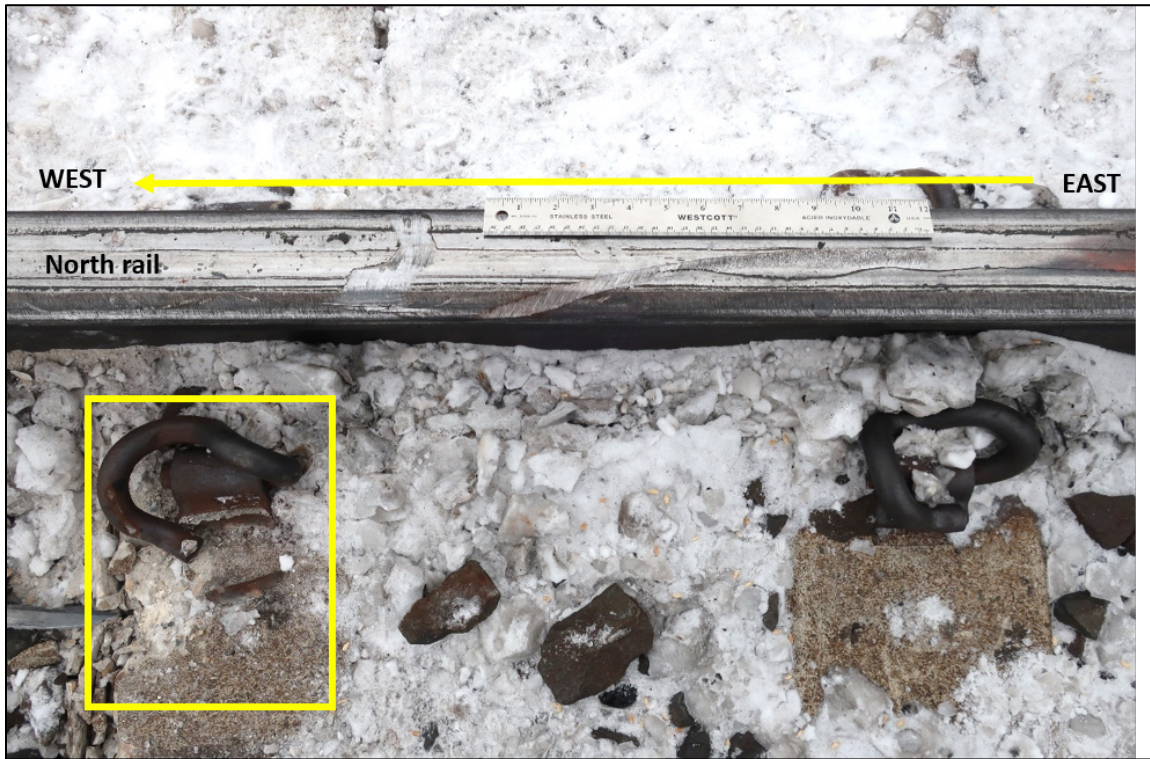
At the east end of the derailment site, a wheel mark was observed on the running surface of the north rail at Mile 166.33, starting in the middle of the running surface and extending westward for about 9 inches toward the gauge side of the rail. A small piece of wheel tread was observed between the rails adjacent to the wheel mark. Immediately west of the wheel mark, there was damage to the track fastener (gauge side) and to the concrete tie (Figure 5).

Figure 5. Wheel marks on the top of the north rail and the damaged gauge-side track fastener and tie (shown in the box) at Mile 166.33 (Source: TSB)

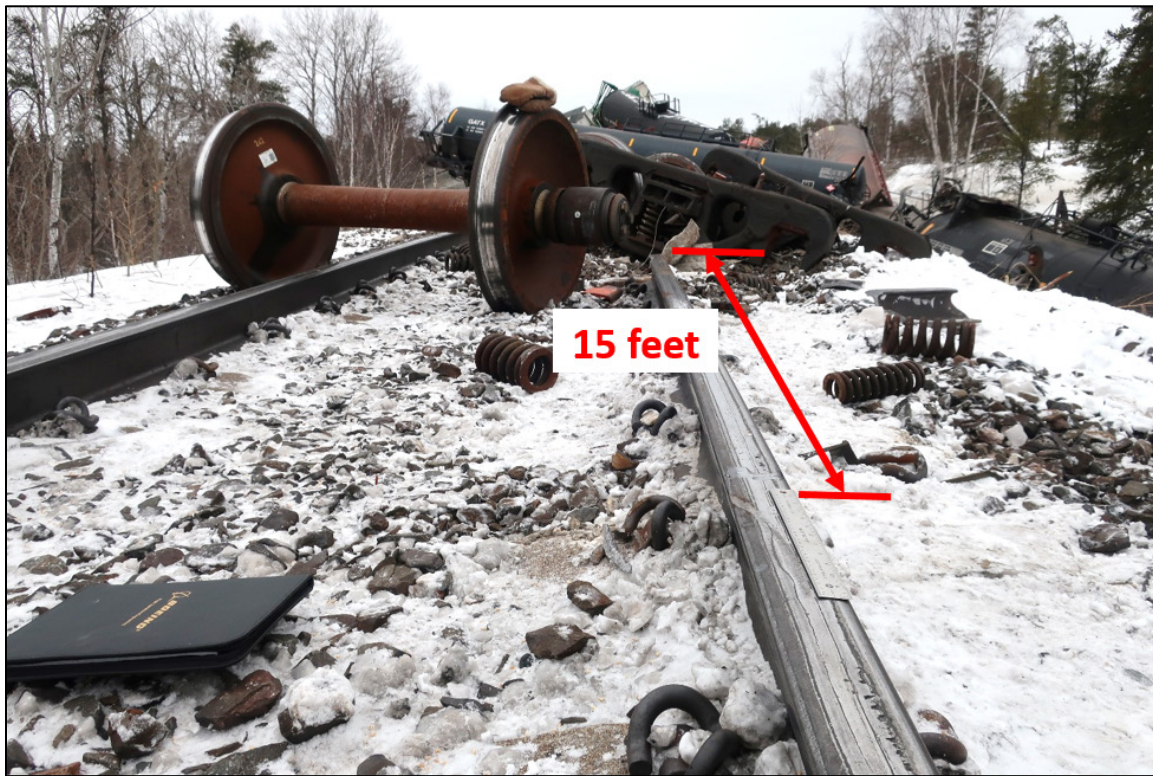
Three feet further west, the tie was damaged on the field side of the south rail, and, about 15 feet beyond the wheel mark, the north rail was broken (Figure 6).

Figure 6. Broken north rail 15 feet beyond the wheel mark on top of the rail (Source: TSB)
