Rail Transportation Safety Investigation Report R21T0007

UNCONTROLLED MOVEMENT RESULTING IN A NON-MAIN-TRACK TRAIN DERAILMENT

Goderich Exeter Railway

01 February 2021

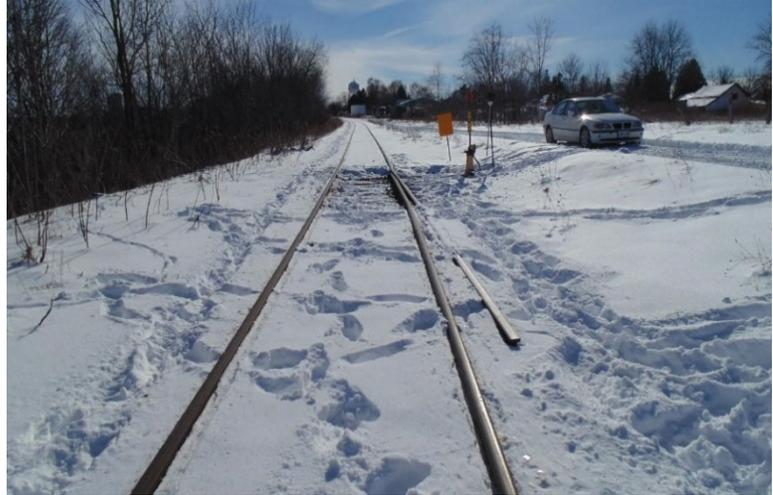
Figure 1. Split switch derail at Mile 46.19 looking eastward (Source: TSB)

At 1328:29, the train came to a stop at Mile 46.21, about 100 feet from a split switch derail² located at Mile 46.19 (Figure 1), on an area of track that had an average descending grade of 1.75%.

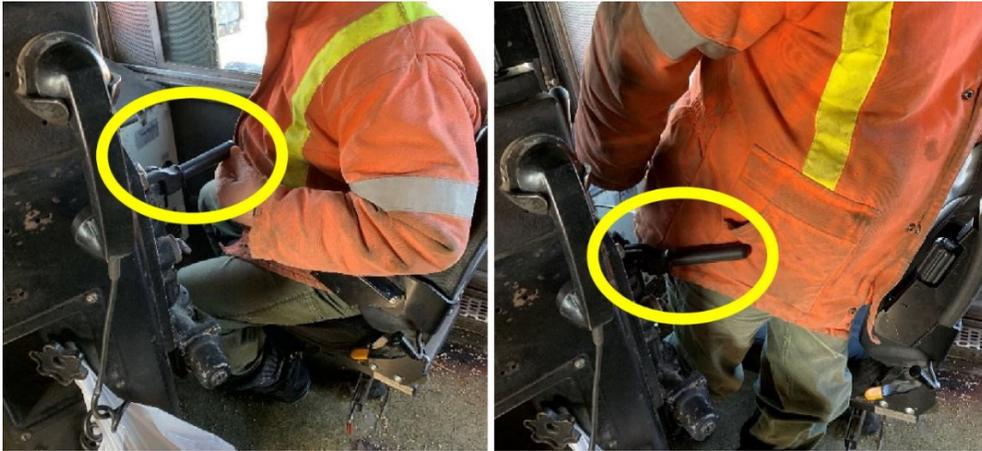
The LE contacted the conductor on the radio and stated that he was detraining to remove the derail so that the train could be pulled further west to give them enough room to shove it back into the yard to complete the switching. As the LE got up from his seat, he accidentally contacted the automatic brake handle and moved it from the fully applied position to the release position (Figure 2).

Figure 2. Photos from GEXR re-enactment of the locomotive engineer's movement in the cab. The left-hand photo shows the air brake applied, and the right-hand photo shows the air brake released. (Source: Goderich Exeter Railway)

At 1328:34 the train automatic brakes began to release.

The LE exited the cab without realizing that the train automatic brakes had been released. The independent brakes of the 2 locomotives remained applied but could not hold the train.

TSB braking calculations confirmed that the full independent brake application on both locomotives did not have sufficient force to hold the 2600-ton train on the descending grade where the train was stopped.

On 05 February 2021, GEXR issued Bulletin No 002-2021, which stated in part that “[e]ffective immediately, Locomotive Engineers operating in Goderich Yard are prohibited from exiting the cab of locomotives to perform other than functions that are directly related to Locomotive Engineers.” That same day, Transport Canada (TC) issued a notice to GEXR to acknowledge the action taken.

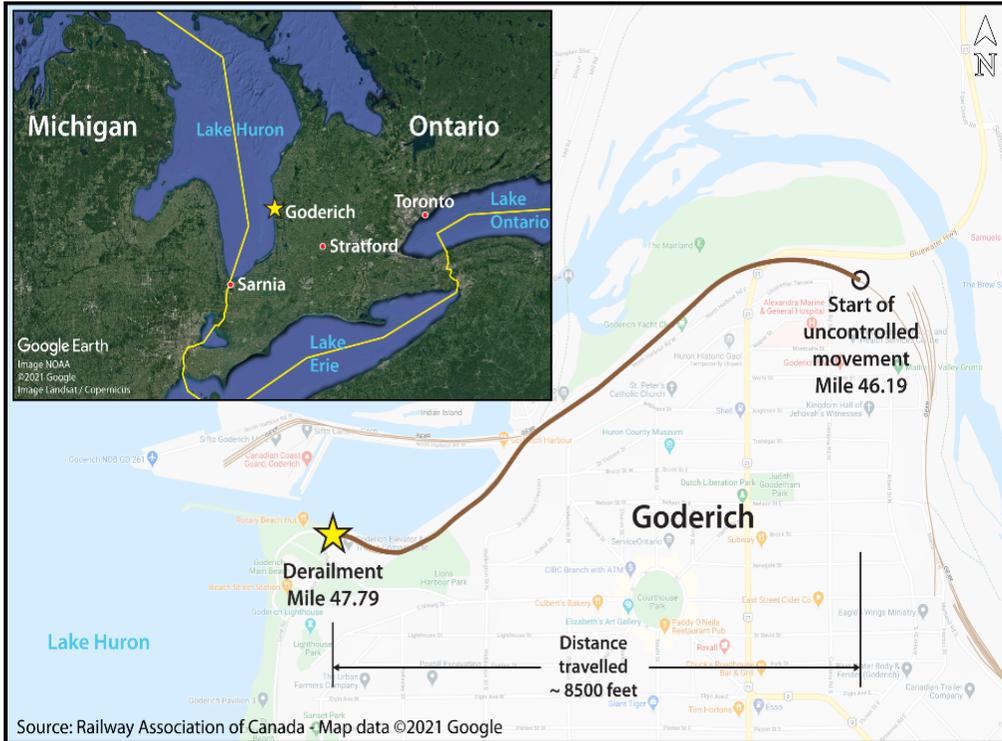
Figure 3. Map showing route taken by the uncontrolled movement, with inset map showing the location of the occurrence (Source of main image: Railway Association of Canada, with TSB annotations. Source of inset image: Google Earth, with TSB annotations)

After travelling about 8500 feet, the uncontrolled movement derailed at 1331:46, off the end of track MD 76 as the grade levelled out. The train came to rest within the facility, about 345 feet past the end of the track, just short of Goderich Harbour on Lake Huron (Figure 3).

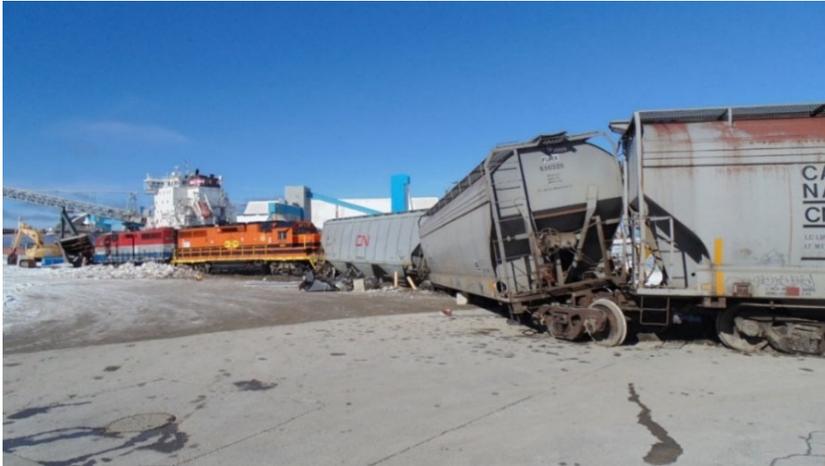
Site examination identified that the 2 locomotives and the first 4 covered hopper cars loaded with peas derailed with all equipment remaining upright (Figure 4).

Figure 4. Derailed locomotives and cars (Source: TSB)

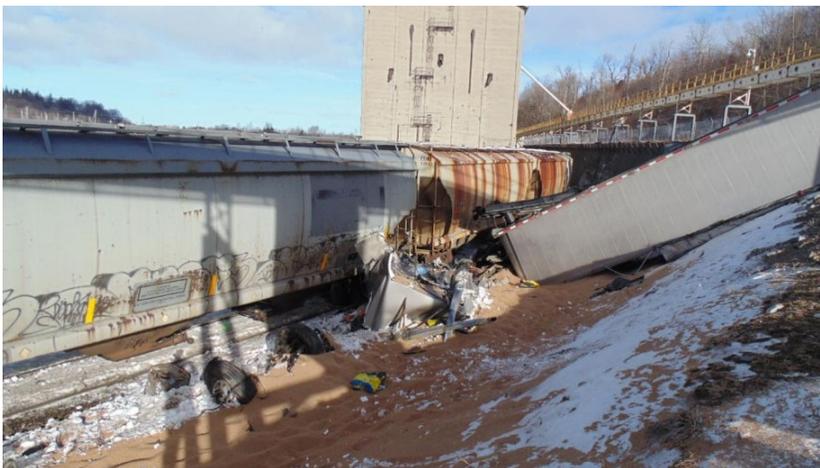
As the train rolled uncontrolled, it struck an unoccupied 18 wheel tractor-trailer loaded with 38 tons of grain that was parked on a crossing within the facility. Both the tractor and its trailer were destroyed and the grain was spilled on the ground (Figure 5).

Figure 5. Damaged tractor-trailer and grain spilled on the ground (Source: TSB)

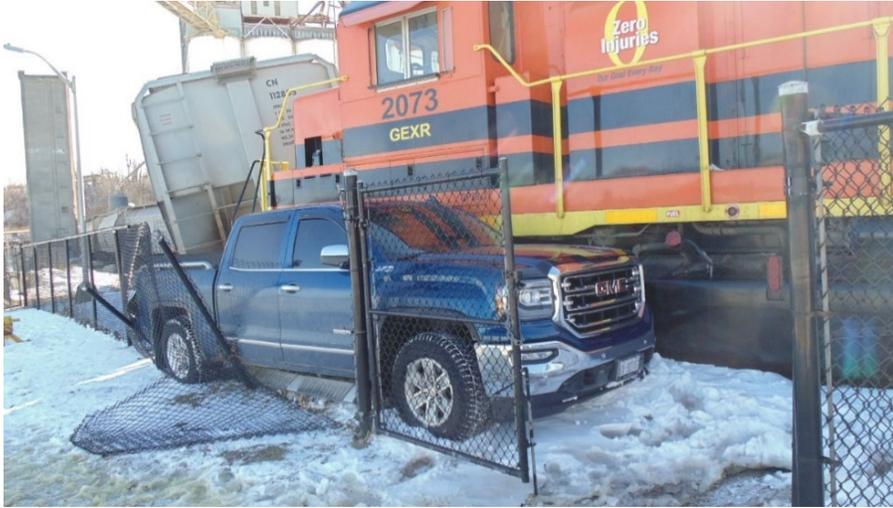
After derailling, the 2nd locomotive struck a half ton pickup truck that was parked in an adjacent parking lot. As the pickup truck was struck by the train, it was pushed up against a fence which trapped the 2 occupants inside the cab (Figure 6).

Figure 6. Damaged half-ton pickup truck (Source: TSB)

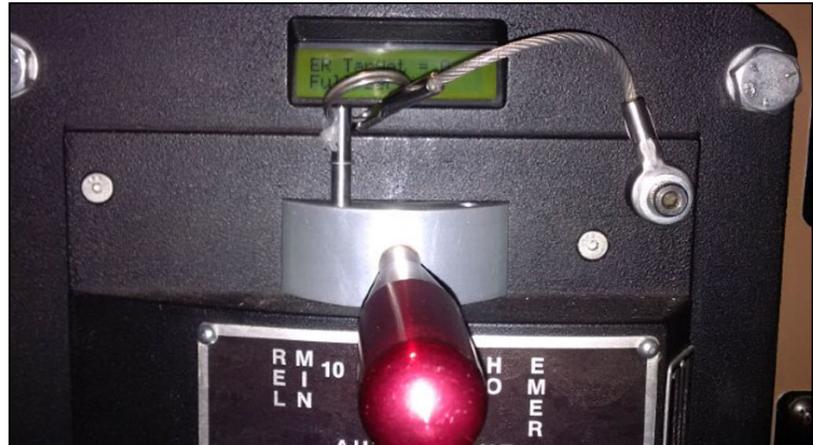
Neither of the locomotives' RSCs were equipped with roll-away protection that activates when a predetermined speed is detected, nor were they required to be. Furthermore, the automatic brake handle on the lead locomotive did not contain a locking pin that could provide additional securement of the automatic brake handle, a feature that is found on many newer locomotives (Figure 7).

Figure 7. Automatic brake handle on newer locomotive with locking pin inserted into a hole on the left side of the base which prevents the automatic brakes from being released (Source: TSB)

Ministerial Order MO 21-01, issued under section 32.01 of the RSA, required all railway companies and local railway companies listed in the MO to implement safety measures “to ensure that an accident caused by an unintentional release of the air brakes does not reoccur.”⁵

Ministerial Order MO 21-02 was issued under section 19 of the RSA. This MO required railway companies and local railway companies listed in the Schedule of the MO to

revise the *Railway Locomotive Inspection and Safety Rules* to incorporate design and performance parameters for locomotives with roll-away protection, and to revise the *Canadian Rail Operating Rules* to develop a precise definition of attended versus unattended equipment as well as incorporate requirements on the use of roll-away protection to reduce the risks of an uncontrolled movement.⁶
