RAILWAY INVESTIGATION REPORT

R98T0292

YARD DERAILMENT

CANADIAN NATIONAL

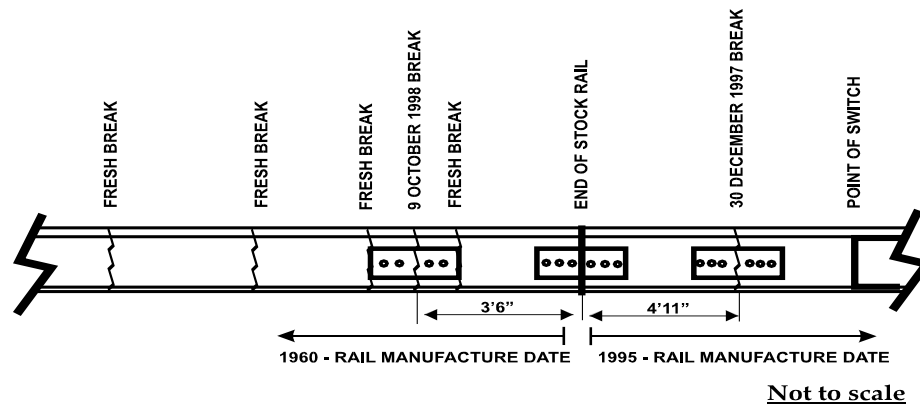
- The four recent rail fractures were mostly overstress in nature. A sub-surface fatigue crack extending across approximately five per cent of the cross-section was observed on the two fractures where details were still visible in the head area. The extent of the sub-surface fatigue cracking, while sufficient to lead directly to fracture, would serve to provide areas of stress concentration where fracture could initiate.
- Sub-surface fatigue cracks were associated with shelling damage. Sub-surface cracking of this type tends to progress internally in directions transverse and longitudinal to the rail axis, making it undetectable by external visual inspection.
- Shelling damage was due to excessive wear.
- The vertical rail wear was 9.5 mm and the combined vertical and gauge side lateral wear reached 14.5 mm.
- Wheel flanges were striking the tops of the joint bars.

Immediately south of the crossover switch point, the rail had a previous fracture that had been observed on 09 October 1998. The adjacent rail length also had been fractured on 30 December 1997.

Both previous fractures had been reported by passing train crews. In both cases, maintenance-of-way personnel were dispatched immediately and repaired the fractured rail with joint bars. The joint bar repairs and the existing rail joint bar were located within a span of eight feet five inches, segmenting the rail into two sections—3 feet 6 inches and 4 feet 11 inches.
