RAILWAY INVESTIGATION REPORT

R99E0023

MAIN TRACK TRAIN COLLISION

JASPER, ALBERTA

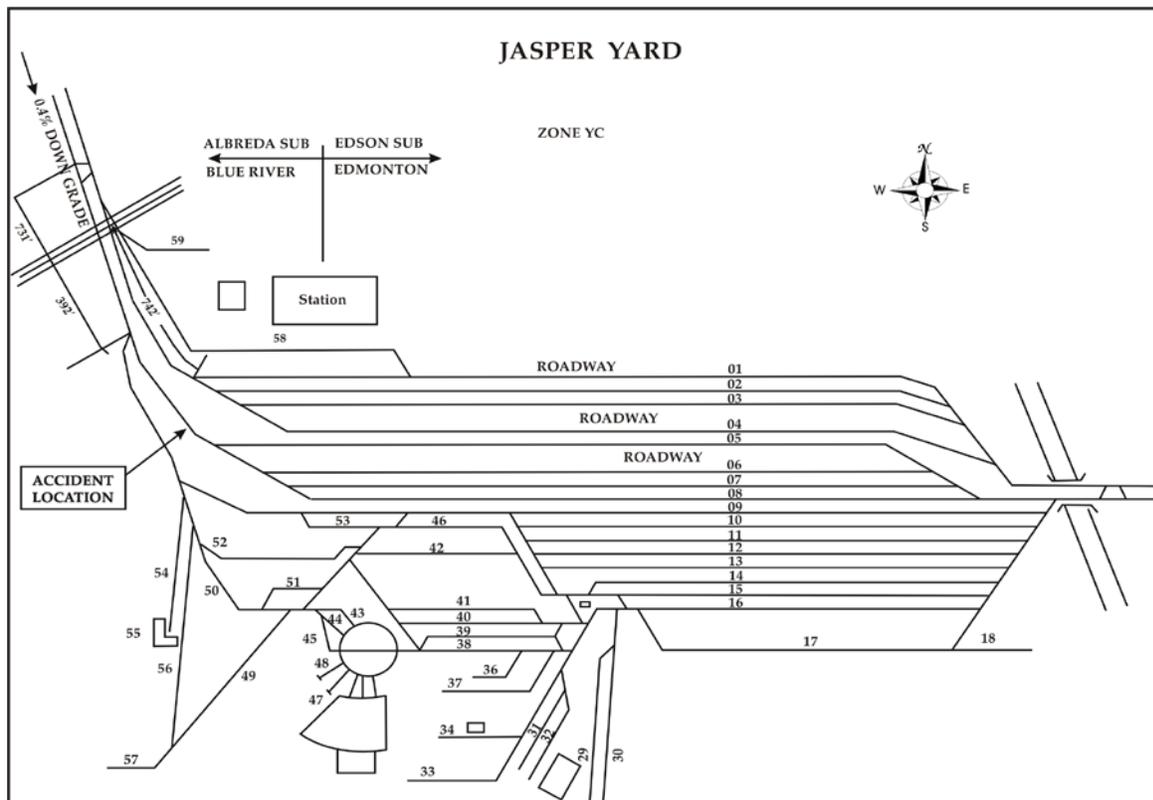
The Albreda Subdivision consists of double main track west from Jasper Yard to Mile 43.7. Between Mile 0.4 and Mile 1.7, the subdivision speed is 30 mph for freight trains and, between Mile 1.7 and Mile 5.2, the subdivision speed is 35 mph. There is a 0.4 per cent descending grade entering Jasper with a one-degree curve at Mile 0.9.
