RAILWAY INVESTIGATION REPORT

R99T0147

CROSSING ACCIDENT

BELLAMY, ONTARIO

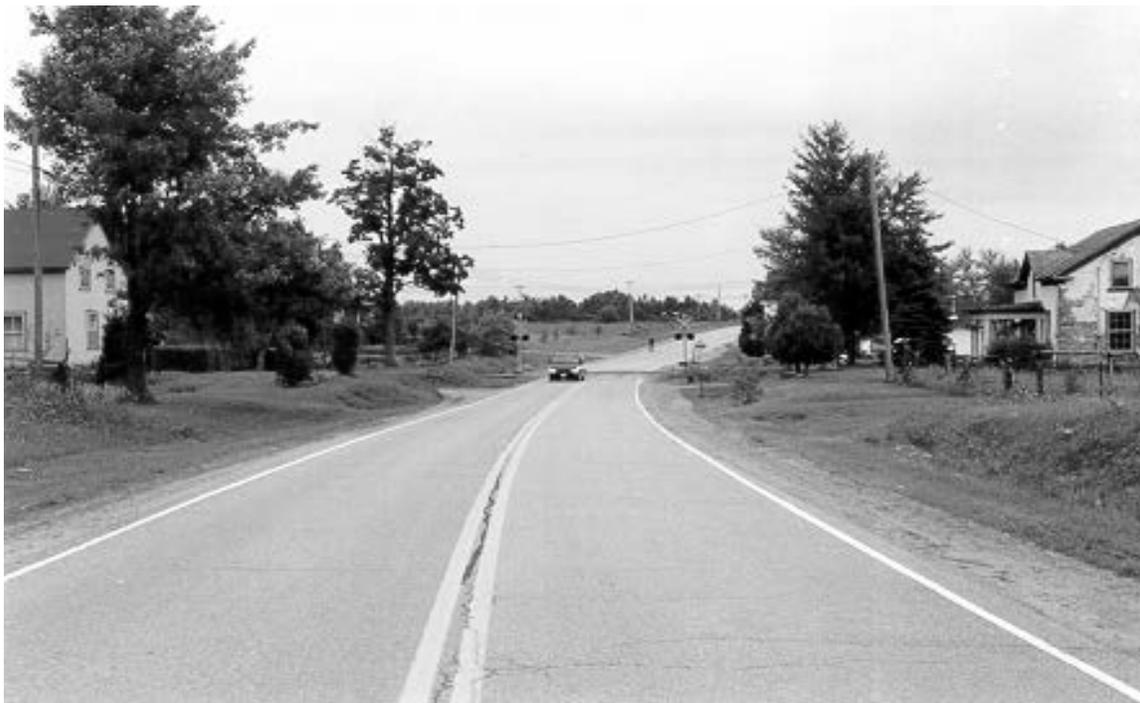
Sight-lines in all quadrants were poor due to obstruction by rock cuttings, vegetation, and private dwellings. A vehicle entering the crossing from the west must be within 6 m (20 feet) of the track for the driver to see 244 m (approximately 800 feet) down the track to the south. Farther than 6 m from the track, the sight-line was completely blocked. Average daily traffic volume is 500 vehicles, which is classified as low by the Ministry of Transportation of Ontario (MTO). Passenger train schedules vary from day to day. On Saturday, June 5, six passenger trains were scheduled to travel through the crossing. Between Sunday and Friday, two freight trains per day pass through the accident location. No freight trains are scheduled on Saturdays.
