MARINE INVESTIGATION REPORT

M98M0078

CAPSIZING

A MUSSEL-HARVESTING PUNT
TRACADIE BAY, PRINCE EDWARD ISLAND
22 OCTOBER 1998

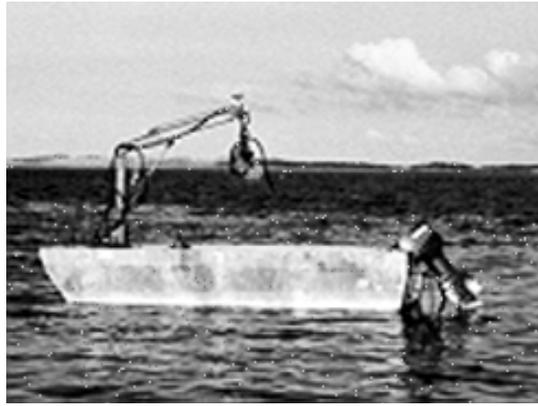
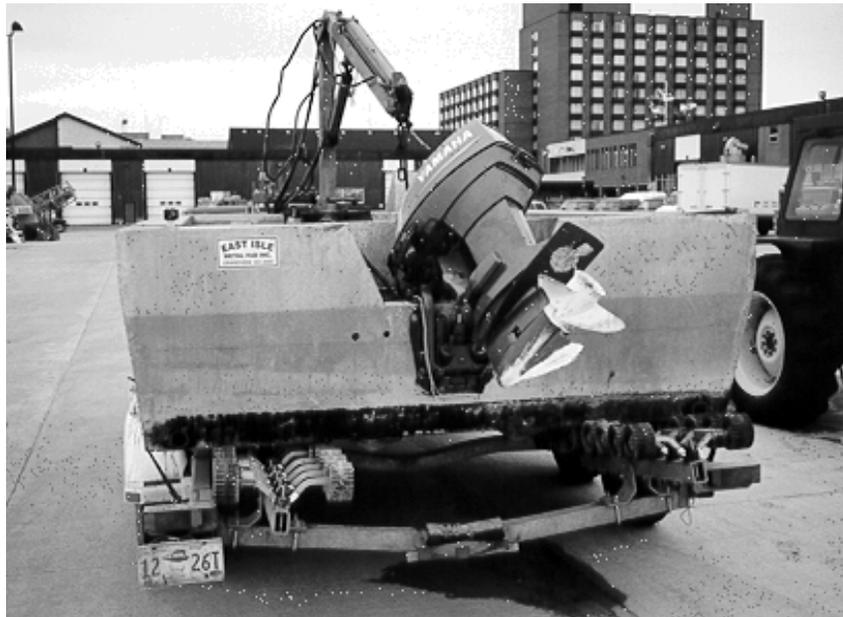
Appendix B - Photographs

The initial gradual reduction and final sudden loss of transverse stability were most likely brought about by the free surface effect of shipped water, downflooding and dynamic rolling energy while the punt was drifting beam-on to the prevailing waves. When the punt encountered waves approximately twice the height of the static loaded freeboard, the rolling motion increased and caused more water to be shipped and retained onboard. The rolling motion in conjunction with the free surface and lubricating effects of the shipped water most likely caused the cargo tote boxes to shift slightly and led to the sudden loss of transverse stability.

1. The mussel-harvesting punt was fully loaded with about five tonnes of mussels when her outboard motor failed.
2. The exact cause of the outboard motor failure could not be conclusively determined.
3. The punt had positive intact transverse stability when empty and when fully loaded.
4. The punt drifted broadside to the prevailing waves for about 20 minutes, and shipped water.
5. The free surface effects of the shipped water, a slight shift of cargo and the additional dynamic influences of the wave rolling motions most likely caused the complete loss of righting ability, and the vessel suddenly capsized.
