MARINE INVESTIGATION REPORT

M99L0098

GROUNDING

PASSENGER VESSEL *NORWEGIAN SKY*  
OFF ÎLE ROUGE, ST. LAWRENCE RIVER, QUEBEC

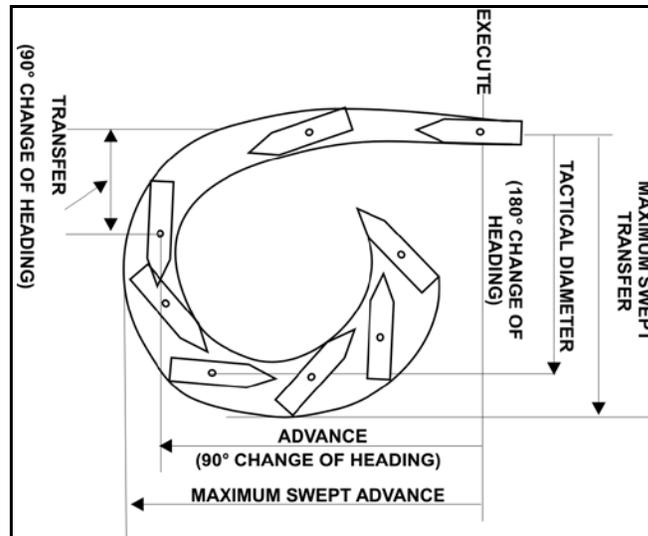
A pilot card was posted on the after bulkhead of the wheelhouse, behind the central integrated bridge system (IBS) workstations. The card indicated the use of hard-over helm at 35° and 45° for sea and harbour applications, respectively, and showed a swept-path diagram. However, the information was limited to the turning circle data and did not contain swept advance and transfer data with corresponding helm angles.
