## MARINE INVESTIGATION REPORT

M04W0034

### CAPSIZING AND LOSS OF LIFE

SMALL FISHING VESSEL *HOPE BAY*  
QUEEN CHARLOTTE SOUND, BRITISH COLUMBIA  
26 FEBRUARY 2004

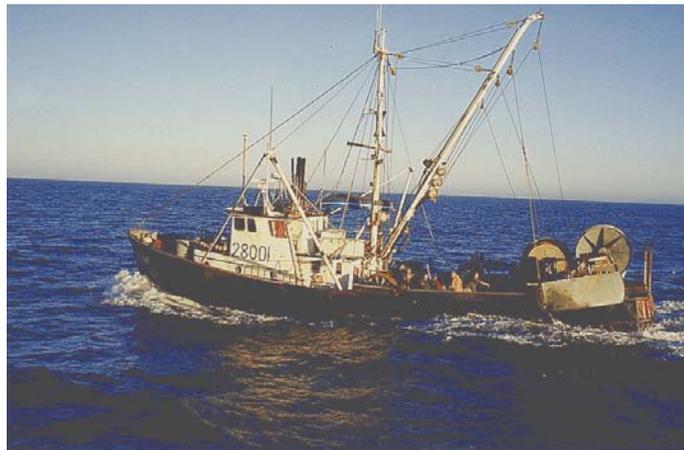
**Photo 1.** *Hope Bay* making way off the west coast of Vancouver Island, circa 2000.

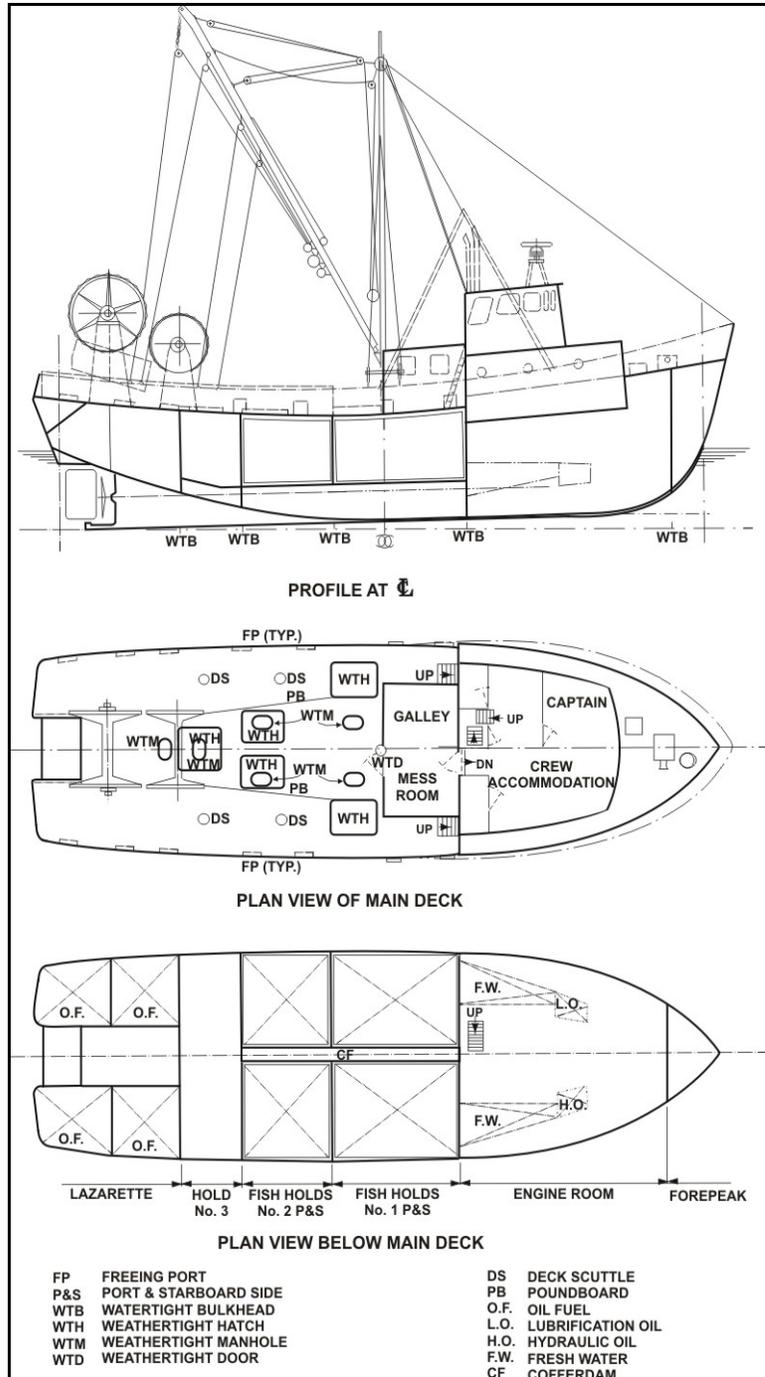
Figure 1. Outline General Arrangement

The *Hope Bay* was a small fishing vessel of closed construction, having an all-welded steel double-chine hull with a partly raised forecastle deck, a stern ramp and a skeg. The hull below the main deck was subdivided by five transverse watertight bulkheads, separating (from forward): the forepeak; engine room; two forward (No. 1 port and starboard) and two after (No. 2 port and starboard) insulated fish holds divided by a centre line cofferdam; a third hold (No. 3 hold) designated as a void space; and the lazarette, which housed the steering gear. Four diesel oil tanks were arranged on the port and starboard sides outboard of the lazarette. Fresh water storage tanks were located on the port and starboard sides of the engine room (see Figure1).

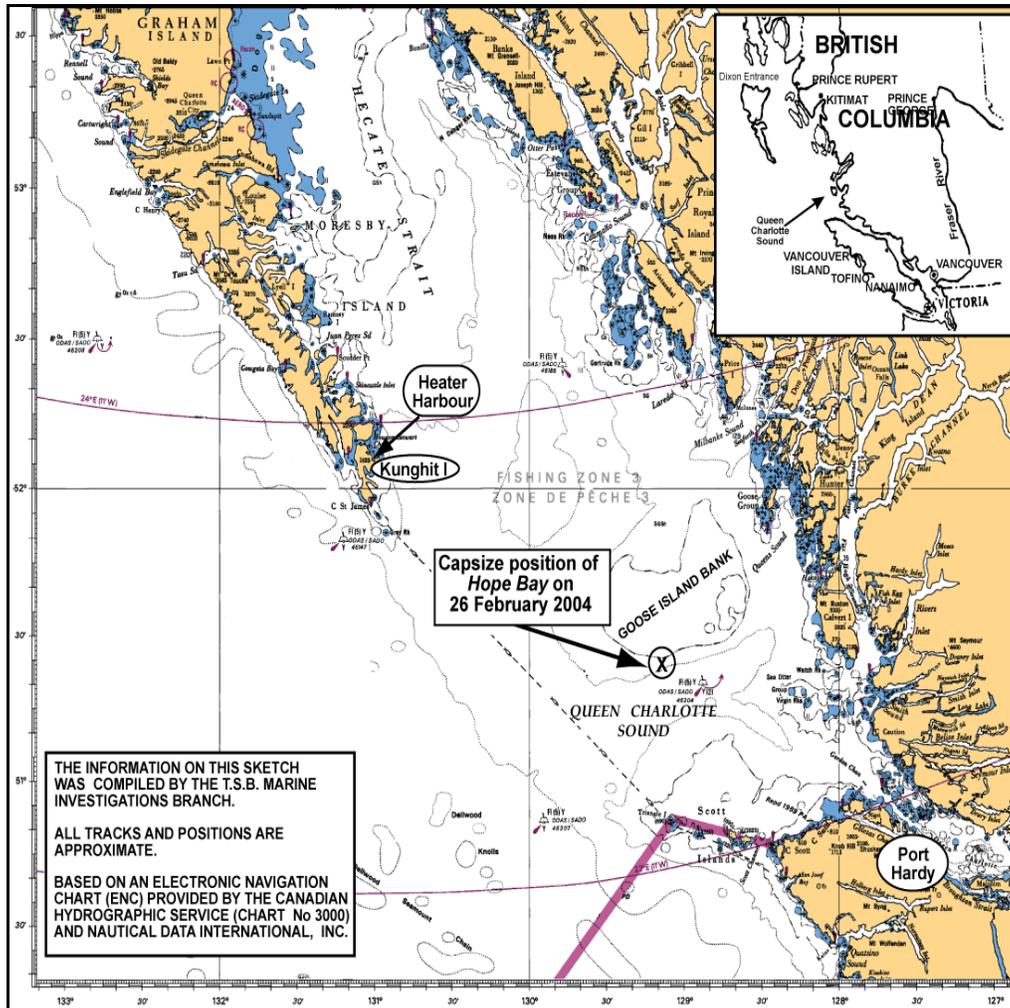
Figure 2. Chart of the occurrence area

The vessel arrived at the fishing grounds at about 1600<sup>4</sup> on 23 February 2004 and began fishing at approximately 1830. Fishing continued for some 25 hours until around 1930 on February 24, when Nos. 1 and 2 fish holds were nearly full with a combination of fish, salt water, and ice. No. 3 hold remained empty. By the time the fish were stowed, the weather had deteriorated and the *Hope Bay* sought refuge from impending southeasterly gales. The vessel had a starboard list as it steamed westward for two hours to Heater Harbour on Kunghit Island, Queen Charlotte Islands, B.C., where it anchored at about 2130. (See Figure 2.)
