**MARINE INVESTIGATION REPORT  
M14C0156**

**FIRE AND ABANDONMENT  
SMALL PASSENGER VESSEL *LA RELÈVE II*  
HAVRE-SAINT-PIERRE, QUEBEC  
11 AUGUST 2014**

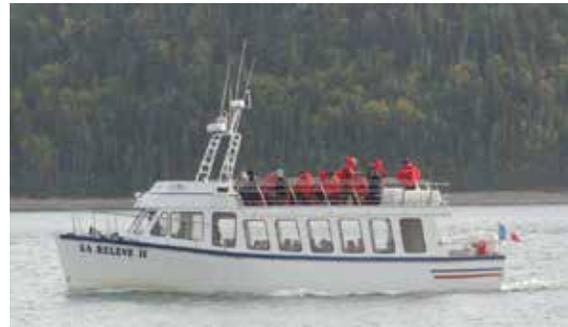
**Photo 1. La Relève II**

*La Relève II* is a small 2-deck passenger vessel (Photo 1) based in Havre-Saint-Pierre, Quebec. The vessel is constructed of wood and covered with fibreglass. Access to the main deck is via the open stern. Forward of this point, the main deck is enclosed within a cabin that includes the conning station and seating for passengers. The upper deck is open and is fitted with additional passenger seating. Access to the upper deck is via stairs at the stern.

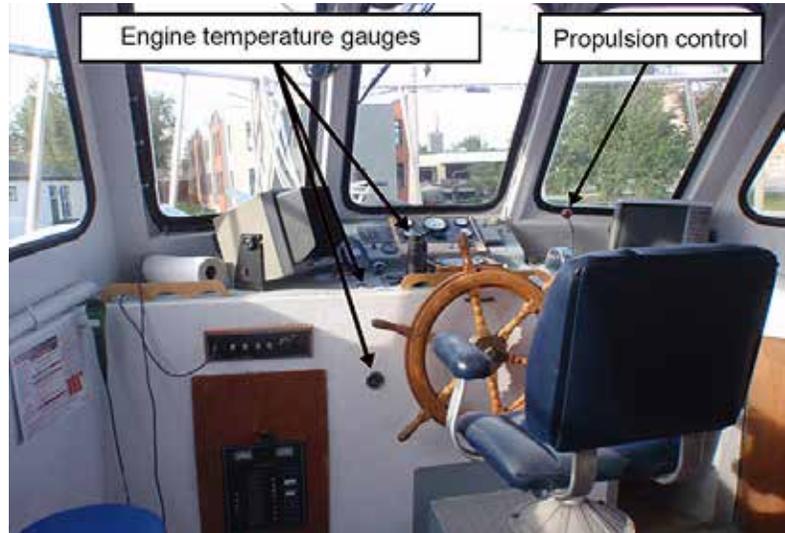
Photo 2. Navigation console

The navigation console includes a magnetic compass, radar, and a very high frequency (VHF) radiotelephone. The engine panel, situated in front of the conning position, includes various indicators for engine parameters (e.g., oil, voltage, revolutions per minute, engine temperature). There are 3 engine temperature gauges on the navigation console: 1 on the engine panel, 1 located to the left of the helm, and 1 located at knee height (Photo 2). These gauges indicate the engine coolant temperature. The console also includes a fire detection system consisting of a visual and audible alarm that is activated by a heat detector located in the engine compartment. The detector was installed on the after bulkhead of the engine
