MARINE TRANSPORTATION SAFETY INVESTIGATION REPORT M18C0225

GROUNDING

Passenger vessel *Akademik Ioffe*
Latitude 69°43.043' N
Longitude 091°20.951' W
Astronomical Society Islands, Nunavut
24 August 2018

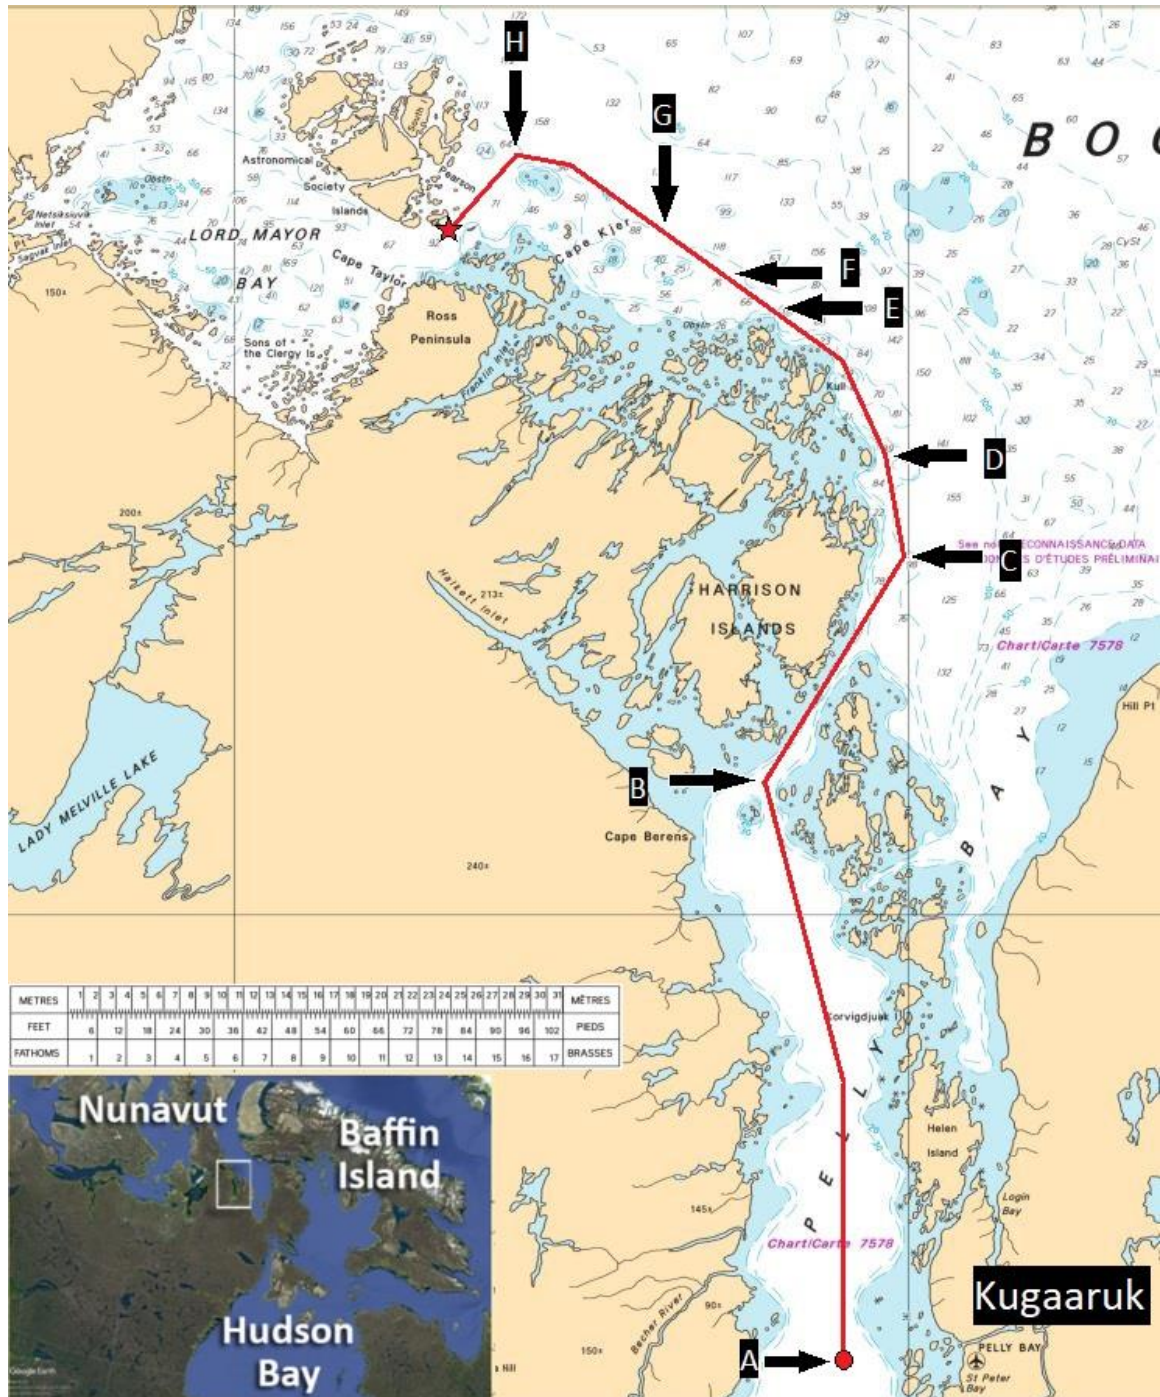
Figure A1. Track of the *Akademik Ioffe*, from departure off Kugaaruk, Nunavut, to position of grounding (Source: Canadian Hydrographic Service chart 7502 and Google Earth, with TSB annotations)

Waypoint	Date and time (Mountain Daylight Time - UTC-6)	Description of event
A	23 August 2018 2045	Departure from the anchorage in Pelly Bay off Kugaaruk
B	24 August 2018 0000	Change of course for the narrows at the entrance of Pelly Bay
C	24 August 2018 0252	Change of course to 352°G to navigate around the Harrison Islands
D	24 August 2018 0440	Change of course to 336°G to navigate around the Harrison Islands
E	24 August 2018 0738	Deviation Report (DR) sent to Northern Canada Vessel Traffic Services (NORDREG)
F	24 August 2018 0801	NORDREG acknowledges receipt of DR; TC accepts the new passage plan
G	24 August 2018 0847	Musters and safety briefings initiated
H	24 August 2018 1027	Change of course to 221°G to enter the narrows between the Ross Peninsula and the Astronomical Society Islands
Star	24 August 2018 1113	Vessel runs aground on uncharted rocky shoal

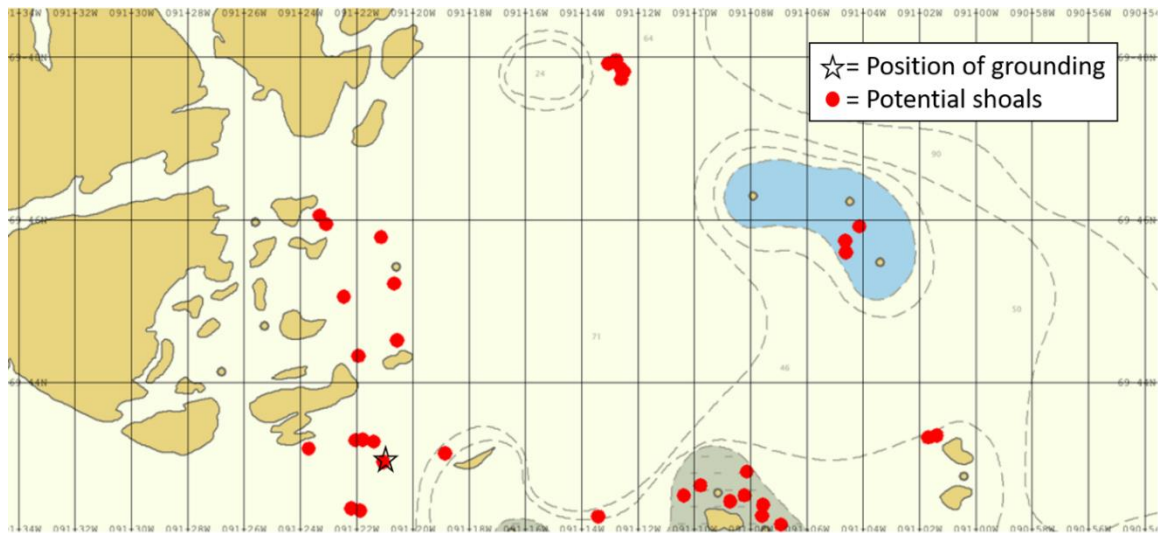
Figure B1. Position of potential shoals and position of the *Akademik Ioffe*'s grounding

In response to the grounding of the *Akademik Ioffe*, and to support anticipated vessel movements in the vicinity of the grounding location during the search and rescue response, the Canadian Hydrographic Service (CHS) analyzed several satellite imagery sources to identify the position of potential shoals. The CHS could not evaluate the depth of these shoals. To provide this preliminary data, the CHS used PlanetScope imagery from 22 August 2018 and Sentinel-2 imagery from 22 September 2017 and 18 August 2018.
