# AIR TRANSPORTATION SAFETY INVESTIGATION REPORT A24P0002

## CONTROLLED FLIGHT INTO TERRAIN

Aircraft Guaranty Corp Trustee  
Bell 206B (helicopter), N617TT  
Revelstoke Aerodrome (CYRV), British Columbia, 11 NM ENE  
05 January 2024

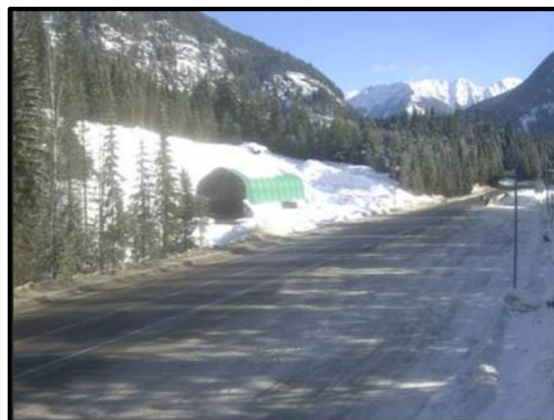
The pilot of a local commercially operated helicopter that was on a return flight from Rogers Pass to Revelstoke reported building fog and cloud layers with light snow showers while passing through the occurrence area at approximately 1600 (Figure 4). As the day transitioned through civil twilight, the visibility likely degraded from a combination of these conditions and the surrounding mountains (Figure 5).

Figure 4. Still image taken from the Albert Canyon webcam at 1600 on 05 January 2024 (Source: DriveBC.ca)
