MARINE TRANSPORTATION SAFETY INVESTIGATION REPORT M24A0412

FIRE

Fishing vessel *Fundy Leader*
100 nautical miles southwest of Cape Sable, Nova Scotia
06 December 2024

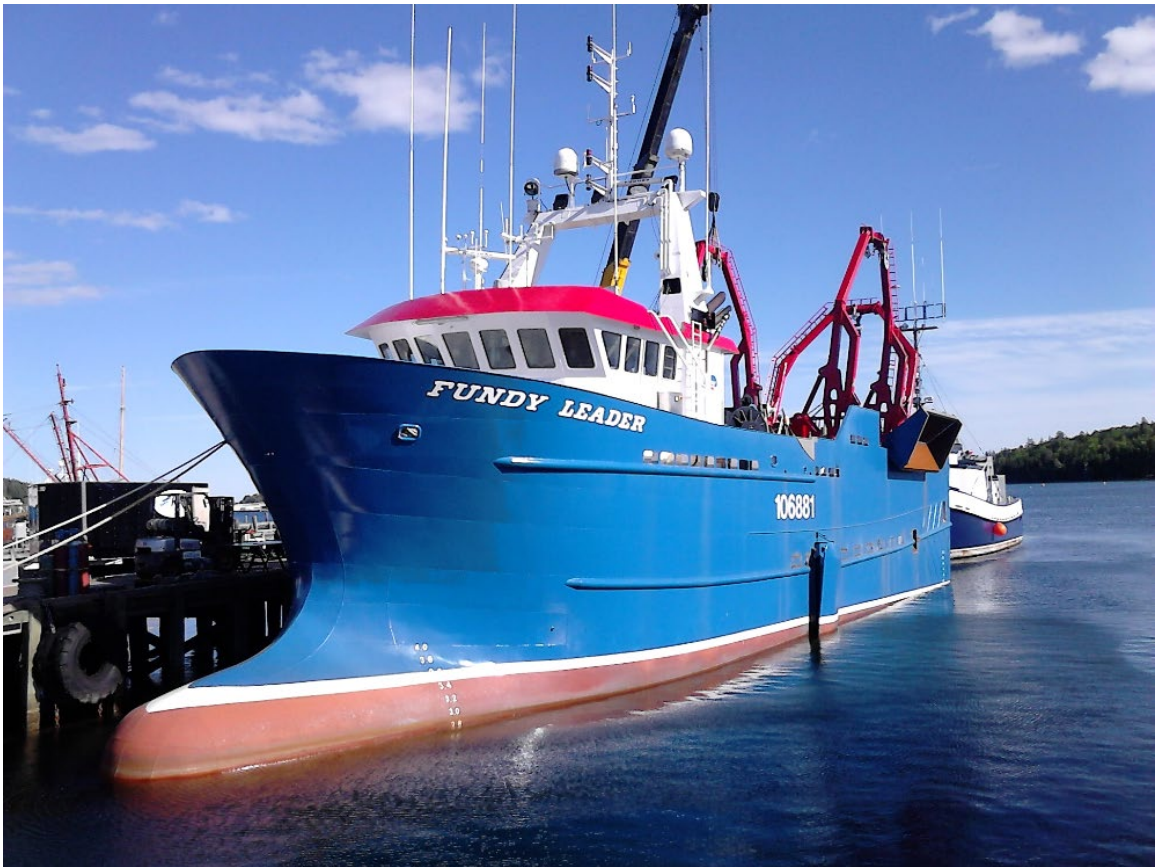
The *Fundy Leader* (Transport Canada official number 828432) is a fishing vessel with a registered length of 32.13 m and a gross tonnage of 419 (Figure 1). The vessel was built in 2005 as a trawler but underwent a major conversion in 2015 to fish scallops. The vessel is owned by Clearwater Seafoods, which owns and operates 20 other vessels.

Figure 1. The *Fundy Leader* (Source: Clearwater Seafoods)
