MARINE TRANSPORTATION SAFETY INVESTIGATION REPORT M24C0217

GROUNDING

General cargo vessel *Heemskerkgracht*
Kahnawake, Quebec
22 August 2024

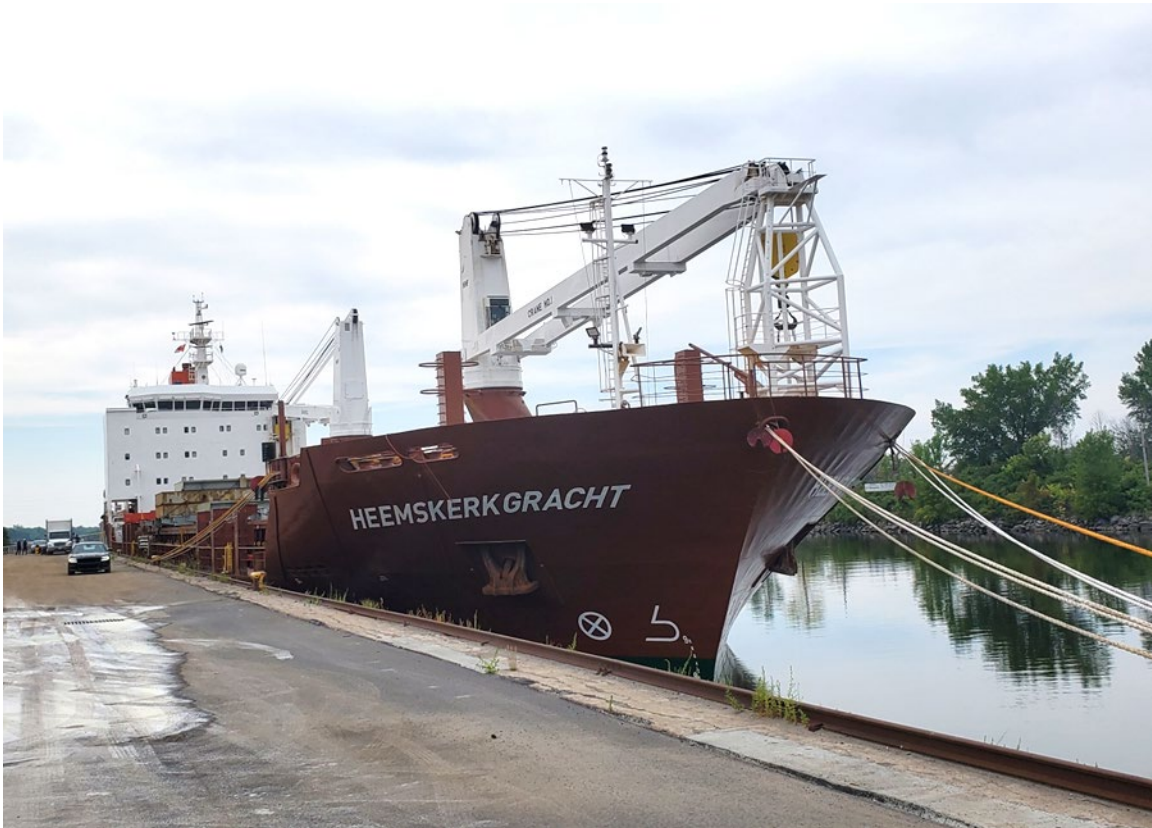
Figure 1. The *Heemskerkgracht* secured alongside at the Port of Côte-Sainte-Catherine in the South Shore Canal, Quebec (Source: TSB)

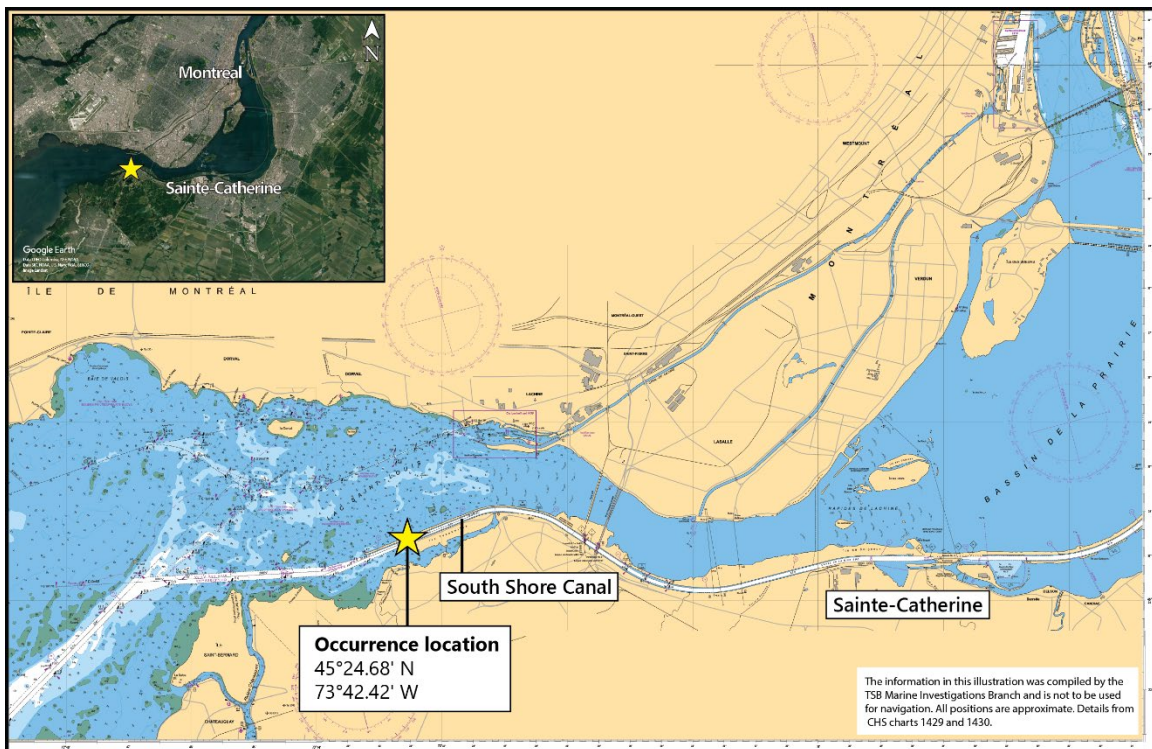
Figure 3. Occurrence map showing the location where the *Heemskerkgracht* went aground (Source of main image: Canadian Hydrographic Service charts 1429 and 1430, with TSB annotations; source of left inset image: Google Earth, with TSB annotations)
