# RAIL TRANSPORTATION SAFETY INVESTIGATION REPORT R24C0014

## NON-MAIN-TRACK TRAIN COLLISION AND DERAILMENT

Canadian Pacific Railway Company, doing business as CPKC  
Remote control locomotive system yard assignment CK31-10  
Mile 8.0, Crowsnest Subdivision  
Kipp Yard  
Coalhurst, Alberta  
11 February 2024

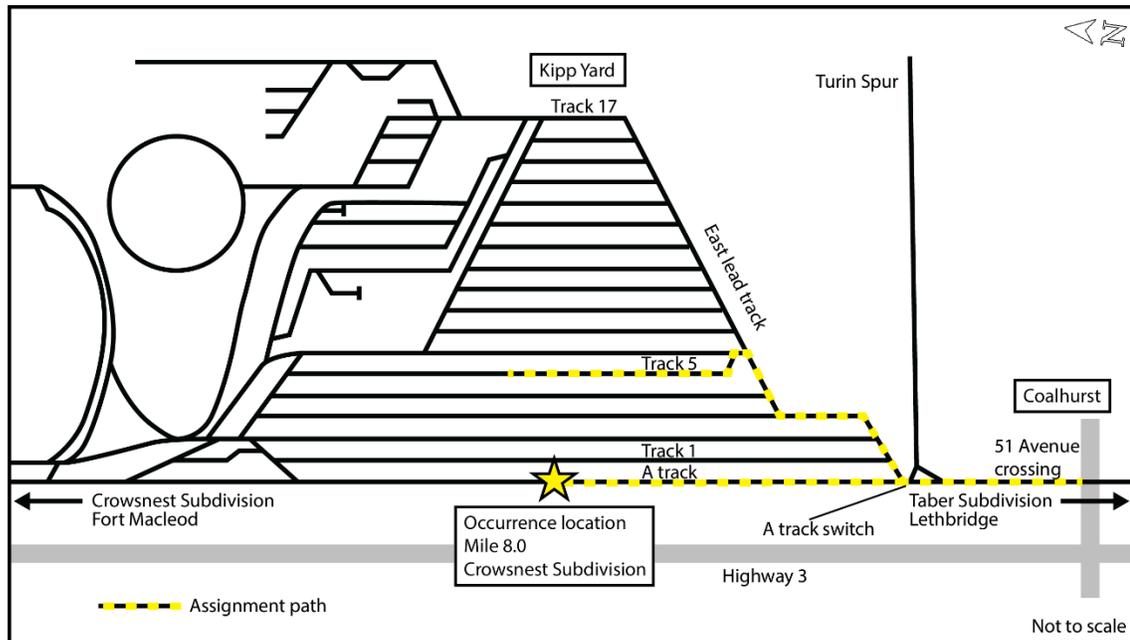
The assignment was to double over<sup>3</sup> a cut of 66 cars, weighing 8551 tons and measuring 3830 feet, from track 5 to A track<sup>4</sup> at the east end of the yard. This move would require the assignment to proceed on the east lead track past the A-track switch, then on the Taber Subdivision beyond the 51 Avenue public crossing until the last car was past the A-track switch. The assignment was then to be reversed into A track and coupled to 79 stationary cars, the first of which was at about the midway point in the track (Figure 2).

Figure 2. Schematic of the tracks at Kipp Yard showing the path of assignment CK31-10 during the double-over operation (Source: TSB)
