AIR TRANSPORTATION SAFETY INVESTIGATION REPORT A23P0136

LIGHTNING STRIKE AND LOSS OF CONTROL

Helijet International Inc.
Sikorsky S-76C++ (helicopter), C-GXHJ
Sidney, British Columbia, 10 NM NE
24 October 2023

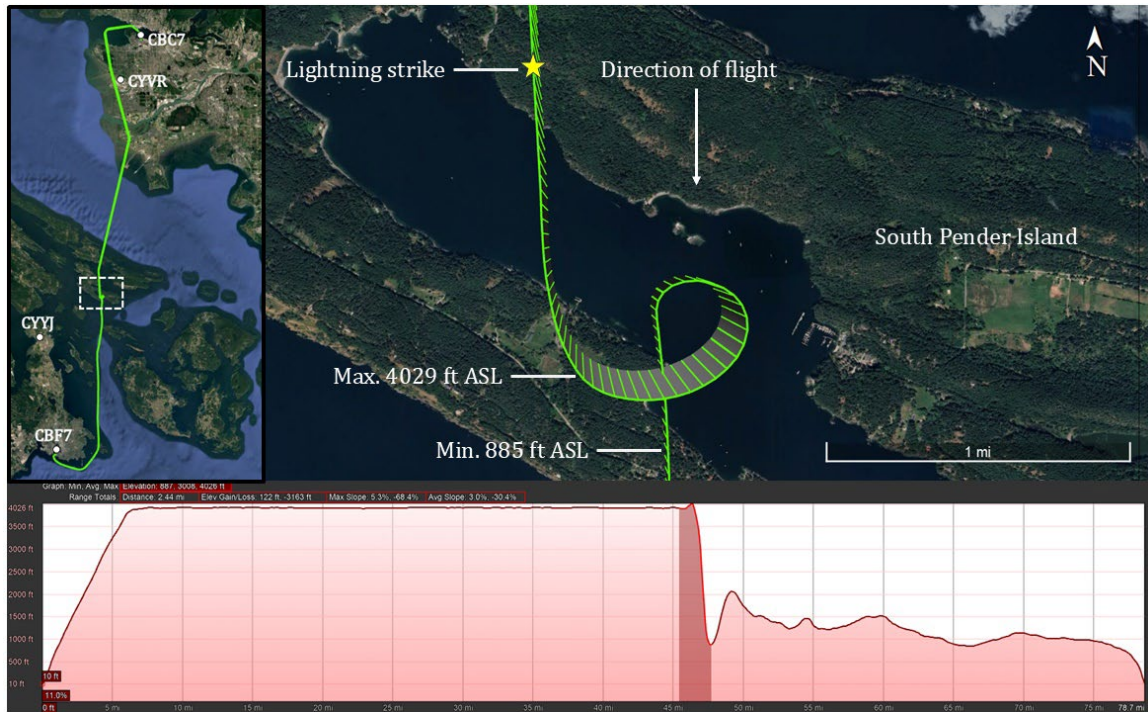
At 0930:21, the helicopter entered an uncontrolled rapid descent from 4029 feet to 885 feet ASL in 36 seconds, reaching a maximum of 63° left roll and 44° pitch down (Figure 1). As the helicopter emerged from the clouds, the captain regained visual reference to the ground and was able to reduce the helicopter's roll angle and stop the descent. The vertical acceleration peaked at 2.48g⁵ before the helicopter climbed back up to 2073 feet ASL.

Figure 1. The complete occurrence flight path (inset) with the occurrence segment enlarged to indicate the location of the lightning strike and the maximum and minimum altitude above sea level (ASL). The graph at the bottom depicts the flight's level altitude followed after the lightning strike and subsequent flight pattern. (Source: Google Earth, with TSB annotations)

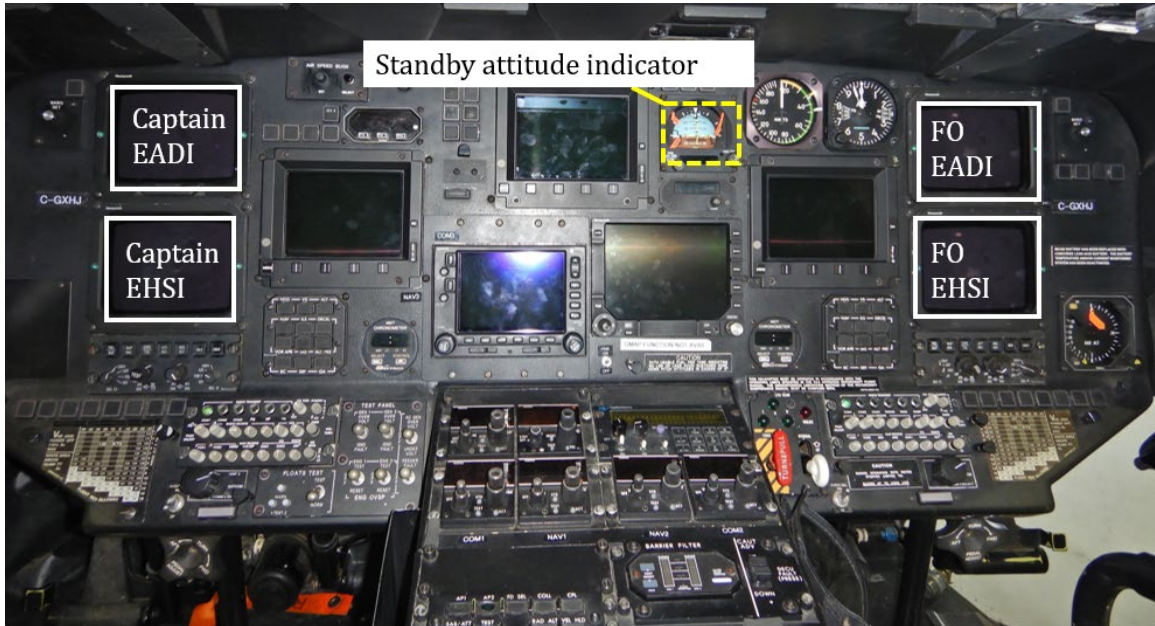
Figure 7. The occurrence helicopter instrument panel highlighting how the smaller size and central location of the standby attitude indicator differ from the larger electronic attitude direction indicator (EADI) and electronic horizontal situation indicator (EHSI) displays that are directly in front of the captain and first officer (FO) (Source: TSB)

The occurrence flight was in IMC and the flight crew relied on the EADI for situational awareness of the helicopter position and the EHSI to navigate to the destination. At the moment of the lightning strike, all electronic displays momentarily went black and did not provide any information. The standby instruments remained operational.

All electronic displays recovered quickly, but the air data computer (ADC) for the right side of the cockpit had failed and the related flight information was no longer valid on those displays. As a result, the FO was reliant on the standby instrumentation for continued flight in IMC until the captain took control.
