# MARINE TRANSPORTATION SAFETY INVESTIGATION REPORT M23A0169

## SUBMERSIBLE IMPLOSION AND LOSS OF LIFE

Submersible *Titan* and cargo vessel *Polar Prince*

18 June 2023

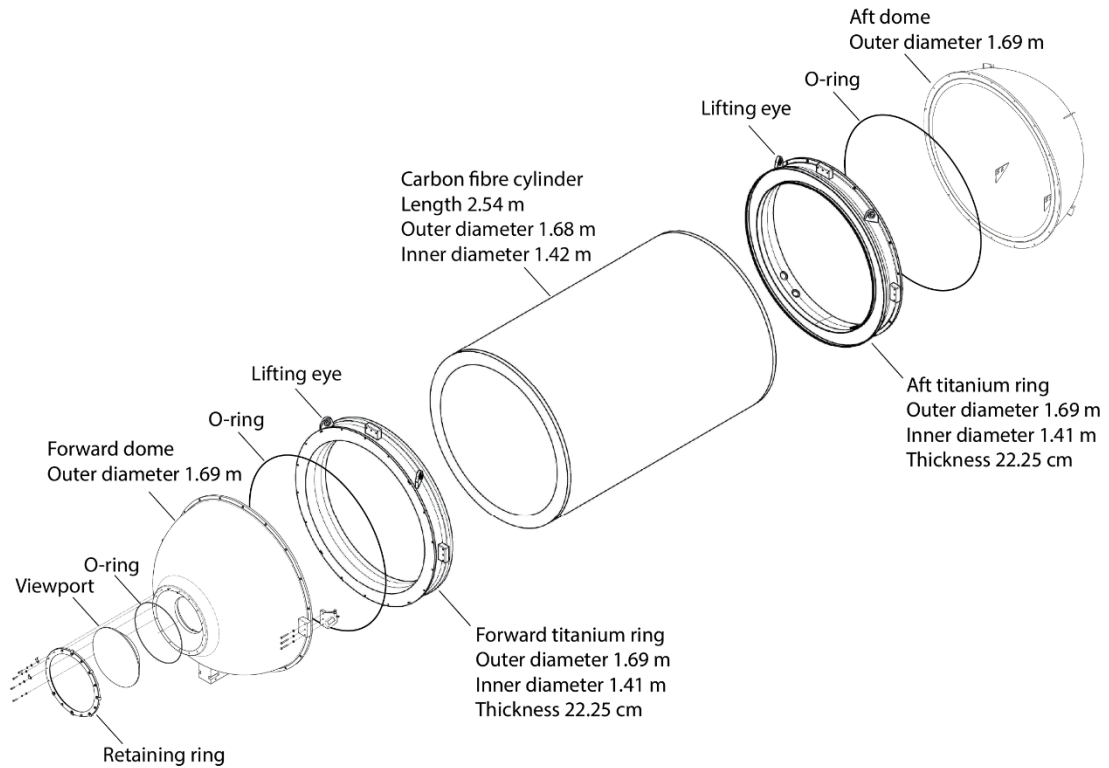
Figure 6. Expanded view of the Titan pressure hull (Source: TSB, based on OceanGate drawings)

At either end of the carbon fibre cylinder were rings fabricated from grade 3 titanium. Each titanium ring had an annular channel where the cylinder was inserted and joined using an epoxy paste adhesive. The forward and aft rings each had 2 lifting eyes welded to the upper sections of them to facilitate lifting the submersible using a crane. The aft ring had 4 penetration plates that allowed for through-hull connections of wiring, tubing, and piping for electrical, air, and hydraulic components.

The hemispherical domes were also made of grade 3 titanium and were bolted to the titanium rings. The domes were 1.52 m in diameter and 8.26 cm thick. The forward dome had the viewport fitted into it. The viewport was made of manufactured acrylic that was 22 cm thick at its thickest point. The outer side of the viewport had a diameter of 58.42 cm and was convex. The viewport tapered to a diameter of 38.62 cm inside the cabin. The viewport was positioned in a machined seat and secured in place by an O-ring and a retaining ring. The viewport was rated for 6.516 MPa, which is equivalent to a depth of 649.08 m (see Section 1.12 for more details on the viewport).

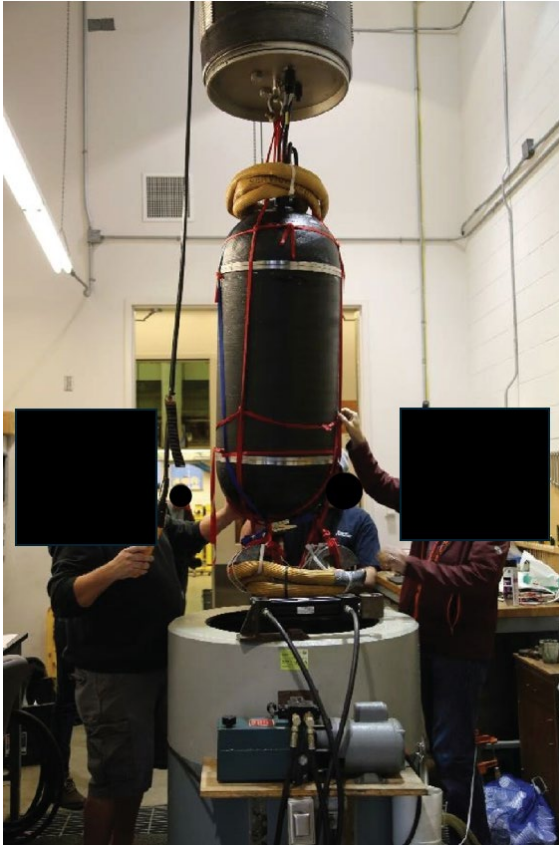
**Figure 8. First pressure test of one-third scale model at University of Washington Applied Physics Lab (Source: OceanGate)**

In December 2015, OceanGate conducted a pressure test on this one-third scale model at the UW-APL (Figure 8). One of the carbon fibre end domes failed at pressures equivalent to depths of around 3000 m. On 23 December 2015, OceanGate sent a letter to stakeholders reporting on the one-third scale model test. The letter indicated that strain gauges were used during the test and that one of the hemispherical end caps had failed well short of the design operating depth of 6096 m. The letter noted that the failed end cap had been sent back for evaluation to the company that had manufactured it. It was believed that the end cap had buckled, which was the reason the strain gauges did not give any warning of the failure.

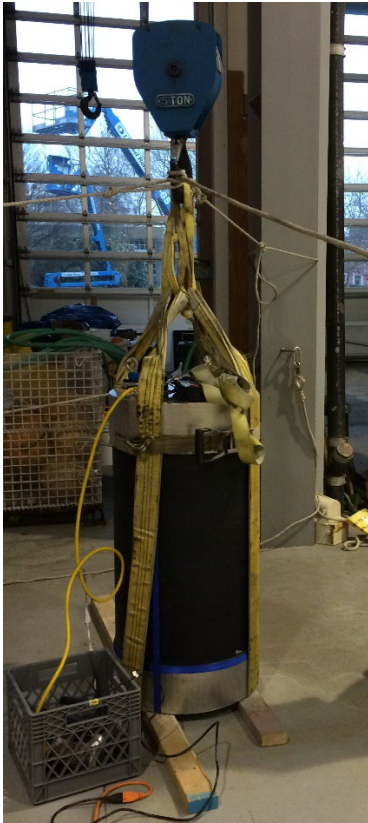
Figure 9. Scale model of cylinder with metal plates (Source: Patrick Loomis)

On 05 February 2016, OceanGate conducted a 2nd pressure test using the one-third scale model with aluminum plates on either end (Figure 9). The one-third scale model failed at a pressure equivalent to a depth of 4200 m (Figure 10). Strain gauges were used during this test.

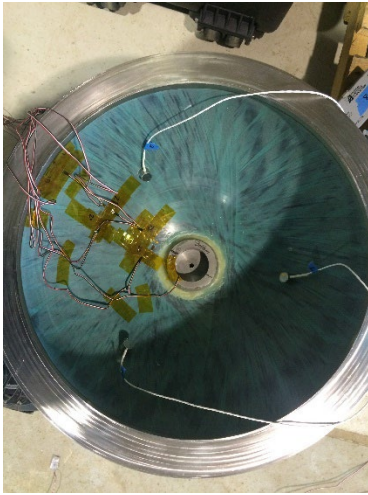
Figure 11. Carbon fibre end dome before test  
(Source: Patrick Loomis)

On 11 March 2016, OceanGate conducted a 3rd pressure test on a new one-third scale model, this one again with carbon fibre end domes (Figure 11). It failed at a pressure equivalent to a depth of 2754 m (Figure 12). This test was done with acoustic emission monitors to measure the effects of the pressure on the carbon fibre components.
