**AVIATION INVESTIGATION REPORT
A04H0004**

**REDUCED POWER AT TAKE-OFF AND COLLISION WITH
TERRAIN**

**MK AIRLINES LIMITED
BOEING 747-244SF 9G-MKJ
HALIFAX INTERNATIONAL AIRPORT, NOVA SCOTIA
14 OCTOBER 2004**

Report Number A04H0004

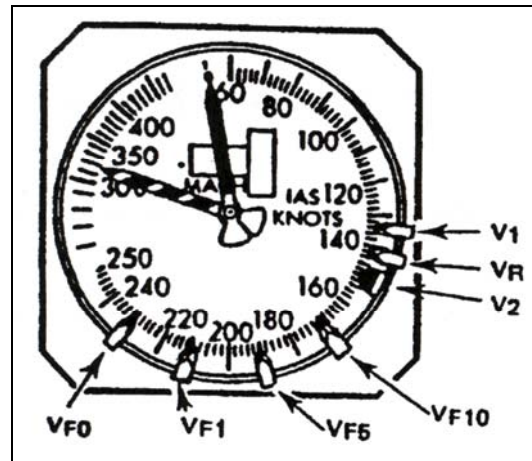
Figure 5. Example of bug settings for take-off

To remind the pilots of their target EPR settings, a moveable pointer bug is pre-set on each of the four EPR indicators on the pilots' centre instrument panel (see Figure 5). The indicators have two modes, manual and automatic. In manual mode, the knob is pulled out and an M flag replaces the left digit in the upper window. The bug and upper digital readout respond to the rotation of the knob. In automatic mode, the knob is in, the M flag is out of view, and the bug and upper digital readout responds to the TAT/EPRL (true air temperature/engine pressure ratio limit)²² mode selector. Climb EPR and go-around EPR are taken from the MK Airlines Limited QRH and transcribed onto the take-off data card.

After, the set bug speeds and EPR setting should have been checked against the speeds on the take-off data card. Gross errors would have been obvious and corrections, if required, would have been made, and the bugs would have been set to the correct take-off (V) speeds and the EPR setting. The first officer should have called the rating (maximum or reduced thrust) being used and noted any surface condition changes since the completion of the take-off data card. A departure briefing should have been accomplished before the engine start and pushback, unless operational factors precluded it at that time.

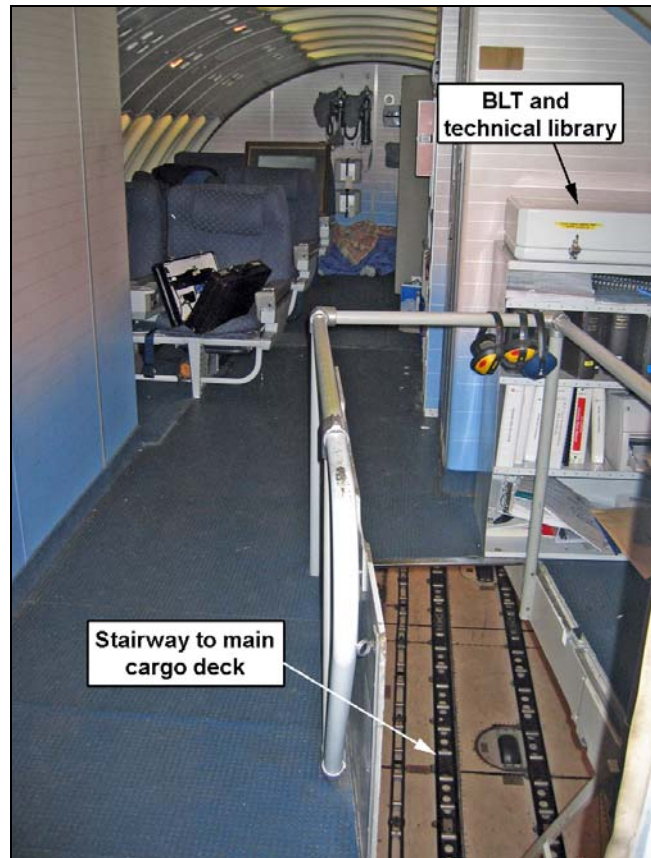
Photo 7. Upper deck configuration

The first officer should have then gone to the company laptop computer in the upper deck rest area and opened the BLT program (see Photo 7). Since the BLT defaulted to the previous information used, and the take-off at Bradley International Airport had been a RTG II reduced thrust take-off, that option (RTG II) should have been selected in the window. The first officer should have then used the drop-down menus to insert on the performance page the airport, runway, runway conditions, aircraft bleeds (always defaulted to OFF), anti-ice, and optimum flap. Since there were no aircraft defects and no applicable NOTAMs (notices to airmen) for Halifax, the first officer should have proceeded to the next step. Without a planned weight in the planned weight block, a maximum take-off weight of 321 580 kg should have been generated after “calculate” was selected. Since the maximum take-off weight calculated by the BLT in RTG II would have been less than the planned take-off weight, the first officer would have had to return to the BLT icon and select the maximum thrust (7Q rating).

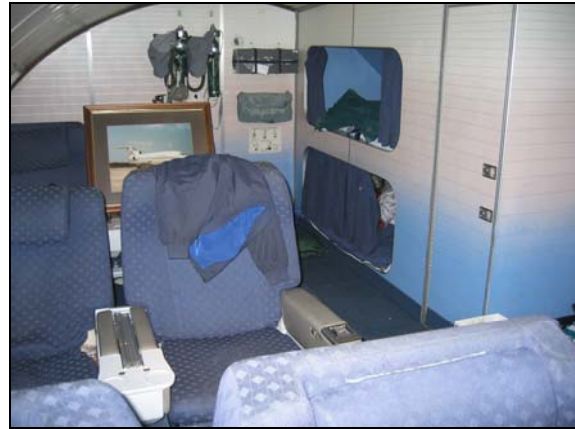
Photo 8. Upper deck crew rest area

The on-board rest facilities on the accident aircraft included a captain's cabin, two bunks, and first-class seats (see Photo 8). The operating captain and the first officer would have had the opportunity to sleep on board the aircraft while transiting from Luxembourg to Bradley. However, other MK Airlines Limited crews indicated that they rarely were able to sleep on the first leg of the MKA1601/MKA1602 route because of the time of day. They also stated that they began to feel the effects of fatigue during the stopover in Halifax and might obtain a nap in Halifax, if the turnaround time permitted. Feeling fatigued at this stage of the flight would be consistent with the expected lowest point of a crew member's circadian rhythm. In the case of the accident flight, which was delayed leaving Luxembourg, the circadian low point would have fallen somewhere between Bradley and Halifax. Other crews also indicated that they normally were able to get several hours of sleep while transiting between Halifax and Zaragoza.
