MARINE INVESTIGATION REPORT
M04C0037

STRIKING OF ST. LAWRENCE SEAWAY BRIDGE 12

BULK CARRIER *FEDERAL MAAS*
ST. LAWRENCE SEAWAY, ONTARIO
15 AUGUST 2004

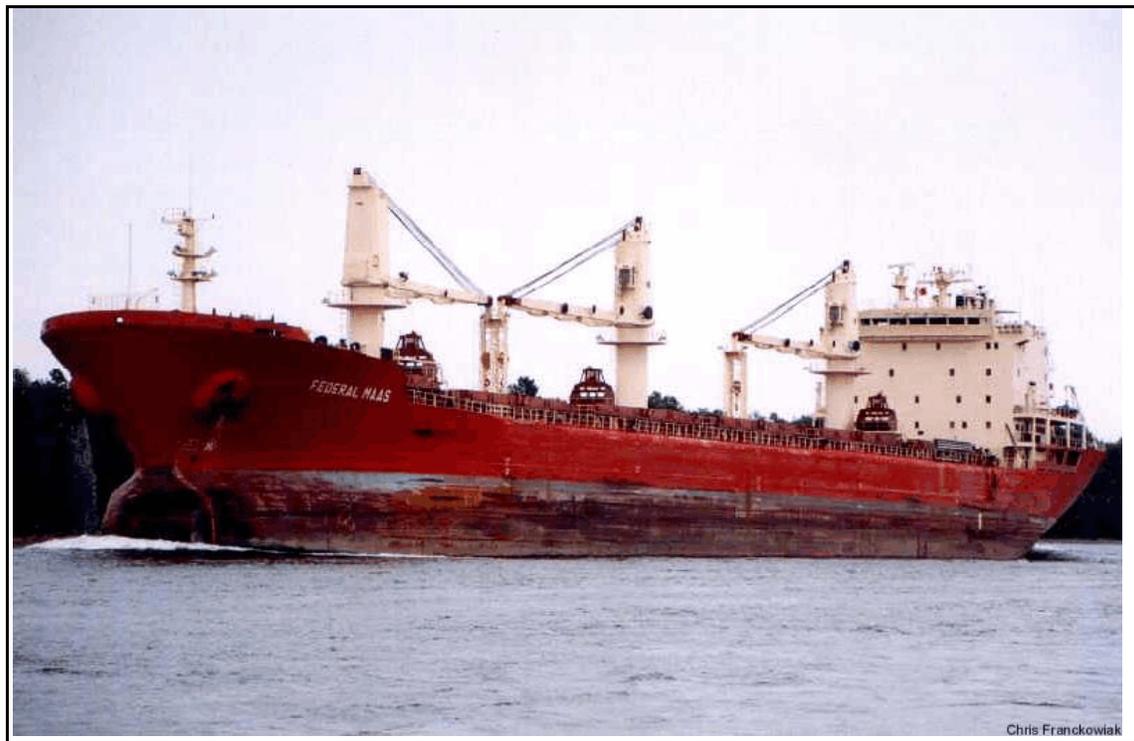
The HSO proceeded to the lower control kiosk and, using the computer control station within, initiated the opening of Bridge 12.³ Before the bridge reached its full open position, the upper approach lights were switched from green to red by CSO 1 from the upper control kiosk using the lock computer control system. Shortly afterward, CSO 1 informed the HSO that the upper end of the lock was ready to close, meaning that the green approach light had been switched to red.

At about this time, the pilot on board the vessel requested that the HSO read the forward draught marks. The HSO proceeded out of the lower control kiosk. The bells on Bridge 12 had stopped, indicating that the bridge was no longer in motion. CSO 2, stationed at the upper control kiosk, then opened the lower gates and arrester boom, and the vessel was cast off, with the HSO releasing the No. 2 wire at the bow.

The vessel exited the lock proceeding at 1.5 knots along the lower approach wall. Both the pilot and master were on the starboard side of the vessel's bridge; as such, Bridge 12 was not clearly in view. As the vessel's accommodation structure passed Bridge 12, the port bridge wing struck the centre of the span of Bridge 12.

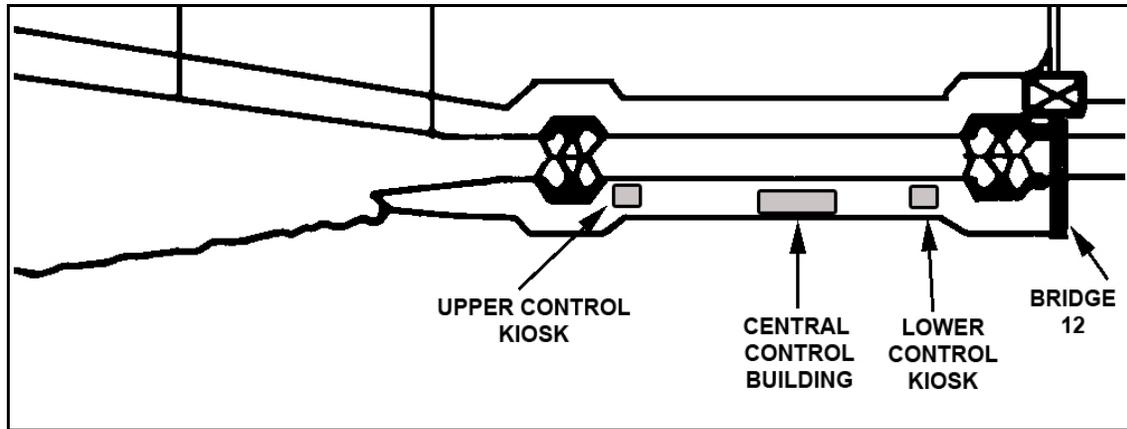
Until 2001, the lock was operated from a control tower located at the lower end of the lock. At that time, a new control system was installed that comprised three computer control stations, one at each end of the lock, and a centralized station in a building midway along the lock.

Closed-circuit television (CCTV) cameras were installed to allow lock operators to view all equipment. Following an accident in 2003 at Lock No. 3 in the Welland Canal, during which a ship arrester was lowered onto the *Federal Saguenay*,⁴ programming changes were made to the control systems at Seaway locks including Iroquois Lock. The changes made by the St. Lawrence Seaway Management Corporation (SLSMC) were as follows:

The changes were not fully tested or simulated before the control system was put in use at the lock stations. Following the implementation of these modifications, the staff noted that, when the lock was opened and the message “end opened and locked” was displayed, equipment at both ends was locked out. The system was again modified such that one end was able to operate should the opposite end be locked out.

Following this modification, another problem was noted by the staff at Iroquois Lock. In order to operate the upper end, the red light must be on. However, when the upper navigation lights are switched from green to red while the bridge is in motion, the bridge immediately stops, regardless of its position. This deficiency was noted by SLSMC staff and, on 05 August 2004, all operating shifts were informed verbally and a warning note was posted on the computer control stations (see Photo 3); however, no formal information concerning the problem or modified procedures was passed on to the affected operating staff.
