MARINE INVESTIGATION REPORT
M05L0203

GROUNDING

BULK CARRIER *CANADIAN LEADER*
OFF CAP À LA ROCHE, UPSTREAM OF
DESCHAILLONS-SUR-SAINT-LAURENT, QUEBEC
26 SEPTEMBER 2005

Report Number M05L0203

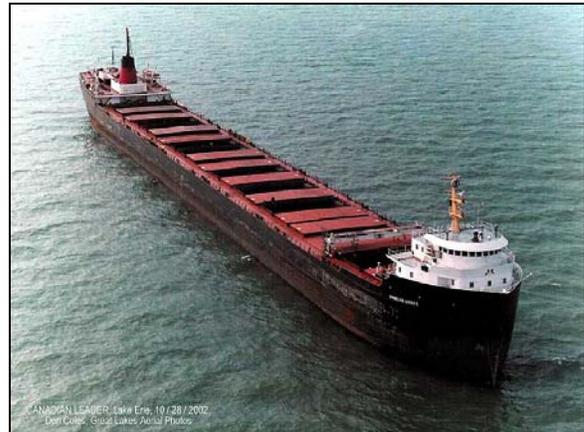
Photo 1. *Canadian Leader*

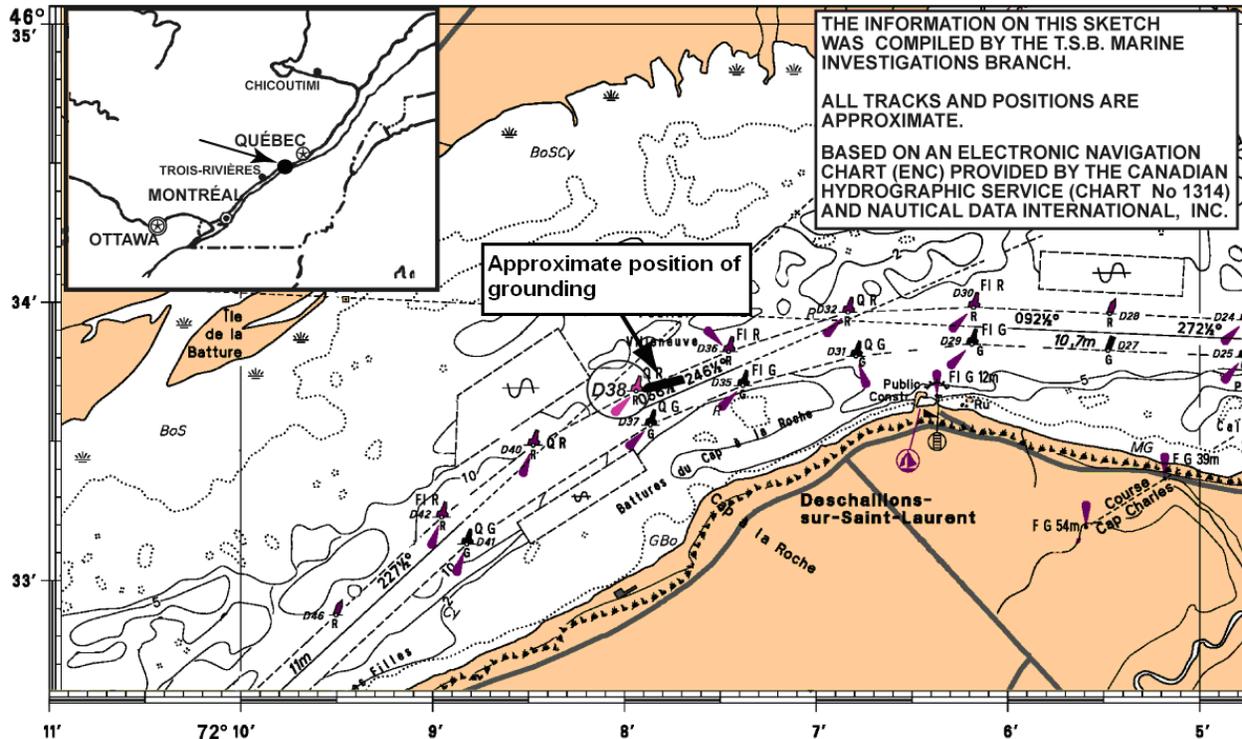
Meanwhile, the OOW phoned the master and briefed him on the situation. The master immediately came up to the bridge. The vessel continued its sheer to starboard, left the channel, and, at 0117, ran aground on the north side of the channel near buoy D38 in position $46^{\circ}33'40''$ N, $072^{\circ}07'56''$ W (see Figure 1). The chief engineer and the third engineer rushed to the engine room to help restore electrical and steam power to the propulsion plant. The helm was regained later but not soon enough to prevent the grounding.

Figure 1. Grounding position on the St. Lawrence River

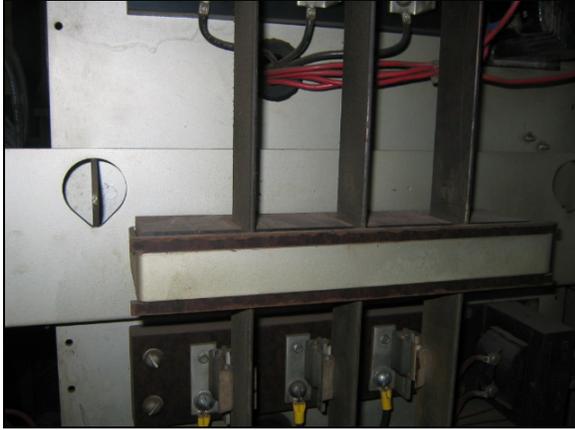
Three bus bars, supplying power to the No. 1 ballast pump, are secured to the switchboard casing with a steel bracket and, to insulate the bars, two styles of bakelite insulation pieces are used. One of the insulation pieces, installed horizontally, has three notches to keep the bars apart. The other insulation piece has an "H" shape and is a 6 mm flat piece. This "H" piece is enclosed vertically between the bus bar edges and the steel bracket, preventing the bars from sliding out of the notches and coming into contact with the steel bracket (Photos 7 and 8).

Photo 7. Side view of a standard arrangement of the three vertical bus bars resting in bakelite insulation and encased by the steel bracket

According to TP 127, an air gap of at least 22 mm would be required to prevent arcing between the bus bars and the adjacent bracket; however, since the bakelite insulation piece was missing, the maximum air gap distance between bus bars and ground would have been only 6 mm.

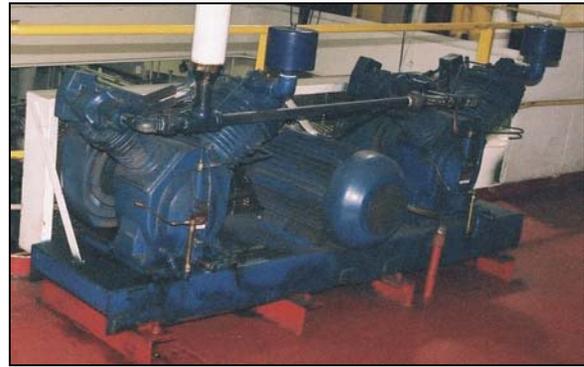
The soot-blowing operation necessitates the use of dedicated air compressors. There are two sets of soot-blowing compressors on board; each set is comprised of one electric motor driving two compressors in tandem (see Photo 14). These sets are identified on the switchboard as AIR COMPRESSOR FWD and AIR COMPRESSOR AFT. Each air compressor set is electrically supplied through a 50 A circuit breaker.

Several hours after the power was restored subsequent to the blackout, the second engineer noticed a dead phase ground fault while closing the circuit breaker connecting the aft air compressor set. One of the wires in the connection box of the electrical motor was later found to have been in contact with the inside top of the casing (see Photos 15 and 16).

Photo 14. Air compressor arrangement showing electrical motor between two compressors
