RAILWAY INVESTIGATION REPORT R15V0191

Grade crossing collision

Canadian National Railway Company
Langley, British Columbia
11 September 2015

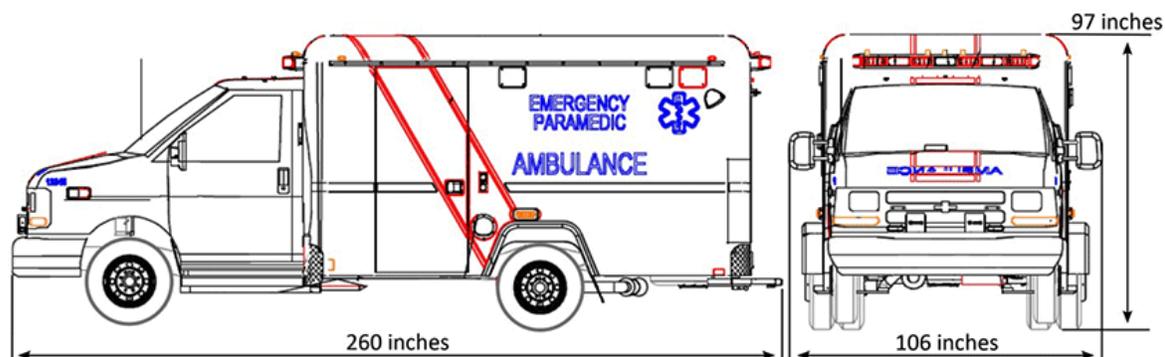
Figure 7. Ambulance dimensions (Source: British Columbia Ambulance Service)

The occurrence ambulance, a 2009 Chevrolet Crestline series, measured 21.5 feet long (bumper to bumper) and 8.8 feet wide (outside mirror to outside mirror) (Figure 7). Based on the repair and inspection records, the ambulance was in serviceable condition. A post-

occurrence teardown and inspection determined that there were no pre-existing defects that would have contributed to this occurrence.

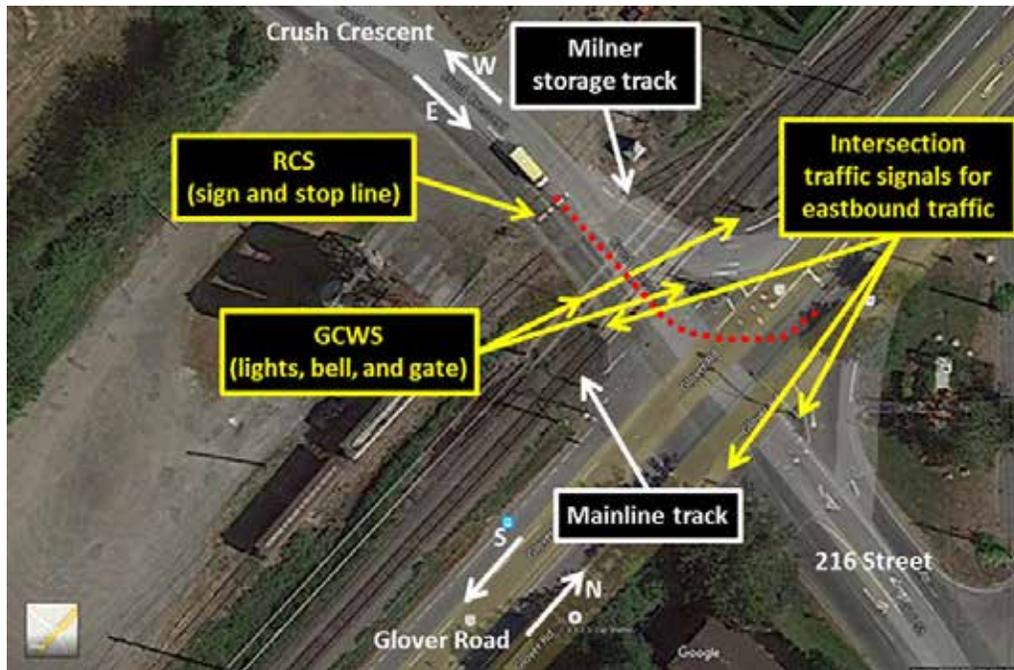
Figure 9. Aerial view of crossing (Source: Google Earth, with TSB annotations)

Approaching the crossing eastbound on Crush Crescent, a driver is initially presented with an RCS and stop line sign (Figure 9) for the Milner storage track. Prior to passing this line, the driver would need to ascertain the status of the GCWS for the main track. The GCWS features must therefore be both visible and sufficiently conspicuous to be seen and to capture the driver's attention:
