RAIL TRANSPORTATION SAFETY INVESTIGATION REPORT R18W0007

MAIN-TRACK TRAIN DERAILMENT

Canadian National Railway Company

Mile 166.33, Redditt Subdivision

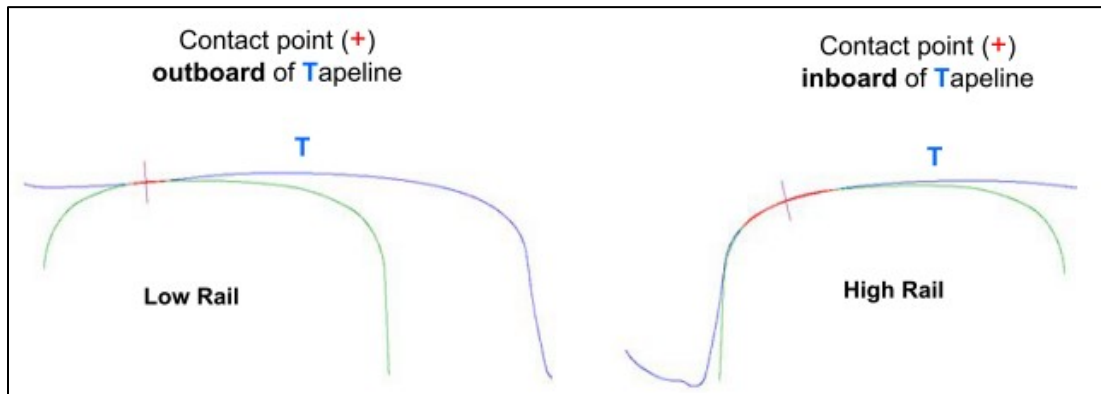
Figure 8. Contact points for wheel impact load detector installation in curves (Source: A. Poudel and M. Witte, "Effectiveness of cracked rim detectors to identify broken wheels," 23rd Annual TTCI Research Review, Colorado Springs, CO [March 2018].)

which permits the field side of the wheel tread to be scanned as it traverses the low rail of the curve (Figure 8).

The recorded impact loads from the tangent WILD and the WILD installed on the curve are compared. Significant differences between the recorded impact loads typically identify wheels with damage on or near the edge of the tread on the field side of the wheel. One challenge for installing this system is to find curves that have relatively high train speeds and curvatures greater than 7°.
