AVIATION INVESTIGATION REPORT

A03P0247

LOSS OF ENGINE POWER – COLLISION WITH TERRAIN

GEMINI HELICOPTERS INC.
BELL 204B (HELICOPTER) C-GEAP
BONAPARTE LAKE, BRITISH COLUMBIA
17 AUGUST 2003

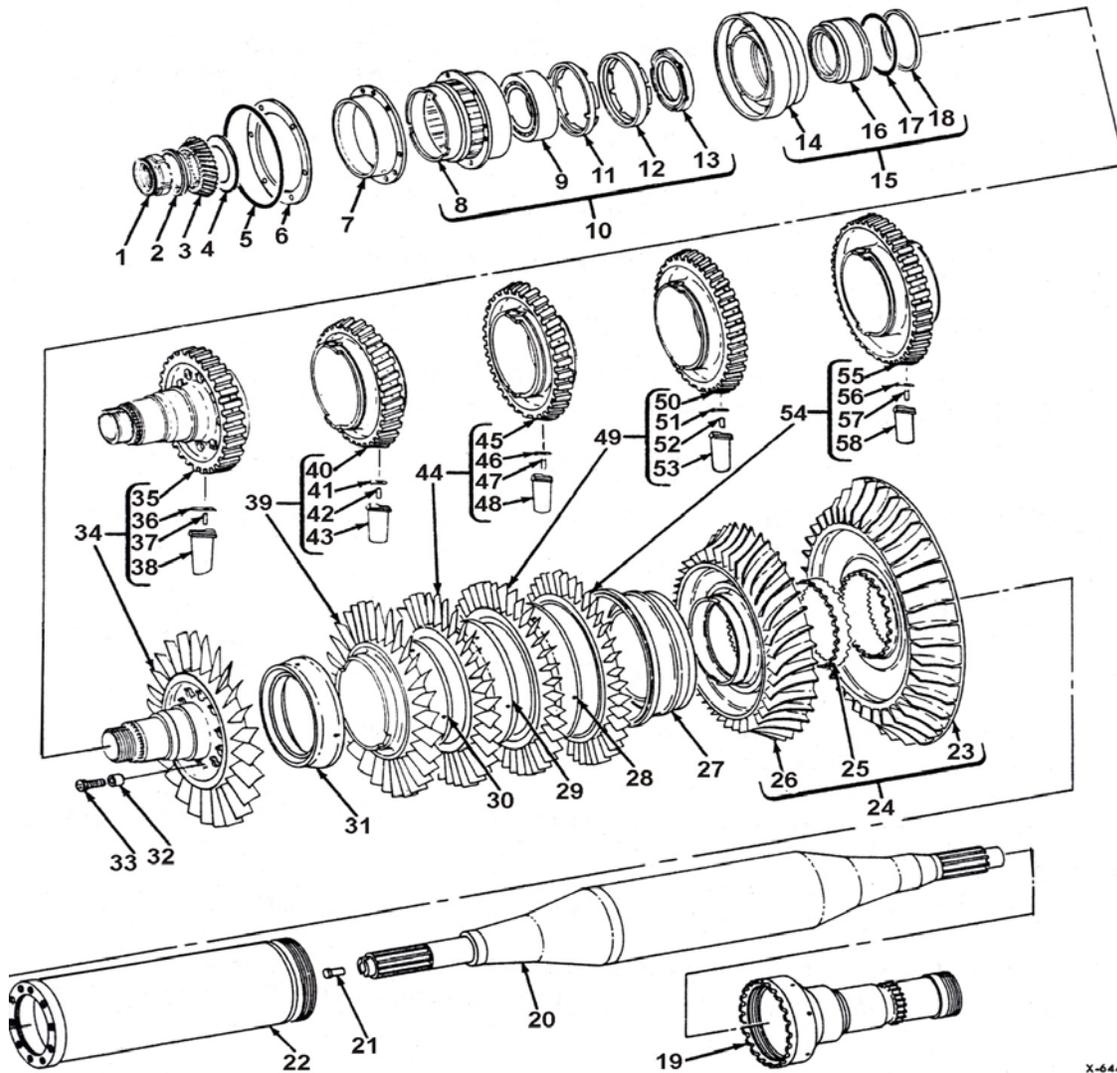
Appendix A - Compressor Rotor Assembly

Compressor Rotor Assembly - Exploded View

The components that make up the rotor assembly all have a circular shape and are designed to rotate about their geometric centre (axis of rotation). A critical design element of any high speed rotating assembly is the balancing of the individual components and of the complete assembly. In a balanced condition, the rotor's centre of mass (mass centreline) is the same as the rotor's axis of rotation. An unbalanced condition is caused by the displacement of the mass centreline from the axis of rotation through the addition or loss of material (mass). This imbalance results in centrifugal forces that cause the assembly to wobble and may result in contact with the stationary component. The results of this contact could be as minimal as blade tip rub (smearing of the blade tip) or as extensive as complete destruction. Since the rotor was dynamically balanced and successful vibration checks were carried out on the engine at the overhaul facility, and again after installation into the helicopter, it is concluded that the rotor assembly's mass centreline was the same as its axis of rotation. The elliptical shape of the blade tip plots was due to the differences in lengths of the blades and likely due to a subsequent misalignment in the rotor assembly.

The damage found within the compressor rotor could only have occurred during the overhaul, and there were known deviations from the specified overhaul procedure. Therefore, the Engineering Laboratory also examined the rotor components to determine whether incomplete seating during assembly may have resulted in seating taking place during operation, causing a loss of torque on the retainer bolts and allowing the assembly to flex and wobble. The Engineering Laboratory reported that:

Since the compressor rotor assembly was balanced prior to installation in the engine and subsequent vibration checks did not identify anomalies, it is concluded that the crushed piece of material found between the first and second compressor disks did not affect the final dimension or alignment of the rotor assembly. The ovalized shape is indicative of the rotor assembly rotating in an unbalanced condition. Each time contact occurred, the centre of mass of the rotor changed, resulting in rotation about a new mass centreline, exacerbating the situation. No conclusion could be reached with respect to the mode of failure of the smeared blade fracture surfaces. It is possible that a progressive or fatigue type of failure may have existed, but none was found.
