AVIATION INVESTIGATION REPORT A0100021

COLLISION

BETWEEN LUFTHANSA GERMAN AIRLINES

BOEING 747-430 D-ABTD AND

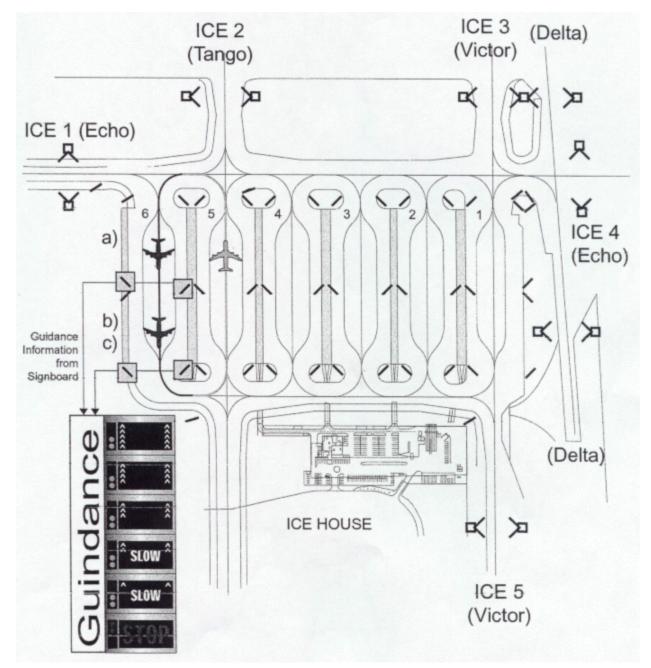
Appendix B—Central De-Icing Facility At Lester B. Pearson

International Airport

Note: This diagram was copied from an original central de-icing facility / Hudson General operations manual. The de-icing bays and the facility layout are accurate; however, the "guidance signboard" (lower left) does not accurately depict the system that was installed and functioning on the date of occurrence.
