## MARINE INVESTIGATION REPORT

M04W0225

### CAPSIZING

FISHING VESSEL *PROSPECT POINT*

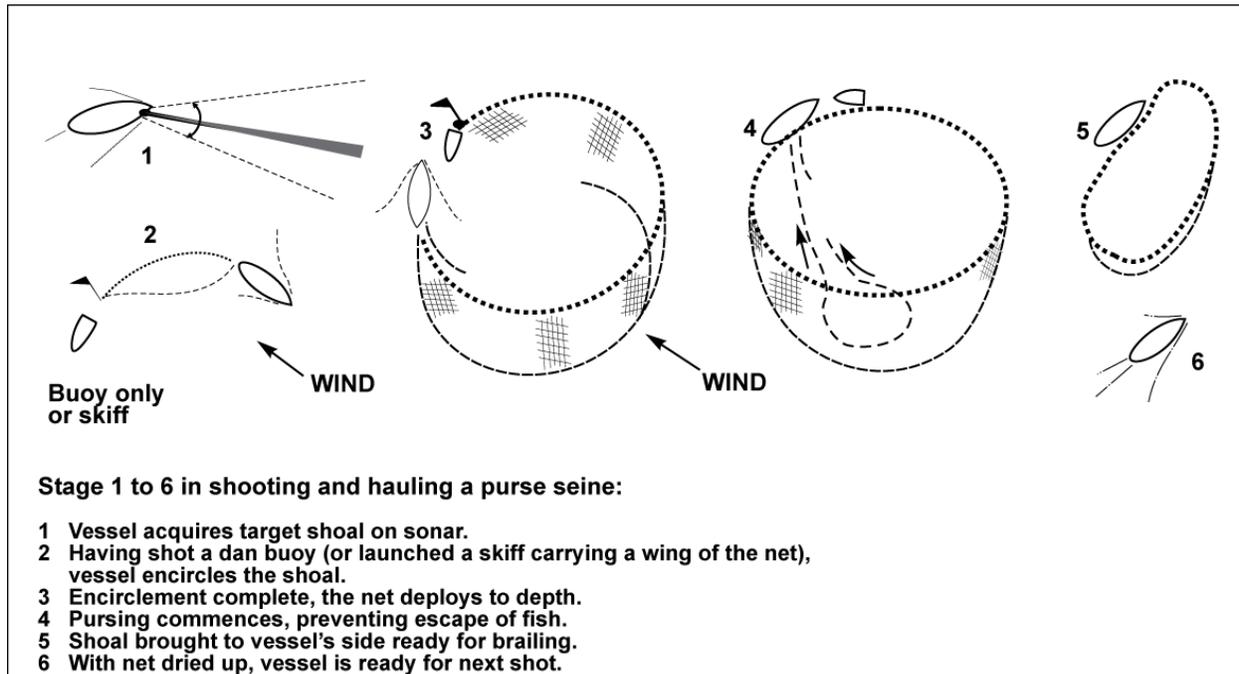
Figure 1. Sketch showing six stages in shooting and hauling purse seine

Purse seining is a method used to catch schooling fish near the ocean surface by encircling them with a net. Once the fish have been encircled, a wire (purse line) running through the bottom of the net is winched tight to "close the purse" from below.

When setting the net, a power skiff secures to the free end of the 410 m long net, then draws it off the seine drum and away from the fishing vessel (seiner). The upper edge of the net is buoyed with floats and remains on the surface. Approximately 35 m below the surface, the lower edge of the net is weighted so that it is suspended vertically in the water. Metal rings connect the “purse line” to the lower edge of the net.

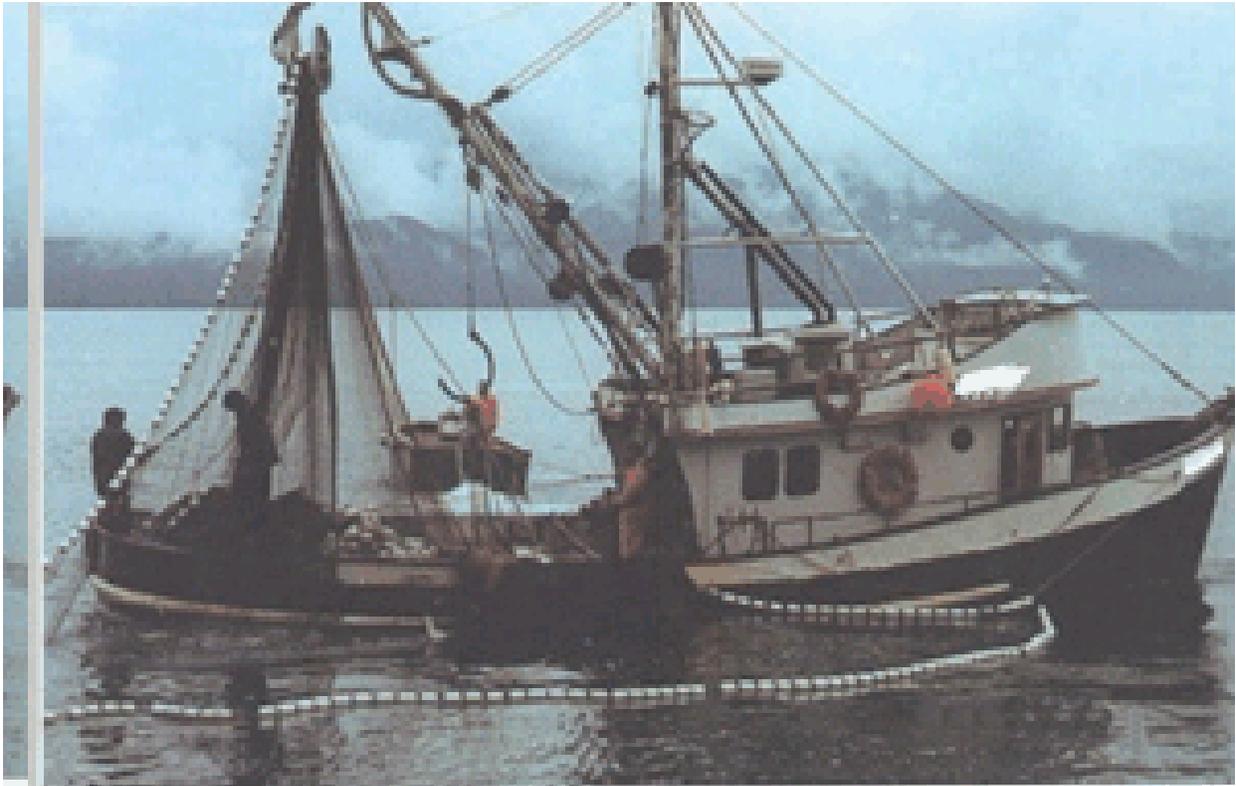
**Photo 1.** Photo of a fishing vessel engaged in purse seining
