MARINE INVESTIGATION REPORT

CAPSIZING WITH LOSS OF LIFE

OPEN SPORTS FISHING VESSEL

*MARABELL 8*

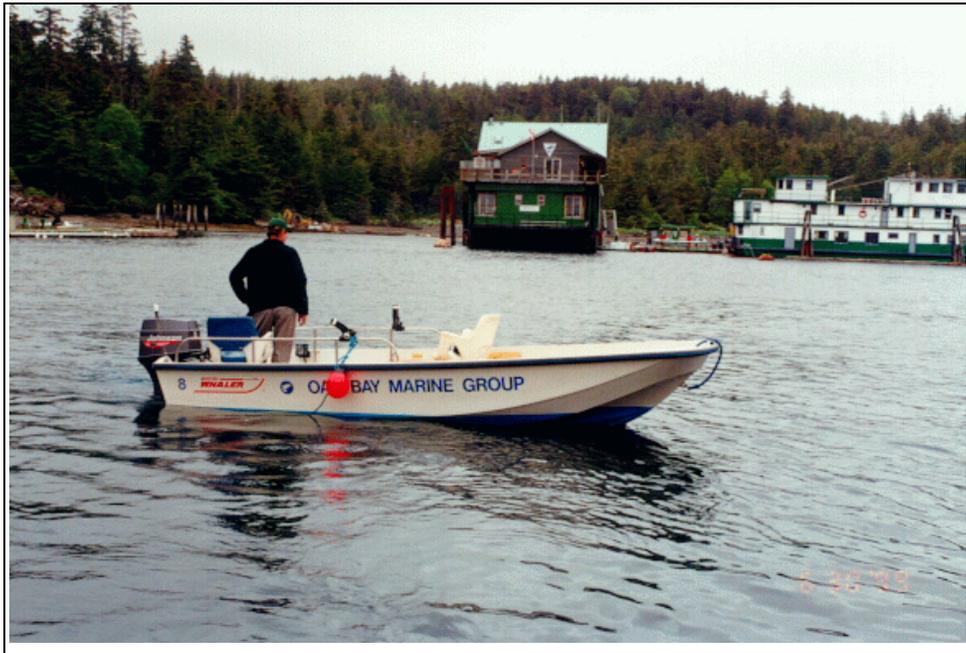
The *Marabell* is a converted hydrographic survey vessel of wood construction. The boat deck consists of an extensive foredeck leading to a raised wheelhouse followed by accommodations and lounges. The after portion of the boat deck consists of a small exterior area surrounded by stanchions and handrails. The weather deck consists of accommodation spaces, an after saloon, a galley, and a stowage area.

The *Marabell* is anchored each year in Henslung Cove, Langara Island, British Columbia, between mid-May and the end of July. It provides accommodation for paying guests who participate in sport fishing for salmon, halibut, and cod. At the time of the accident, a floating dock was secured to the port side of the vessel and was used as a moorage site for 13 small fishing boats, one of which was the *Marabell 8*.
